1(4) SB1204

TOPIC: OVER TENSIONING OF INLET MANIFOLD FASTENERS

LEADING TO GASKET FAILURE

APPLICABLE TO: ALL SANDVIK CAT C7 ACERT EXPLOSION PROTECTED

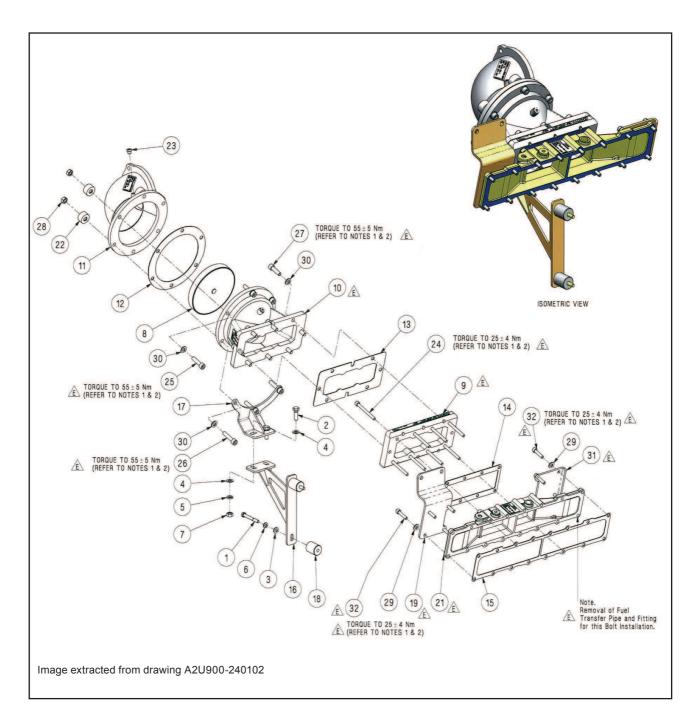
- 1. Remove all traces of the old gasket from the contact faces carefully so as not to mark or score the metal surfaces.
- 2. Perform Code D component compliance check on the inlet manifold (see separate dwg. BD00009952, sheet 2/2).
- 3. Once the inlet manifold has passed, proceed with the assembly of all components (Ref 1.4).
