ALERT SERVICE BULLETIN

ASB221E

INSPECTION OF MODEL 1A103/TCM PROPELLER HUB FOR CRACKING AND REWORK PROCEDURES

1A103/TCM (All Serial Numbers)

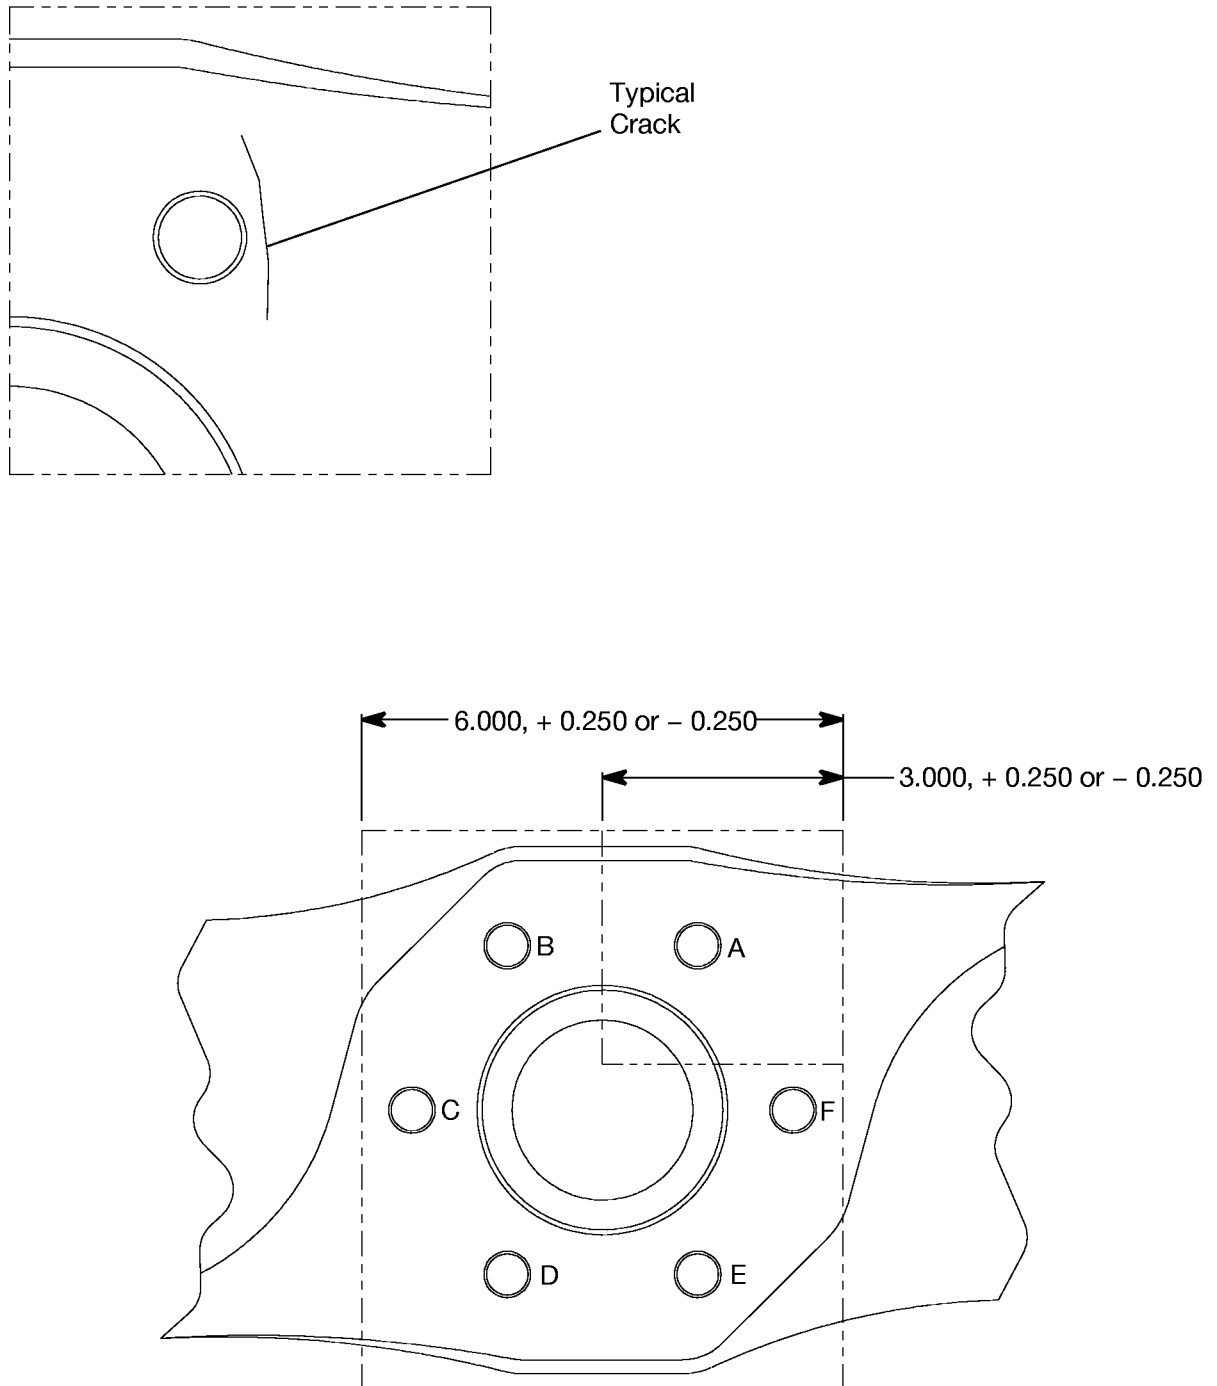
Figure 12. Typical Crack Appearance and Location (Sheet 1)

McCauley has received reports of cracks in the 1A103/TCM model propeller hub. Cracks have been found on the camber side of the propeller hub near the mounting bolt holes. These crack(s) have been observed primarily in areas where fretting is present around propeller mounting bolt holes.

- B. Strip paint from the propeller hub area.
 - (1) There should be no paint on the face (aft) side of the propeller hub. If there is, make sure all paint in that area is removed. Remove the paint from the camber (forward) side of the propeller hub. Make sure all paint is removed from the hub area of the propeller. Refer to Figure 12. for an illustration of the inspection area on the camber (forward) side of the propeller.

- (b) Anodize the propeller. Refer to the Standard Practices Manual, Protective Treatments 60-00-04, Anodize.
- (3) Repaint the propeller hub. Refer to the Standard Practices Manual, Paint Instructions 60-00-06. Do not paint the engine mounting surface (face/aft side) of the hub within the dimensioned area as shown in Figure 12.

NOTE: Figure 12. is an illustration of the camber (forward) side of the propeller, transfer the dimensioned area shown to the engine mounting surface (face/aft side) of the propeller hub.

F. Repaint the propeller hub. Refer to the Standard Practices Manual, Paint Instructions 60-00-06. Do not paint the engine mounting surface of the hub within the dimensioned area as shown in Figure 12.
