SERVICE BULLETIN

APPLICABILITY: 2013MY Legacy and Outback 2.5L Models
 2012-13MY Impreza 2.0L Models
 2013MY XV Crosstrek
 2011-2014MY Forester NA Models Only
 2013MY BRZ

NUMBER: 11-130-13
DATE: 04/05/13

SUBJECT: Difficulty Starting, Rough Idle, Cam Position or Misfire DTCs
 P0340, P0341, P0345, P0346, P0365, P0366, P0390, P0391,
 P0301, P0302, P0303 or P0304

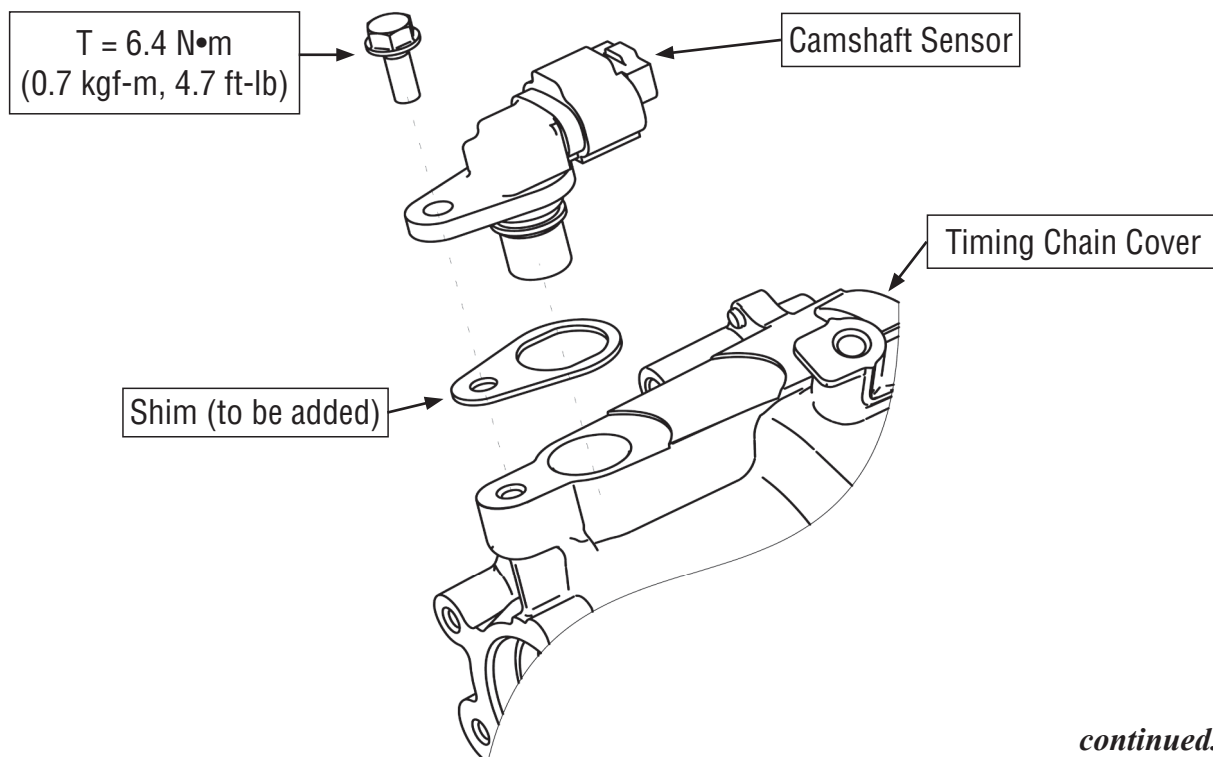
The specified clearance is 1.3 +/- .05mm (1.25 to 1.35mm or .049" to .053").

1. Record the customer's radio station presets (and navigation system favorites if applicable).
2. Disconnect the negative battery cable.
3. Remove the camshaft position sensor from the timing chain cover using the procedure in the applicable Service Manual.

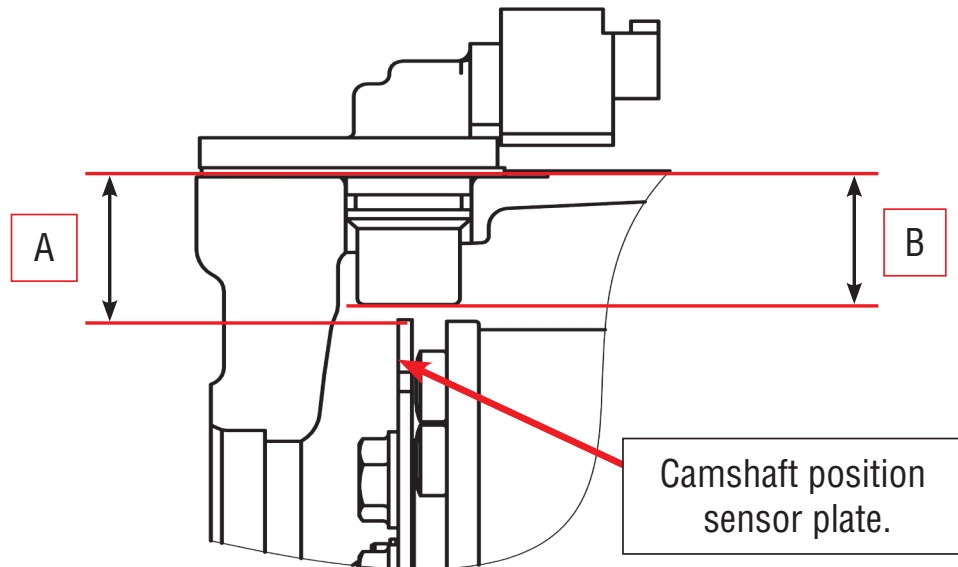
A = Top of timing chain cover to camshaft position sensor plate

B = Camshaft position sensor mating surface to the bottom of the sensor

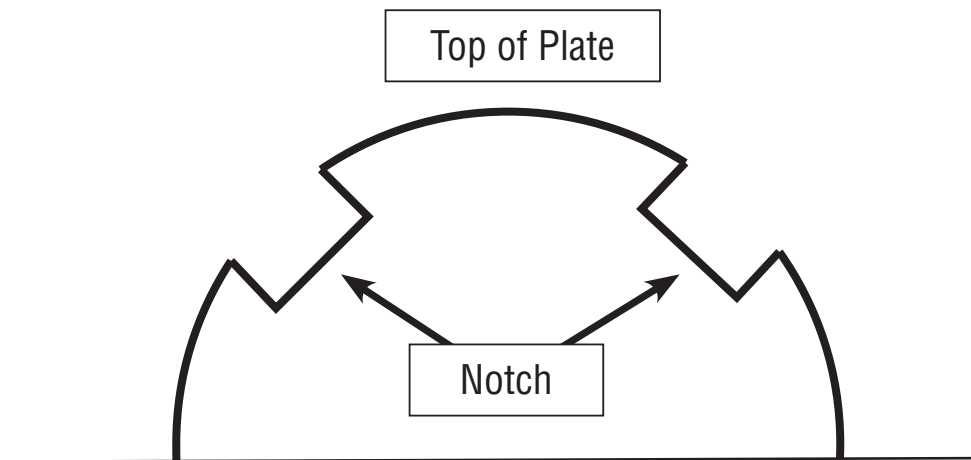
NOTE: When measuring “A”, make sure you are measuring to the outside diameter or “top” of the sensor plate and not to the bottom of a notch as shown below. Be sure to record all measurements.

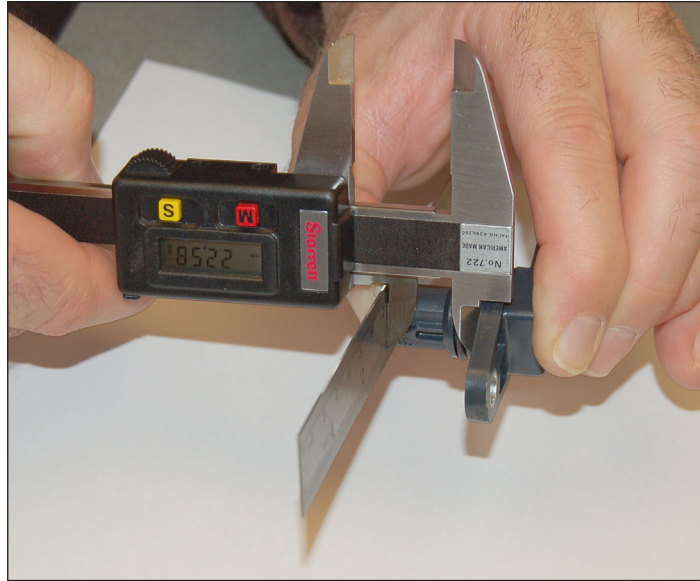
When taking measurement “B”, use a flat steel ruler or equivalent along with the digital caliper.

7. Measure the distance between the camshaft position sensor mounting surface and the bottom of the sensor as shown above.

IMPORTANT: Be sure to account for the thickness of the flat washer (if you are using one) when performing your calculations to determine the required shim thickness.
