Applies To: **2006 Ridgeline** – From VIN 2HJYK1...6H500001 thru 2HJYK1...6H521114
2007 Ridgeline – From VIN 2HJYK1...7H500001 thru 2HJYK1...7H550722

April 15, 2008

Diagnosing and Repairing Water Leaks

(Supersedes 07-082, dated November 28, 2007, to update the information marked by the black bars)
 (Replaces 05-045, *Water Leak at Right Front Floor*, dated November 17, 2005, and 06-016, *Water Leak Near the Right Rear Door*, dated April 11, 2006.)

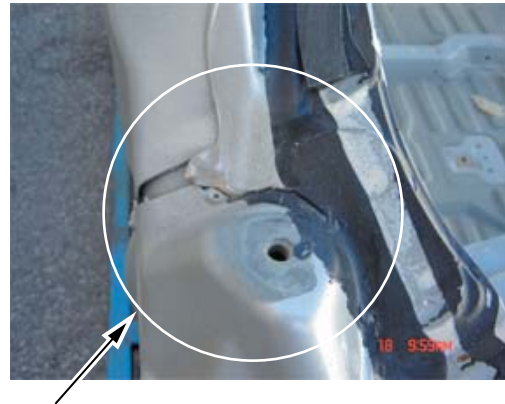
- Remove the fender as shown in the photo. Spray water on the lower left corner of the windshield. If water enters the interior of the vehicle, go to **REPAIR PROCEDURE C**. (Do not confuse this procedure with **REPAIR PROCEDURE F**.)

Remove the fender.

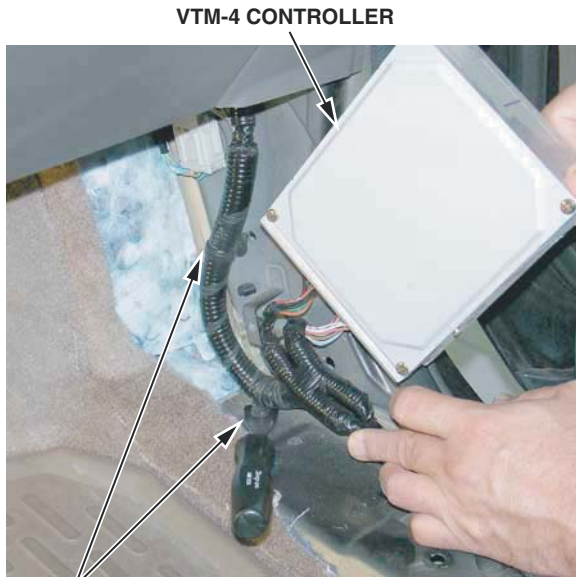
WIRE HARNESS CLIPS
(Detach in two places.)

3. Using a pry tool, detach the wire harness clips at the locations shown, then move the VTM-4 controller out of the way.

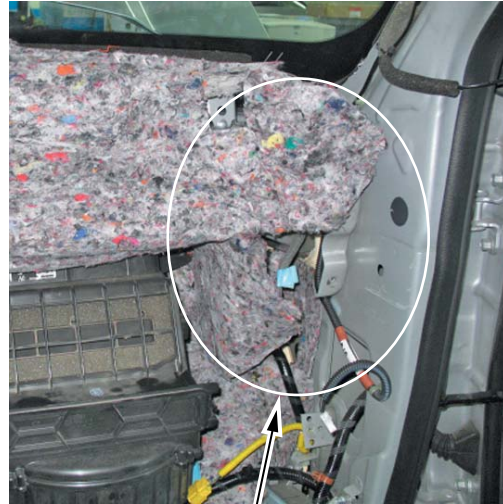
Remove the insulation from this area.

1. Remove the front seats:
 - Refer to page 20-97 of the Service Manual, or
 - Online, enter keywords **SEAT REMOVAL**, and select **Front Seat Removal/Installation** from the list.
2. Remove the instrument panel:
 - Refer to page 20-81 of the *2006–2008 Ridgeline Service Manual*, or
 - Online, enter keywords **INSTRUMENT PANEL**, and select **Instrument Panel Removal/Installation** from the list.
3. Remove the insulation from the area shown below.
