JAGUAR

IMPROVED ENGINE SUMP OIL SEALING

SERVICE BULLETIN

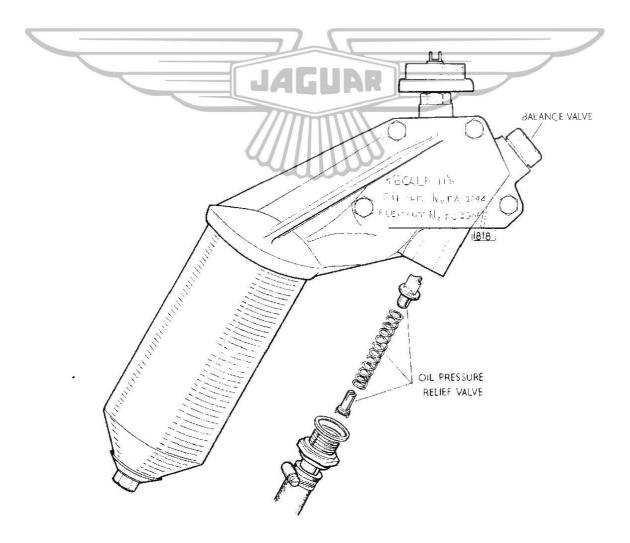
On cars with the above engine numbers and enwards a modified oil filter (Part number C.16296) is fitted. The canister of the new oil filter is inclined downwards and therefore no drain plug is fitted. The oil pressure relief valve is retained by the outlet adaptor to which oil return hose is fitted and must not be confused with the balance valve (see illustration overleaf). The element (Part number 1526 - FG.2306) and sealing ring (Part number 6883) are the same as fitted to the previous type of oil filter.

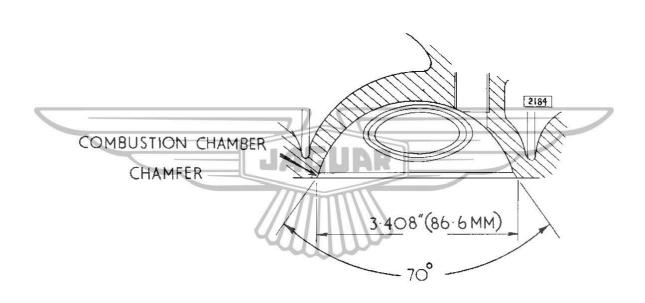
If replacing either cylinder head or pistons on any 3.8 litre 8 to 1 compression ratio engine, it is essential that the following facts should be noted. (Piston part numbers are stamped on the flat portion of the crown of the piston).

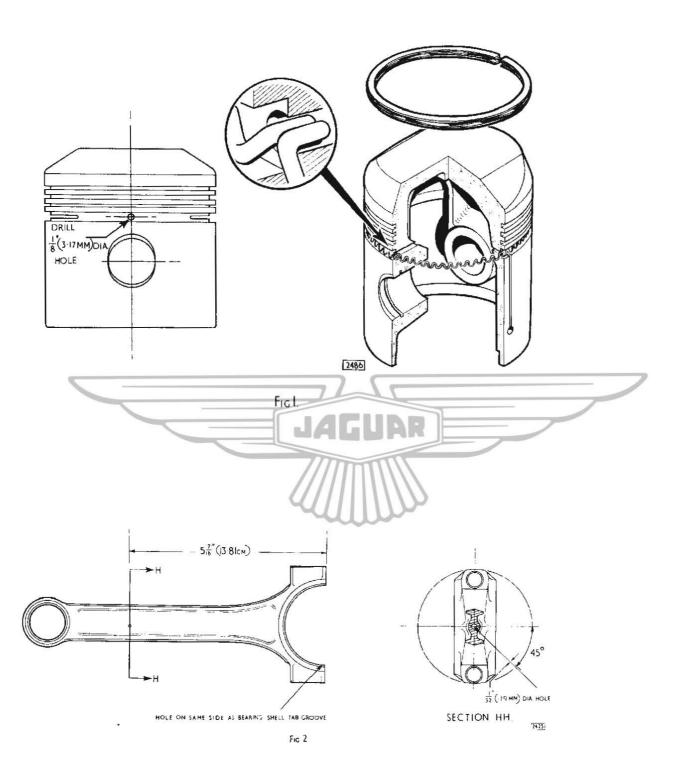
The oil control ring gap when fitted is .015" - .033", (.38 - .83 mm).

It is recommended that a self-locking type of piston ring clamp such as the Churchill 38.U.2. is used when refitting the pistons to the cylinder bores.
