Tips from Comanche *Flyer* magazines Feb 2002 – Aug 2009

CHAPTER THREE

FUEL SYSTEM

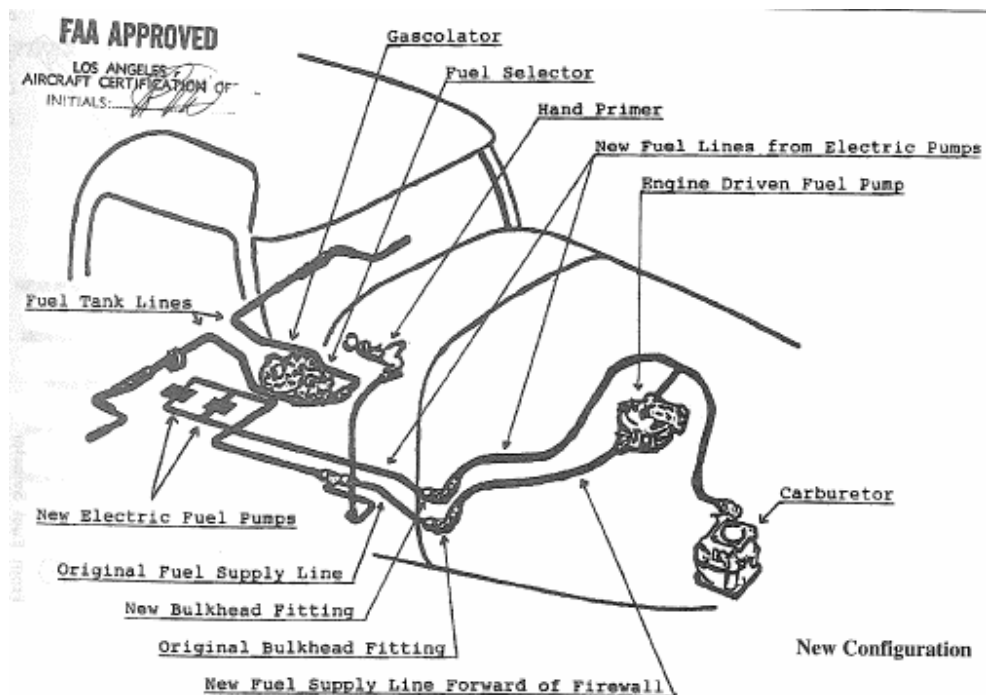
Top View Looking Down

Original Fuel System Configuration with Interrupter type fuel pumps, hoses and connections all located in lower aft section of engine compartment.

b. Make and model designation of product to be modified Piper PA24-250, Serial No24-2999, N7782P	
c. Description of modification Replace and relocate the electric fuel pumps from the engine compartment to the gascolator compartment. See attached drawings and information
