January 2015, Volume 17, No. 1

TECHLINE

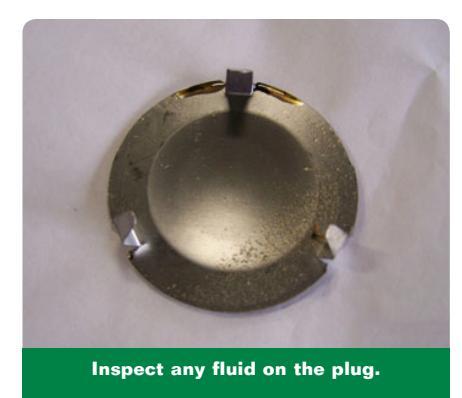
On some 2015 Colorado and Canyon models equipped with an automatic transmission (RPO MYB), what appears to be an oil drip may be found on the inspection plug on the bottom of the torque converter housing or the crossmember.

will be much thicker than oil.

If grease is found, clean out the inspection hole and plug with degreaser and reinstall the plug. Clean any other affected surfaces.

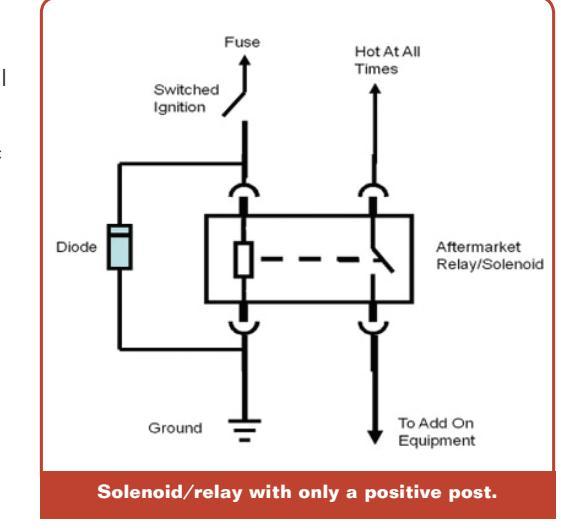
This condition may be caused by the Transfer Case Control Module (TCCM) back feeding voltage into the fuse block with the ignition off. If the TCCM is disconnected, the voltage at the fuses will be gone. If the TCCM is replaced, the issue may only be corrected for a short time. The internal circuitry of the TCCM may have been permanently damaged by a voltage spike, causing the back feed.

In most cases, the voltage spike is caused by an aftermarket accessory, which uses a solenoid or relay, that is wired onto the F30DL fuse or to the X61A I/P Junction Block connector X7, terminal 11, or connector X5, terminal 35. If these solenoids or relays are not properly suppressed, they will produce a voltage spike. The voltage spike can be transmitted onto the Run/Crank Ignition Buss Bar and permanently damage the TCCM.

Insulate the diode with heat shrink tubing before installation.

Also install a diode, P/N 12112422, across the coil of the relay. Connect the striped end of the diode to the positive terminal of the coil and connect the other end of the diode to around. Be sure to insulate the diode with heat shrink tubing before installation.
