SERVICE EDGE

The Laser Printer Tech Quarterly
from Liberty Parts Team

Winter 2011

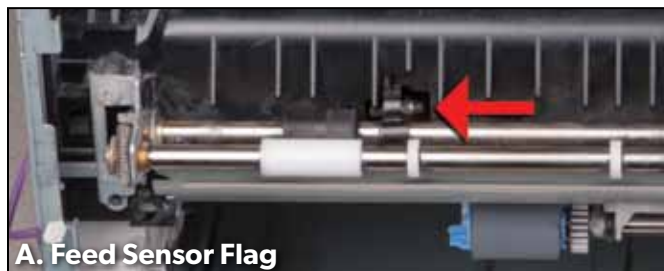
remanufactured paper feed assembly, which includes the actuator arm and spring, RM1-0012-R. The optical sensor is part of the transfer assembly. Note that the spring must be installed with the tail tucked back into the transfer assembly to maintain tension.

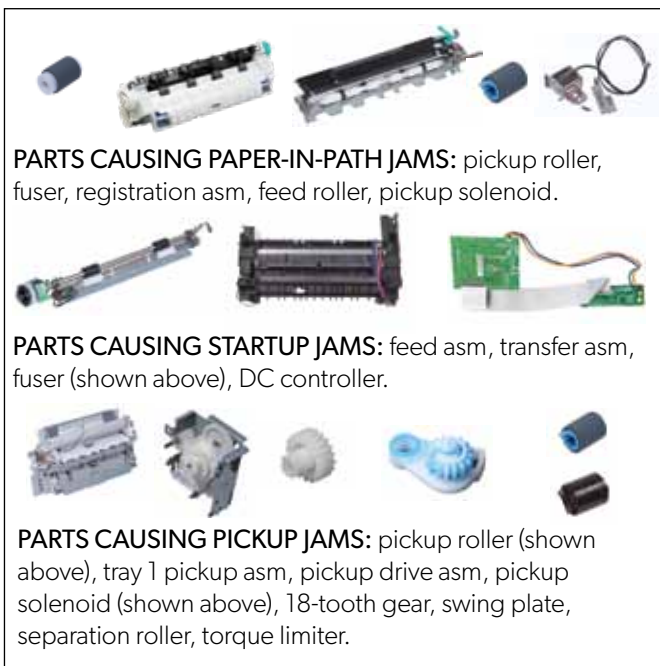
Swing Plate Asm Replacement, 42xx/43xx

A worn-out fuser drive gear, causing grinding noises while printing, is a very common problem in this series of printers. This gear is part of the swing plate assembly, which contains the black fuser drive gear and another white gear. Usually, you only need to replace the black gear, and this is a relatively simple procedure which is available on our website. But occasionally, both gears are worn, and then you will need to replace the entire swing plate assembly. There is no procedure for this in the service manual, so we provide one here.

When re-installing the new swing plate assembly, make sure that it is mounted flush to the printer chassis, and that the swing arm moves freely.

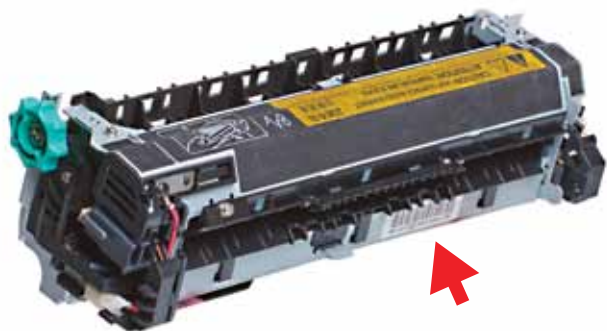
Many parts interchange in the HP LaserJet 4200/4200, 4240/4250/4350 and 4345, but the fuser generally doesn't. Whenever you see a 13.20 or 50.5 error after installing a fuser in one of these printers, you should check that it's the correct fuser for that printer. Here's how.

1 Find the fuser's part number on the bar code label above and to the right of the connector. If the label has been removed or is unreadable, go to 2.
