# E020 Error Code Workflow

- In an effort to assist the field troubleshooting E020 Error Codes, Canon U.S.A., Inc. is introducing this imagePRESS C1 Series E020 Workflow Course. The workflow includes links to valuable information, including error code definitions, theory, practical fixes, and most importantly direction on how to troubleshoot various E020 Error Codes.

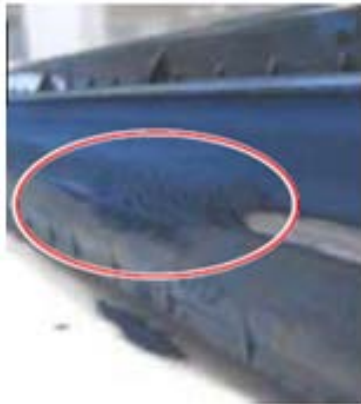
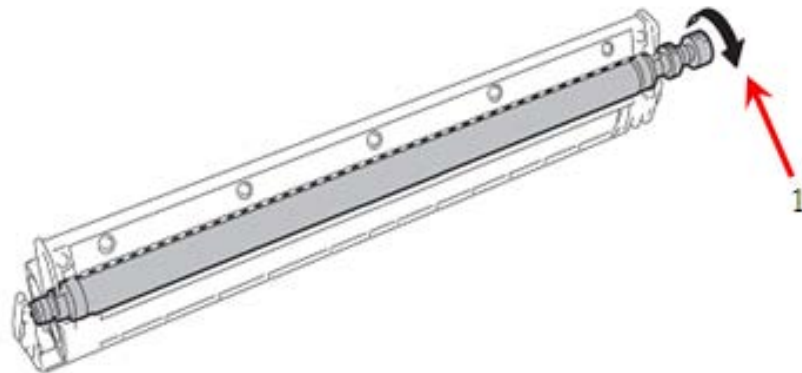
# Developer Assembly

The readings from the Patch Image Sensor (PS3) and the ATR Sensor (PS7) can be affected by the fluidity of the Start Developer and the Toner inside the Developer Assembly. As a result of contamination or the Developer Cylinder being rotated in the reverse direction, fluidity can be disrupted and a buildup of Developer/Toner material in one area of the Developer Assembly, or across the entire Developer Cylinder can occur. If the buildup cannot be removed by rotating the Developer Cylinder in the normal direction [1], try removing the build up with a clean sheet of paper, by scooping it out and then carefully pour it back onto the Developer Cylinder while rotating the Developer Cylinder in the normal direction.
