HP LaserJet 9000,9050, 9000mfp, 9040mfp and 9050mfp Series Printers-TWI: Troubleshooting and Resolving 13.20 Paper Jam Error Messages

Document number BPL90217

This document will assist in troubleshooting 13.20.00 paper jams. Any of the following can cause 13.20 errors.

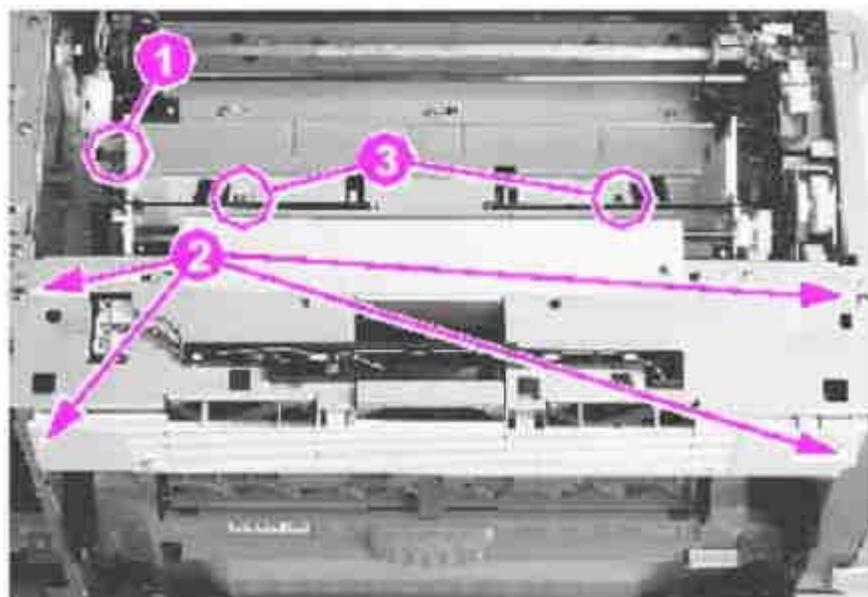
Figure 6: Delivery assembly removal

NOTE: After removing the left top cover look at the delivery assembly. Examine the two sensors and their respective flags for any damage or stuck media. If there is stuck media in the sensors, remove it and verify the flags move freely through the sensors. If this is the case then the issue is probably resolved at this point. Reassemble the printer and test to verify the error message has been cleared. If the assembly is damaged then proceed with replacing it.

1. Remove the control panel. (Figure 2.)
2. Remove the right-top cover (Figure 3), the left-top cover (Figure 4), and the left-back cover (Figure 5).
3. Open the left door.
4. Face the top of the printer.
5. Unplug one cable connector (Figure 6, call-out 1).

6. Remove four gold screws (Figure 6, call-out 2) and two silver screws (Figure 6, call-out 3).
 7. Lift the delivery assembly out of the printer.

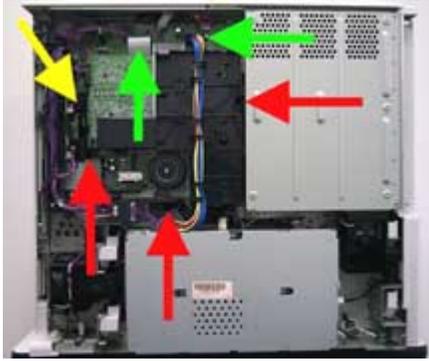
Figure 3

Nothing, many would say, but recently after reinstalling an HVPS into an HP LJ 9000 printer, we started getting instant 13.20 paper jams. What could be going on? After checking for paper that may have been left in the machine and verifying the flags were ok, I opened the Service Manual (OK, I was really stumped). One of the steps in the Service Manual is to verify the proper seating of the leaf springs under the HVPS. After removing the HVPS, I found that one of these leaf springs was bent to the right (Figure 1) and out of the case. These leaf springs should be to the left over the case, so when you reinstall the HVPS, the contacts on the board touch the leaf springs. These contacts are labeled TB1009 & TB1010 on the HVPS (Figure 2).

2. Remove the HVPS by:
 - Disconnecting two cables (green arrows, Figure 3).
 - Removing three screws (red arrows, Figure 3).
 - Unlatch one tab (yellow arrow, Figure 3).

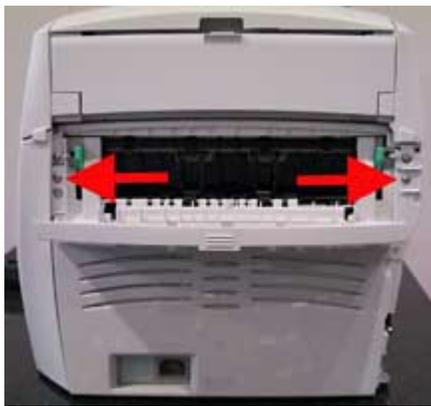
Figure 6

Upon further investigation, the customer had admitted to trying to fix the printer himself for a separate problem, and not knowing which wire went to where, he assumed it didn't matter. When connecting these wires, note that both are red and both connect the exact same way. It's important not to cross them as they go straight up to their appropriate connectors (again, see Figures 4 and 5 for the proper and improper connections).

1. Open the toner cartridge door.
2. Remove the left side panel (as looking from the front).
3. Remove the two screws as indicated by arrows in figure 6 and remove the rear panel.
