~ Kansaki KBW 10 Transmission Fluid Leak Repair ~

Replacing the oil seal, O ring and locking nut on *Spináche*

1989 Island Packet 35

Spring 2015

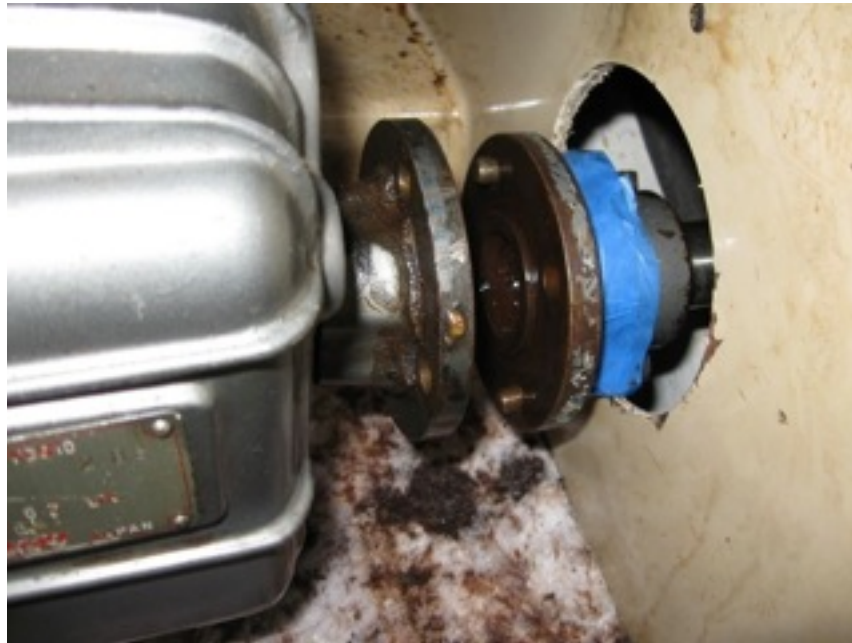
There I discovered several people who had done the repair without removing the transmission, one in particular who did it on an Island Packet. Below is his photo of the first step in this process: separating the couplings that connect the output shaft coming out of the transmission to the prop shaft running out to the prop. There are 4 grade 8 bolts that hold these together....

To separate these couplings, you have to slide the prop shaft aft (far enough to slide the output coupling off the output shaft). To accomplish this, you need to unthread the stuffing box packing gland to relieve pressure on the prop shaft.

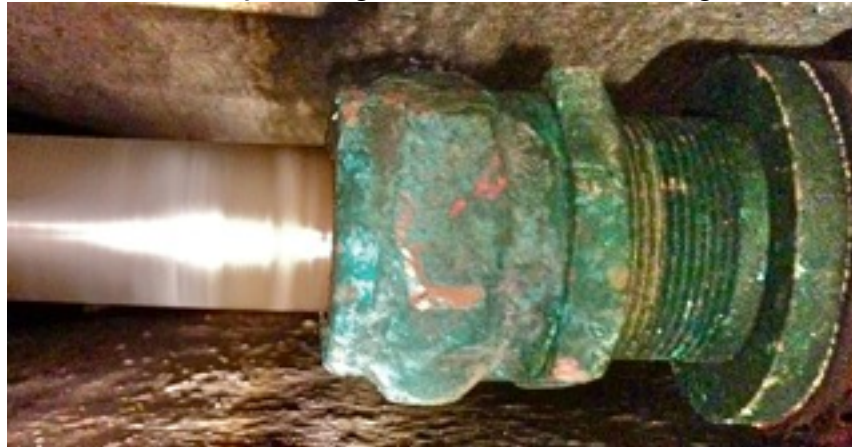
This is my stuffing box before unthreading....

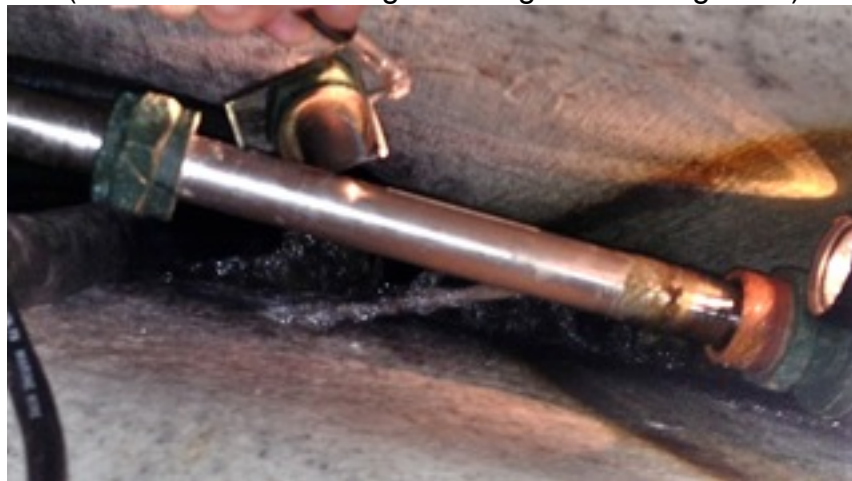
...and after....

(note the water rushing in through the through-hull)

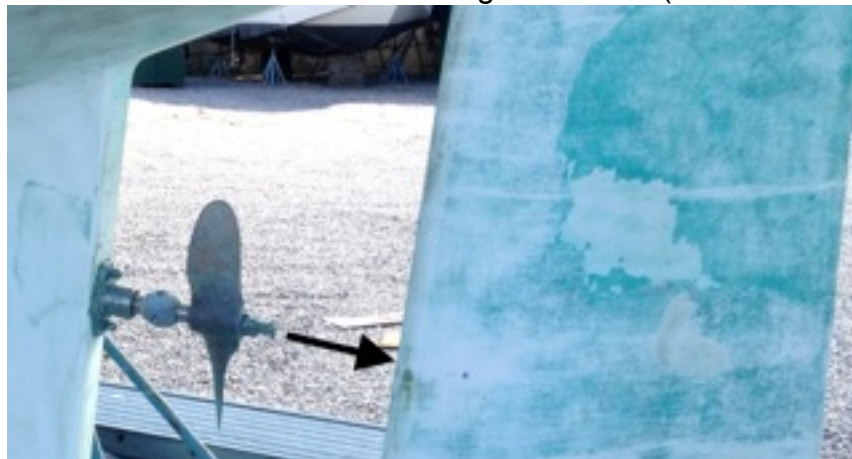
This is how much room I had before hitting the rudder (more than enough)...

Then it was easy to slide the prop shaft aft.

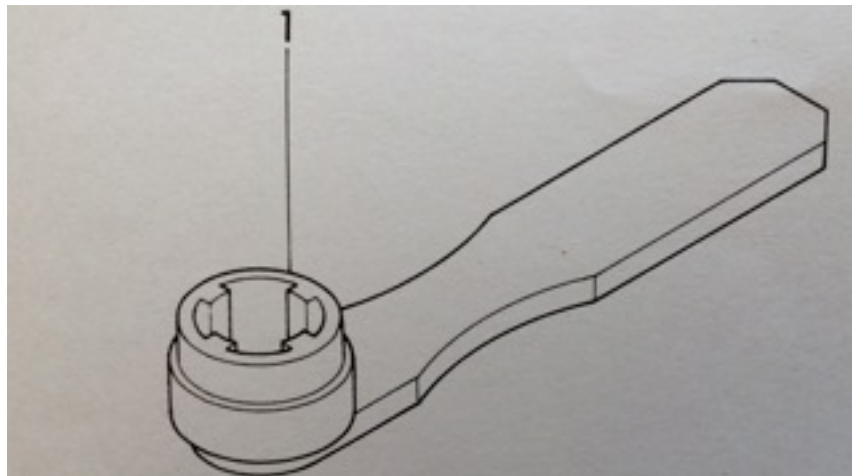
Yanmar sells the wrench shown below (part # 177099-09010) expressly for that purpose...at a cost of about \$235!...

Before dismantling the coupling, the transmission had to be drained of lubricating fluid. Then the locking nut had to be removed. This would require enough torque to break the caulking (dent) in the nut's lip. Due to the unique shape of this nut, it requires a custom tool in order to be removed or tightened.

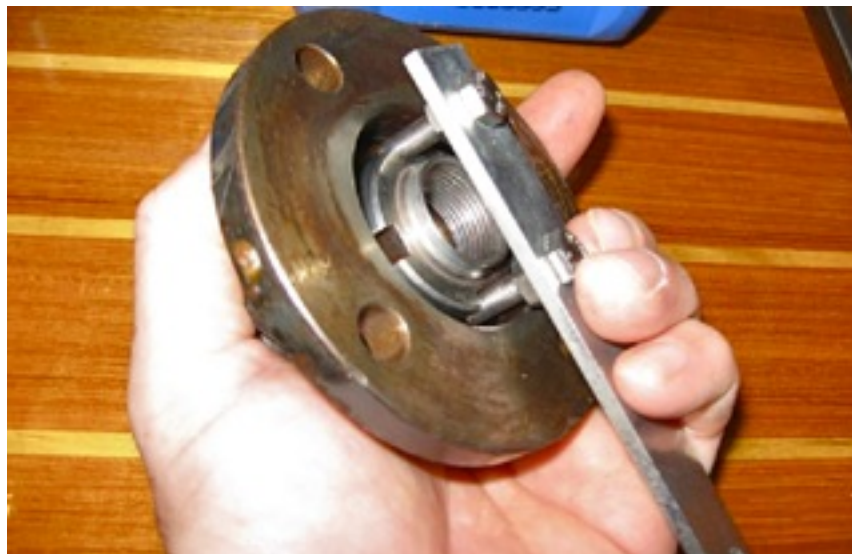
Online I found this photo of a homemade wrench...

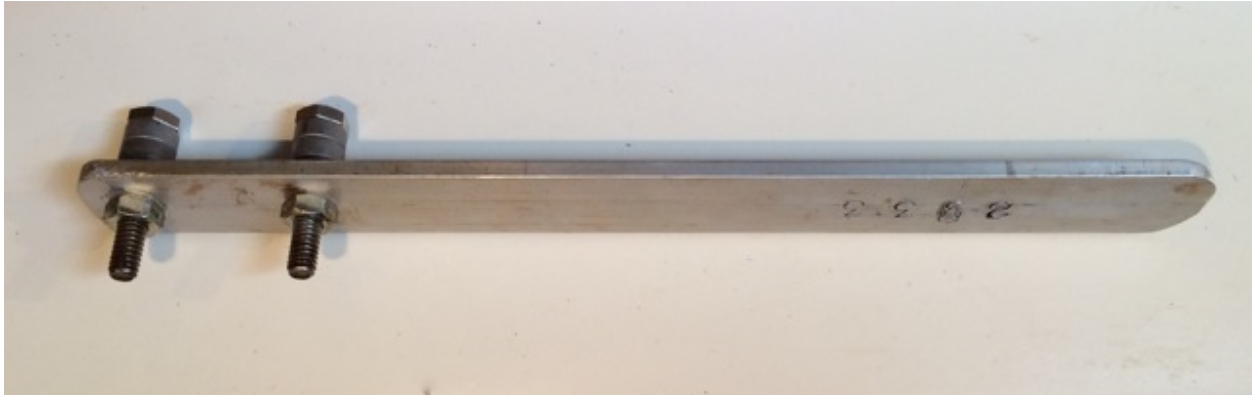
I showed the nut, and the photo of the homemade wrench, to my very handy brother-in-law, Jack Roberts (former owner of ***Packet Inn***, a 1984 IP31), while visiting him this winter. He fashioned me a similar tool from an aluminum bar into which he drilled and tapped 2 holes, then added some stainless steel bolts. He even added some "serial numbers" just for authenticity! ...

The spacers under the bolt heads made it easy to adjust the length of the bolts so that the handle lay as close to the coupling as possible when engaging the nut with the nut fully threaded in, making the tool much stiffer when force was applied.

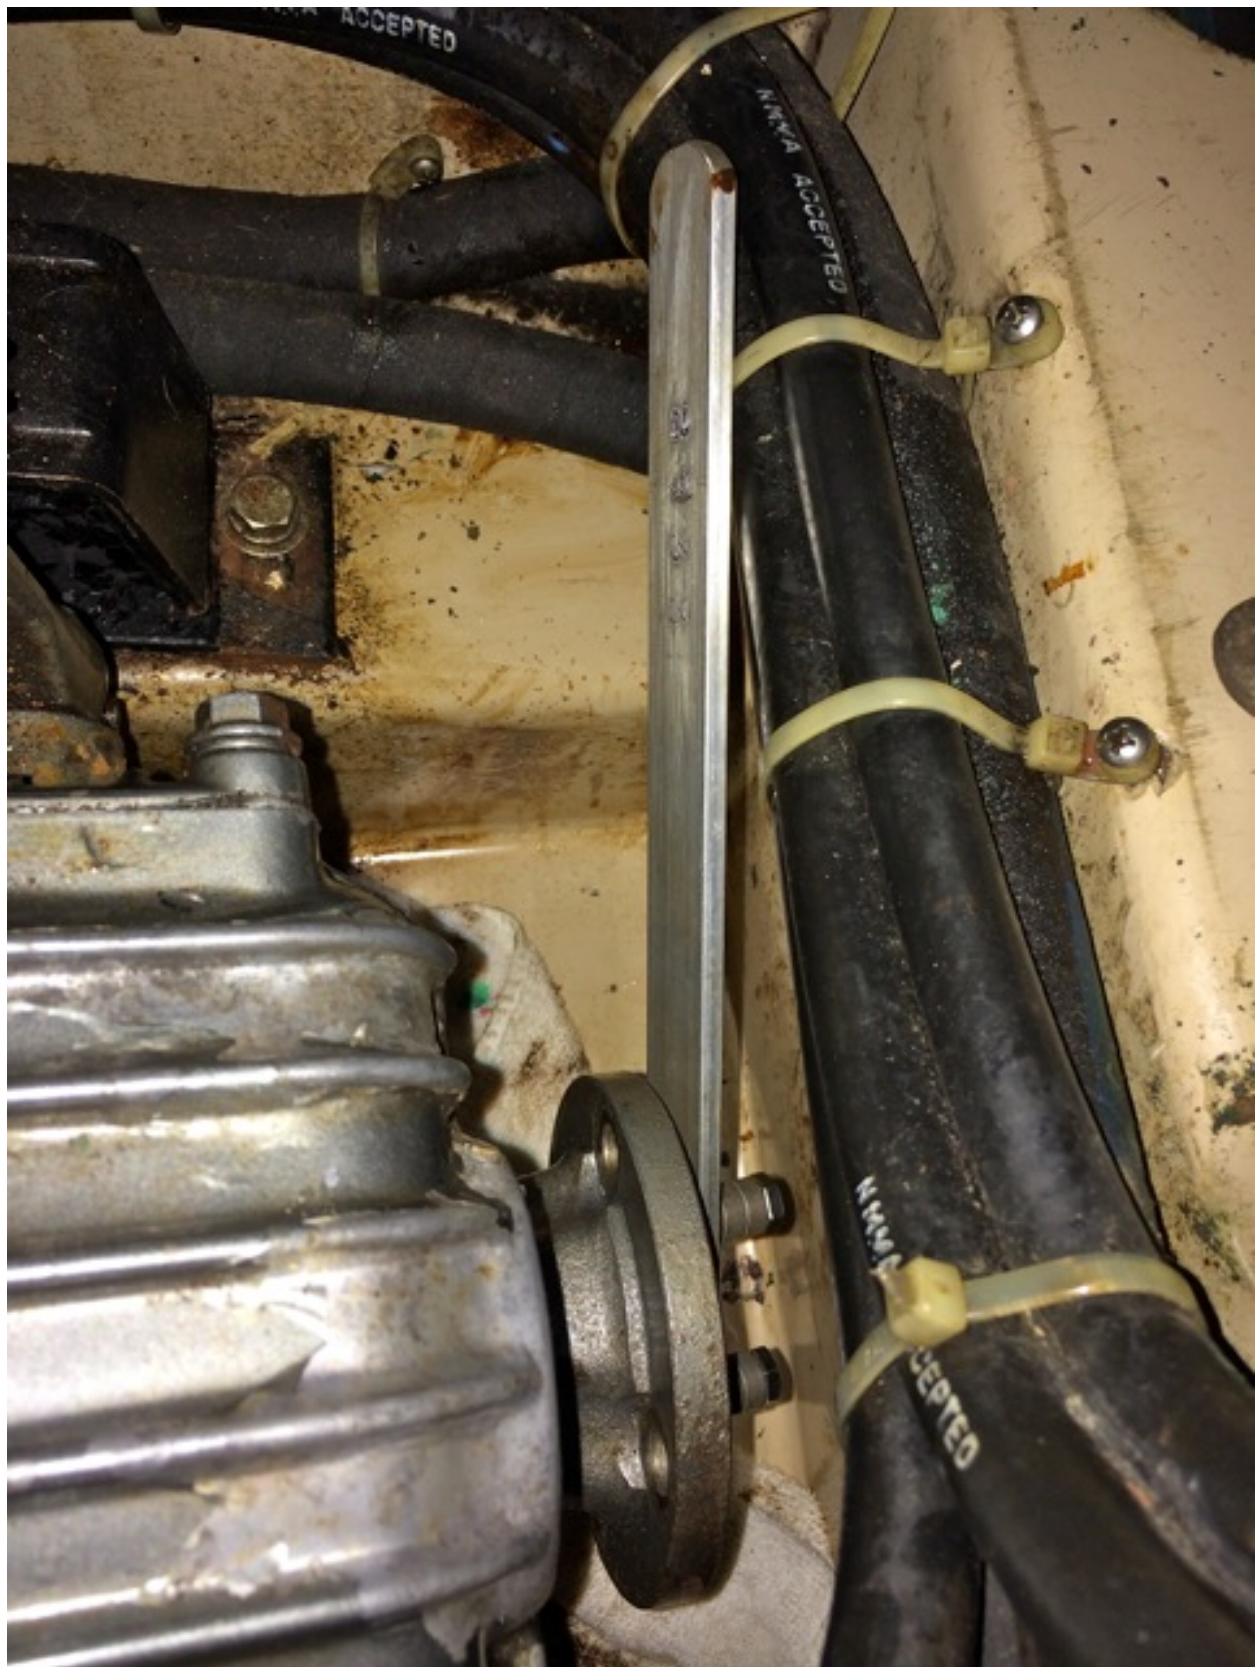
On the next page is Jack's homemade tool in place, with the bolts inserted into the notches on the nut. With a little force, I was able to break the caulking and unthread the nut...it worked like a charm!

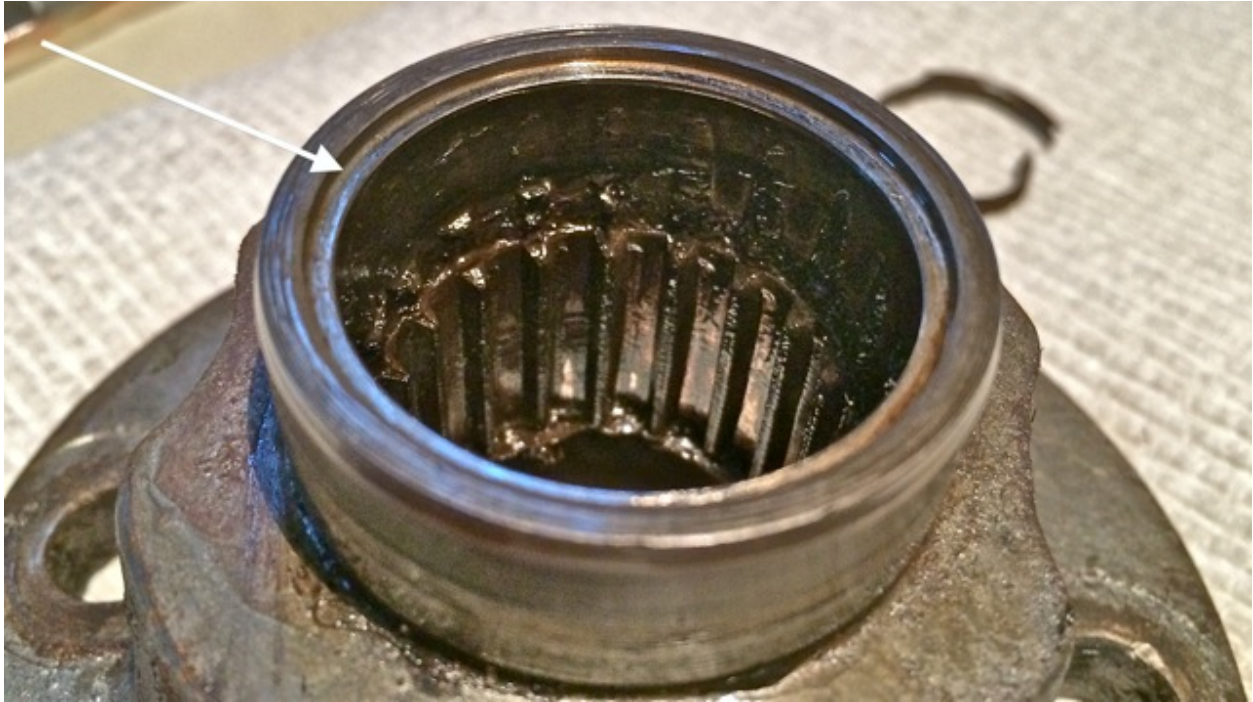
This is the output coupling removed, cleaned up and showing the splines. Note also the impression along the inner edge of the forward end that accommodates the O ring (arrow)...

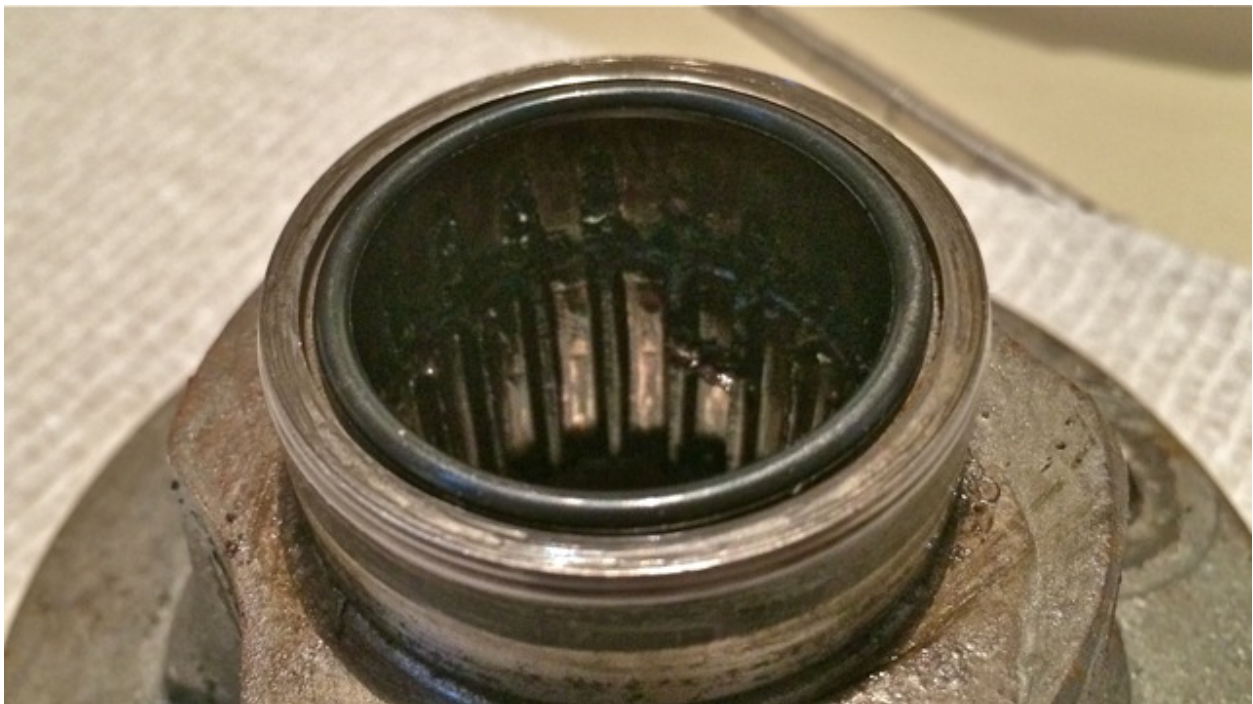
This shows how the O ring fits against the forward end of the coupling...
(later the O ring will actually be placed around the shaft and rolled forward to set in the groove on the shaft)

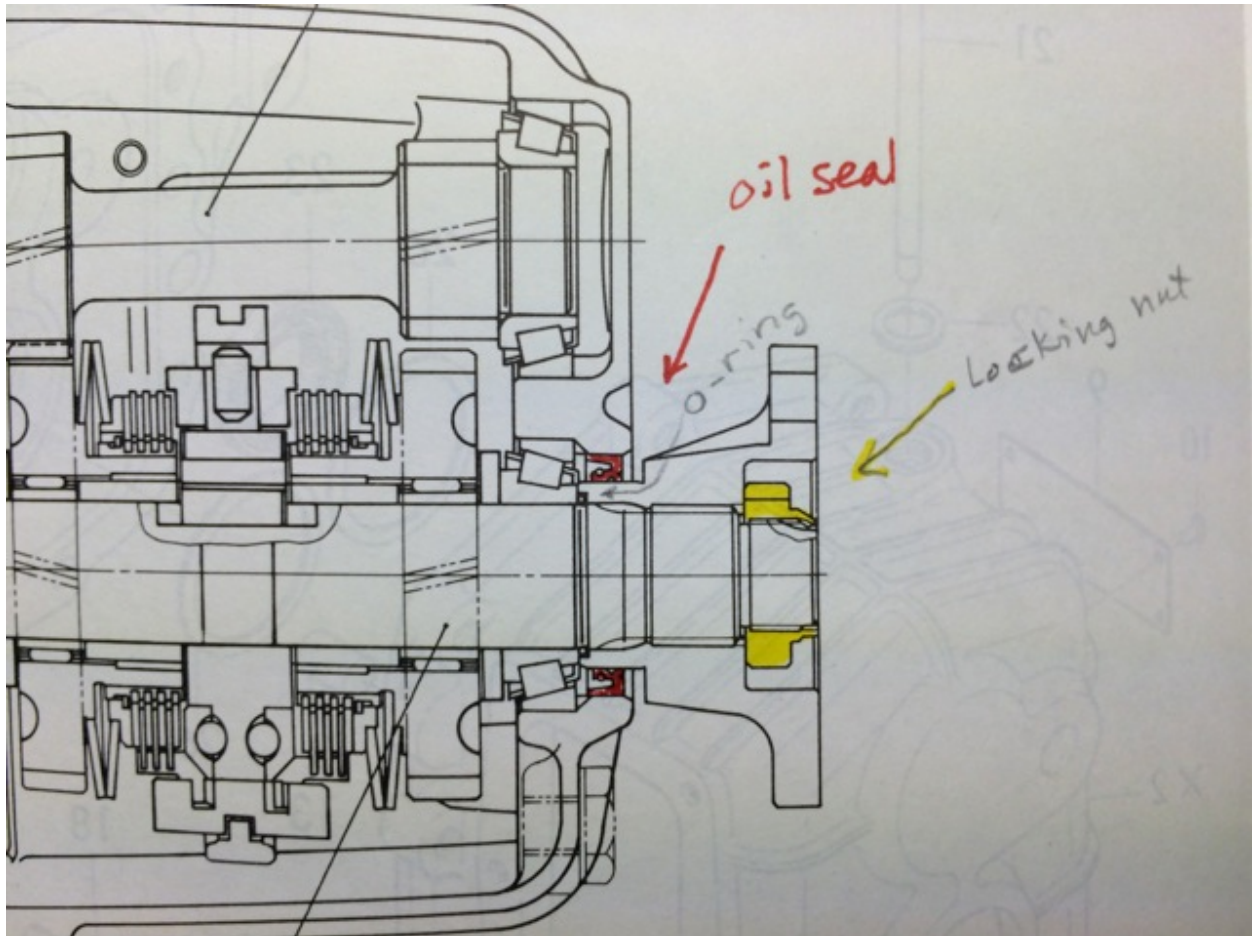
This cross section gives you an idea of the arrangement of these parts...

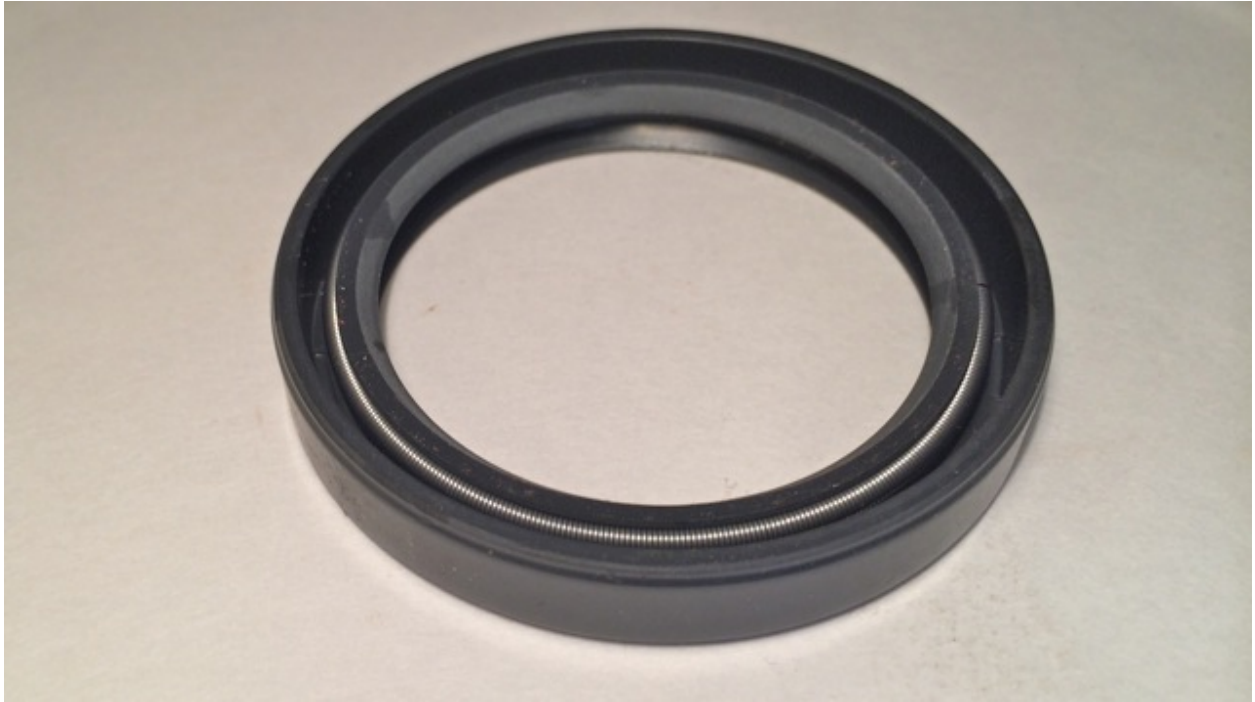
Next was the oil seal:
The new oil seal as seen from the side that goes into the housing first...

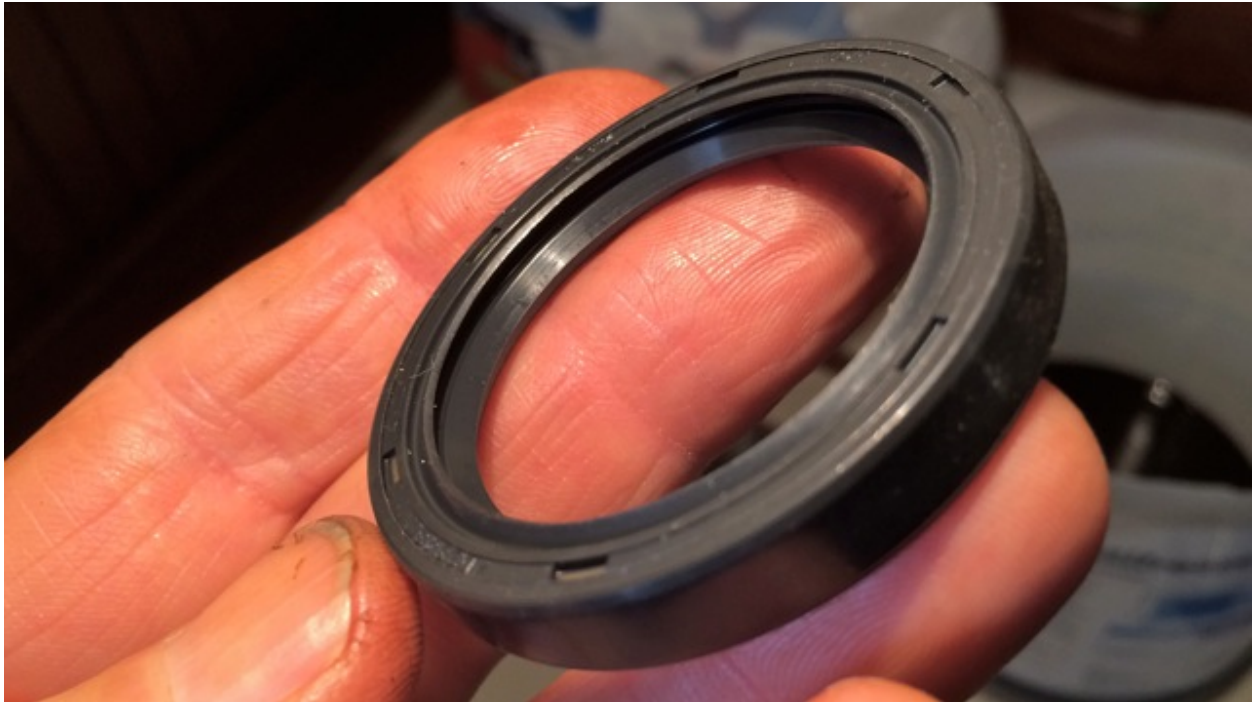
The "outside" (aft) surface of the seal...
