TIPS – Chapter Eight

Airframe

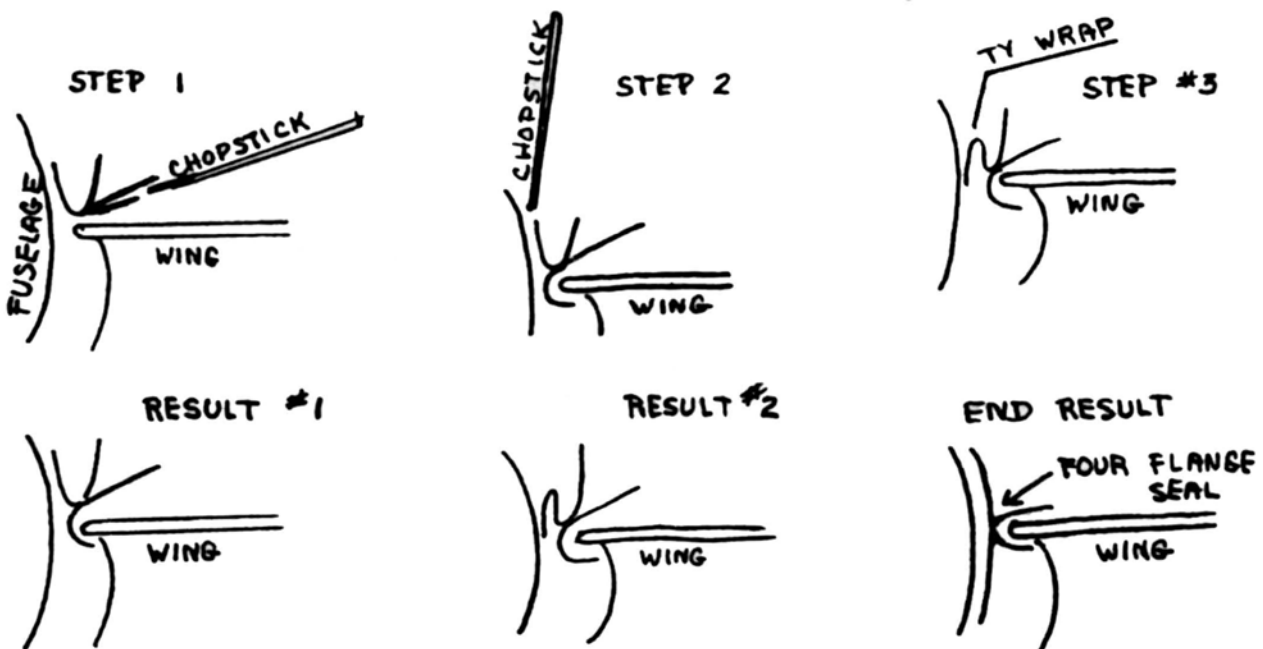
The seal is a four flange seal. Two flanges grip the wing skin and two lap against the fuselage, one up and one down. Don't despair. Go have a good Chinese dinner and save the chopsticks! Chinese chopsticks, the round, smooth kind, will help quite a bit. Now get a big tie wrap, i.e., one that is about 3/8 inch wide and 12 inches long. You are now armed with the tools to do the job. Lubricate the side of the fuselage with WD- 40 or Teflon lightly. Just make it a little slippery.

Now, place the seal in the proper alignment above the wing skin and lower it till the flange that will be under the wing touches the top of the wing and bends slightly. Keeping pressure on the seal from above, tuck this flange back toward the fuselage with the chopstick until you see it flip underneath the wing. Do this only for about a 2 inch span. Then, keeping pressure on the seal at this point, begin tucking the flange (with chopstick) that will point downward and lap against the fuselage. Simply force it to bend on itself and fold against the fuselage. It will now be in a "U" shape against the fuselage. Then, using the tie wrap end, force the flange to snap down in position underneath the whole seal. You can move the whole thing up and down gently with the big end of the chopstick and a peek underneath (remove fairings) will confirm the correct position. Cut off bottom pieces of seal where it goes over wing spar. Have patience and you'll get it eventually.

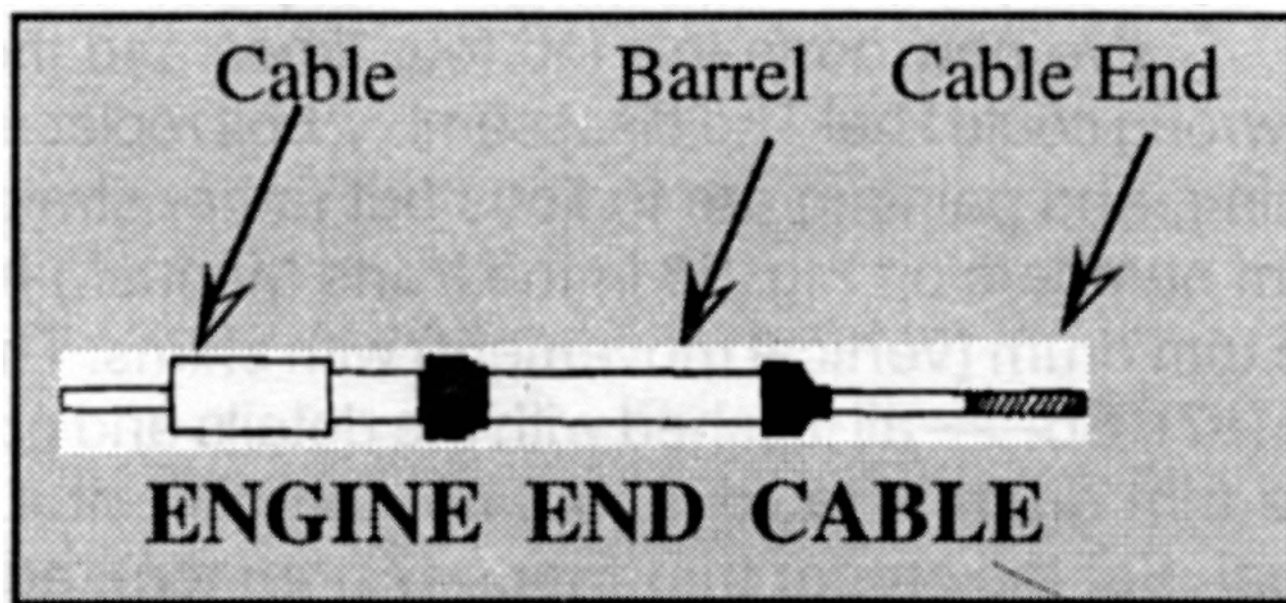
The Gremlins have been at it again! After a recent trip to Lubbock I noticed that all the controls on the throttle quadrant were binding abnormally. I concluded that it was due to the 23° overnight temperatures in Lubbock. Upon return to Dallas I tubed all the cables (discussed in a later article) and they were still binding. I was sure that I was about to install new cables. Before this drastic measure was taken it was time to go to the mountain and talk to the Guru. He told me that the hollow tubes at the engine end of the cables were bent! Say What? What barrels? Here is how to find out if your cable barrels are bent. Push all control levers forward. Start at either engine, any control. Try to turn the barrel it should rotate easily on the cable. Now move control to mid position and try again. The barrel should turn as easily as it did before. We're almost finished. Now move the control to rearward position and turn barrel. Did it turn as easily as the first two times? It did, well it ain't bent. Repeat for each control. Did the barrel bind in any of the positions? It did, well it's bent. For repairs to be made the cable will have to be disconnected from engine. Be sure not to move the turnbuckle. Place the barrel on a short piece of two-by-four or anything straight and turn to find the high side. Take a hammer and slightly tap the barrel to straighten. Now try the cable in all of the fore mentioned positions, better huh? How did the barrels get bent in the first place? Well I'm going back to the mountain real soon to find out. Gremlins maybe!
