SERVICE EDGE

The Laser Printer Tech Quarterly
from Liberty Parts Team

Fall 2012

HP CP6015, CM6030/40 “Internal Door 2 Open” Error

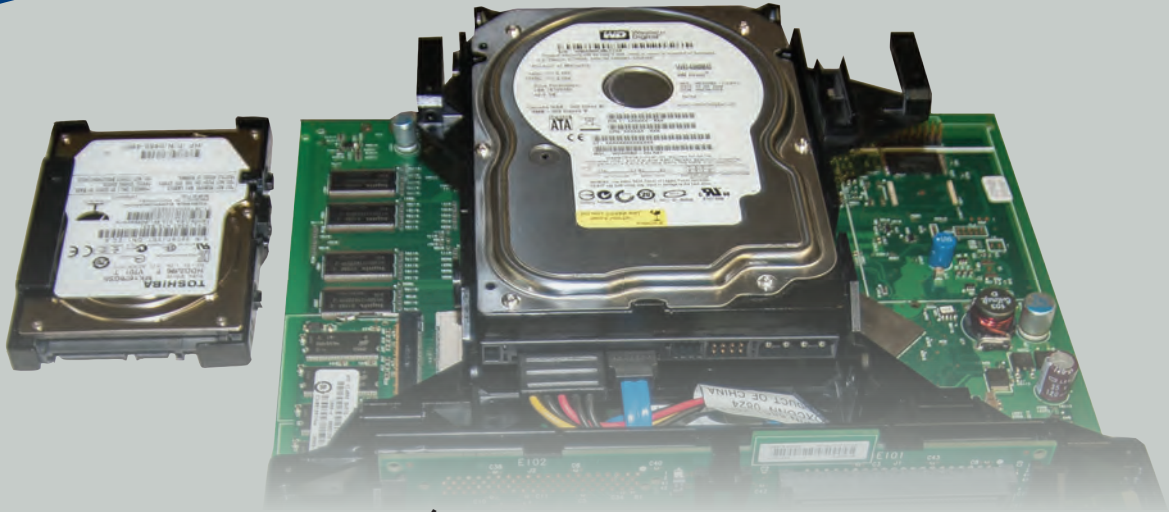
CM6030/CM6040 Hard Drive

Careful comparison will generally yield a clue to the compatibility of the two parts. Fig. A shows a 3.5 inch hard drive (Q3938-67961) installed on a CM6030/CM6040 formatter. The smaller hard drive to its left is its 2.5 inch replacement (Q3938-67985). If you'd been sent this skinny hard drive, you'd certainly suspect some sort of mistake. However, note the two connectors on the replacement. They seem to match

Here's how to replace the larger hard drive with the smaller.

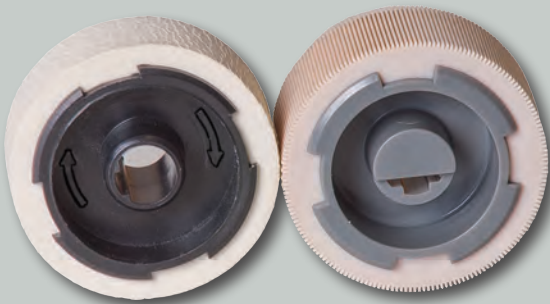
T-series Pickup Roller

the radically different replacement cassette rollers for the Lexmark T-series, the hole of which does not go all the way through, and which is of different color and texture. Yet these new rollers work on every Lexmark T-series printer.

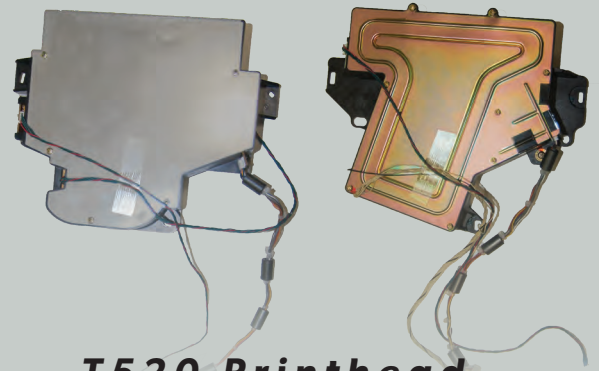
T520 Printhead

Some T-series printers have print-heads in two radically different versions. In the case of the T630 (56P1396) there are difference in color and cable location that have prompted customers to try to return their replacement. A clue that all is well is the screw holes, which match perfectly.
