# SERVICE EDGE

The Laser Printer Tech Quarterly  
from Liberty Parts Team

**Spring 2015**

# STILL WAITING

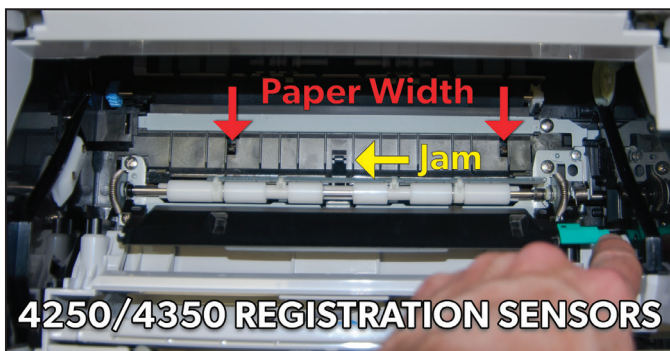
of paper stops here, the sensors will detect it and you'll see a 13 PAPER JAM message. The same result occurs if only the middle, or only the left sensor is activated. However, if you turn the printer on with the right sensor activated, something else may occur: the printer initializes without the motors turning. Then it will alternate WAITING FOR TRAY X TO LIFT with READY, or it may remain in READY until a door is opened or a print is attempted, and then alternate WAITING FOR TRAY X TO LIFT begins to alternate with another message.

*Note: Testing has shown the problem is independent of the formatter and firmware upgrades. Process of elimination indicated the DC controller. Also, the version of DC controller is given in hexadecimal notation on the configuration page. The newer boards no longer had this blind spot about the right paper width sensor.*

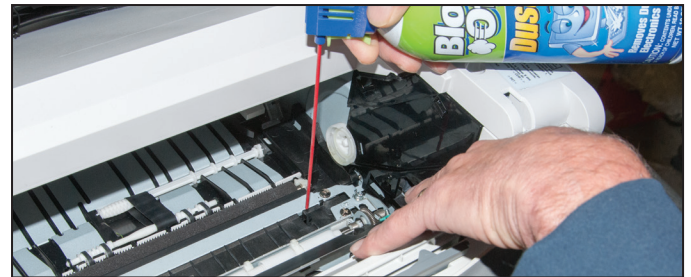
The optical sensors are part of the transfer block assembly. Blow compressed air down

the hole the right sensor comes through. This will clear settled dust.

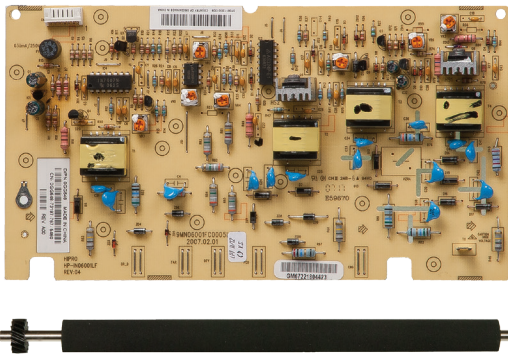
the transfer roll in the event of a Lexmark **917 TRANSFER ROLL SERVICE** message, as it certainly seems to be saying it's time to replace it. The correct reading is "Call a tech. Something's wrong with the transfer roll." The manual will tell you that the transfer roll isn't getting a good high voltage charge. The defective part is usually a bad high voltage power supply (or occasionally a system board) or a bad connection at the transfer roll.
