ELECTROLUX HOME PRODUCTS NORTH AMERICA

2003 Technical Training Manual

2003 Technical Training Manual Table of Contents

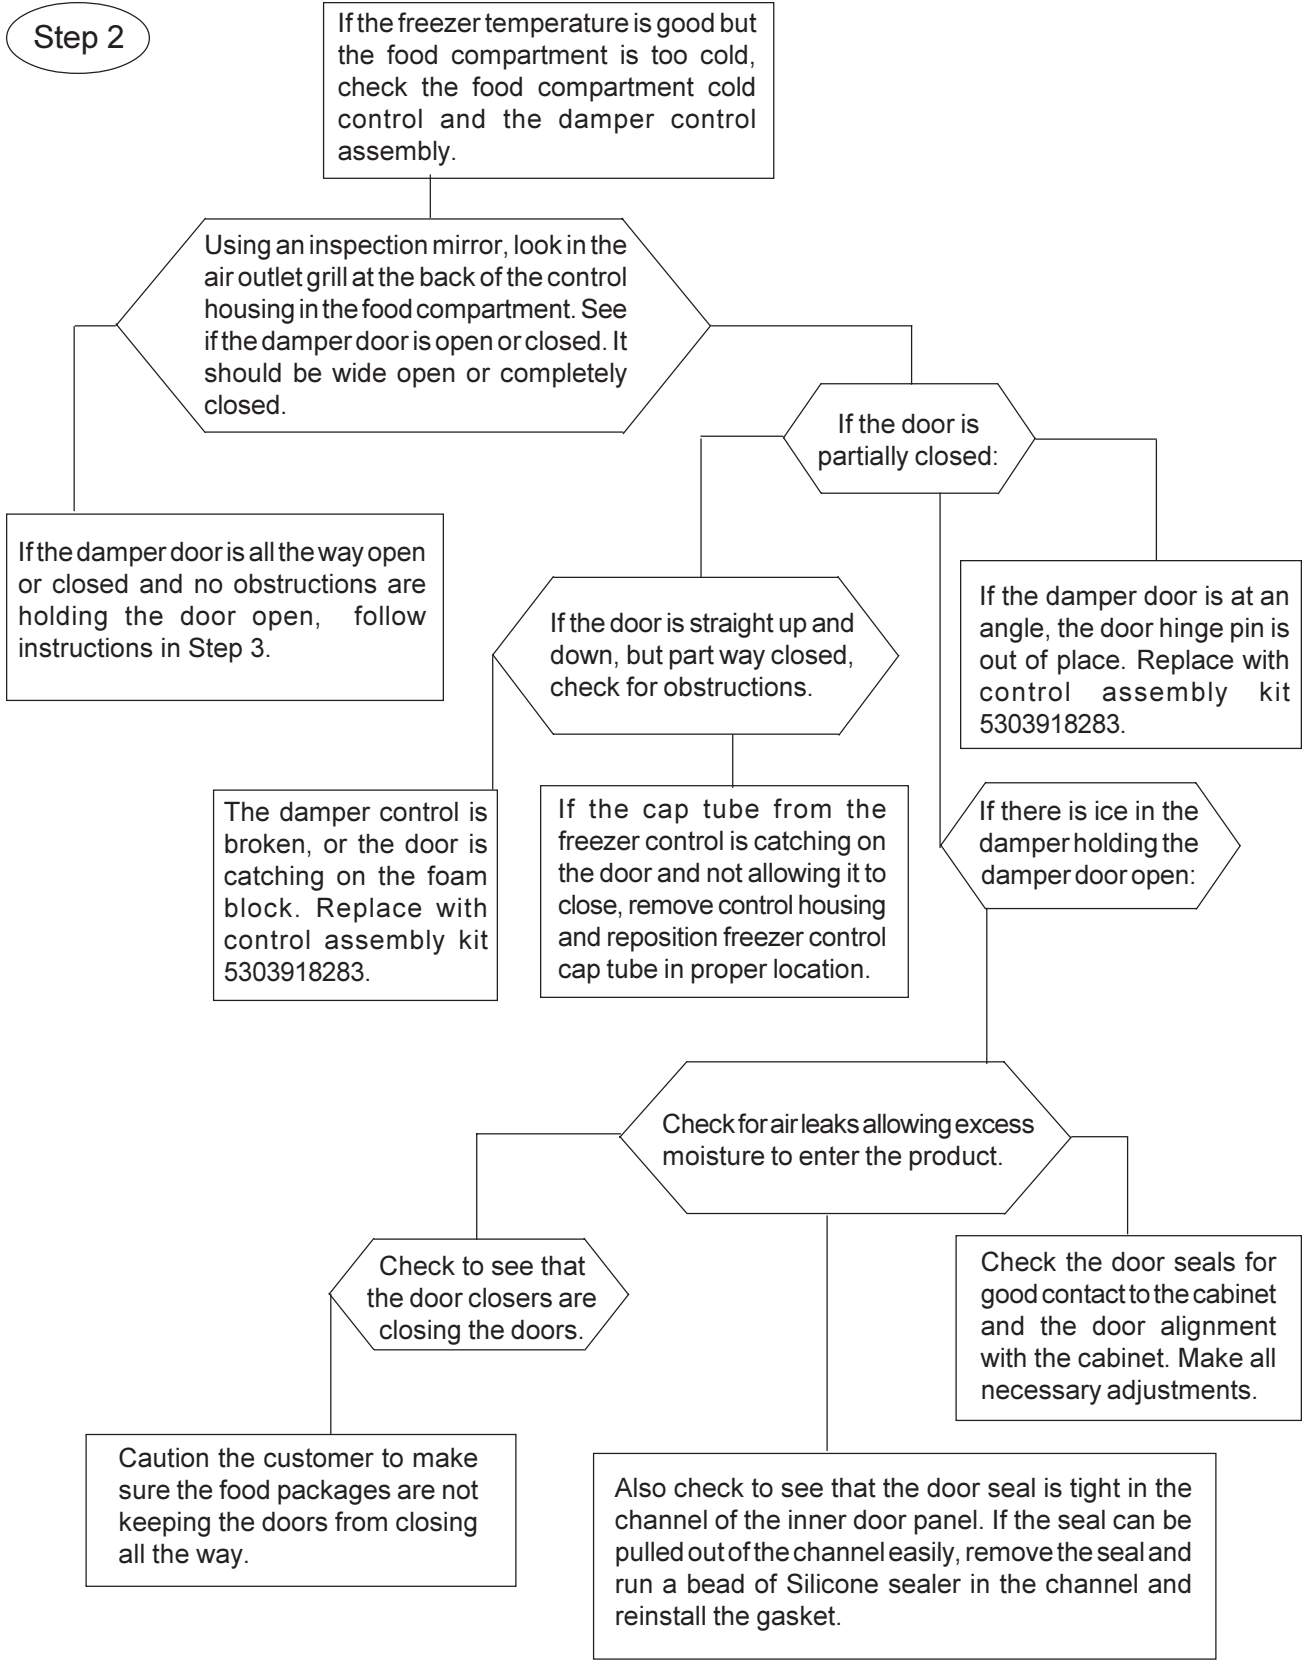
NOTE: If there is ice in the damper door holding the damper door open, then there is an excess amount of moisture entering the product and it is not all condensing on the evaporator coil. When the circulating air still contains a large amount of moisture as it turns to go through the damper, it will slow down and allow the moisture to condense on the damper door. This moisture will then collect and freeze at the bottom of the housing.

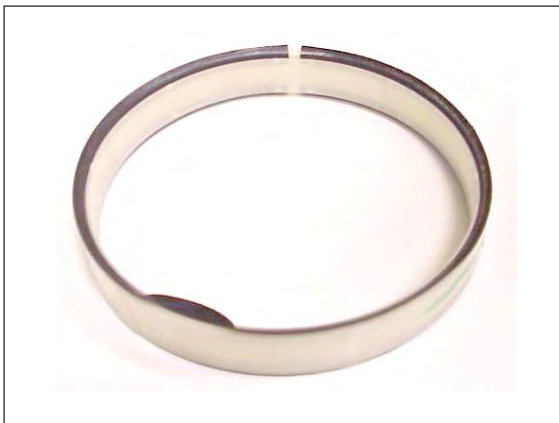
- d. Inspect the snubber carefully. The teflon strips on upper and lower edges of the snubber must be perfectly smooth and undamaged in any way. The example in Figure 3 shows the top strip bent over. This would cause the distinctive “fingernails on blackboard” sound. Also note the arrow on the side of the snubber. When reinstalling or replacing the snubber, the arrow must be pointing upward.

- f. Before installing a new snubber, have it out of it's packaging, with arrow positioned upward, and ready to be installed. While holding the assembly up, you will not have time to mess with tearing it out of its bag. When the job is completed, make sure to test the machine in the spin cycle to make sure that you were successful. Unbalance the tub with a few towels on one side to test it. When the job is done, make sure to reposition the machine to its original position and re-set the rear leveling legs.
