Tektronix 49x/275x/279x-Series Spectrum Analyzer Service Notes

**John Miles, KE5FX
john@miles.io**

November 30, 2015

Errata and helpful notes on calibration/service procedures

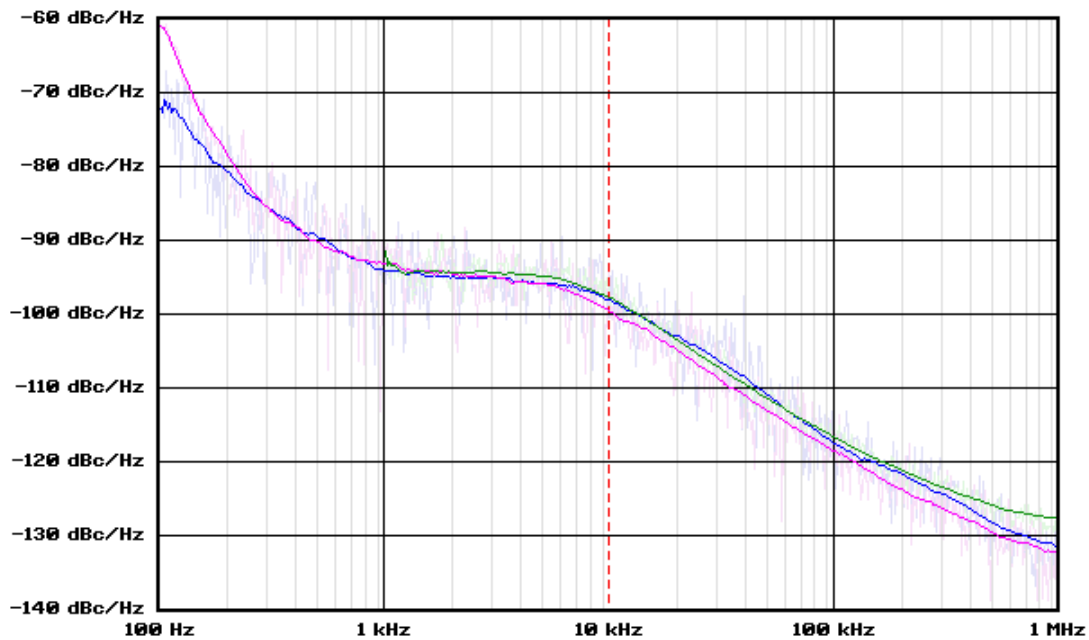
The traces below were acquired with PN.EXE from the GPIB Toolkit, measuring the output of a Wenzel crystal oscillator whose phase noise is substantially lower than the analyzers' own. Typical examples of the 494AP, 494P, and 492P spectrum analyzers were compared. Minimum RF attenuation was set to 0 dB in all three cases, and 20 dB of carrier clipping was used.

Trace	Carrier Hz	Carrier dBm	dBc/Hz at 10000 Hz	Clip dB	Instrument
S/N B010388	100 000 000	8.00	-98.1	20	TEK 494AP
S/N B010845	100 000 000	8.00	-99.6	20	TEK 494P
S/N B055692	100 000 000	8.00	-97.8	20	TEK 492P

The 494P appears noisier close to the carrier, but this is actually a consequence of its broader 30-Hz RBW specification compared to the 494AP's 10-Hz minimum bandwidth. The 30-Hz filter skirt, and not the LO phase noise, is responsible for the observed performance at offsets below about 300 Hz.

At offsets of 10 kHz and beyond, all 49x/275x analyzers should generally perform within +/- 5 dB of these traces. All three analyzers meet Tektronix's rather-loose PN specifications easily.
