Service & repair hints of NOKIA 3210

Service & Analysis Center

The purpose of this document is to provide some further service information for NOKIA 3210 phones.

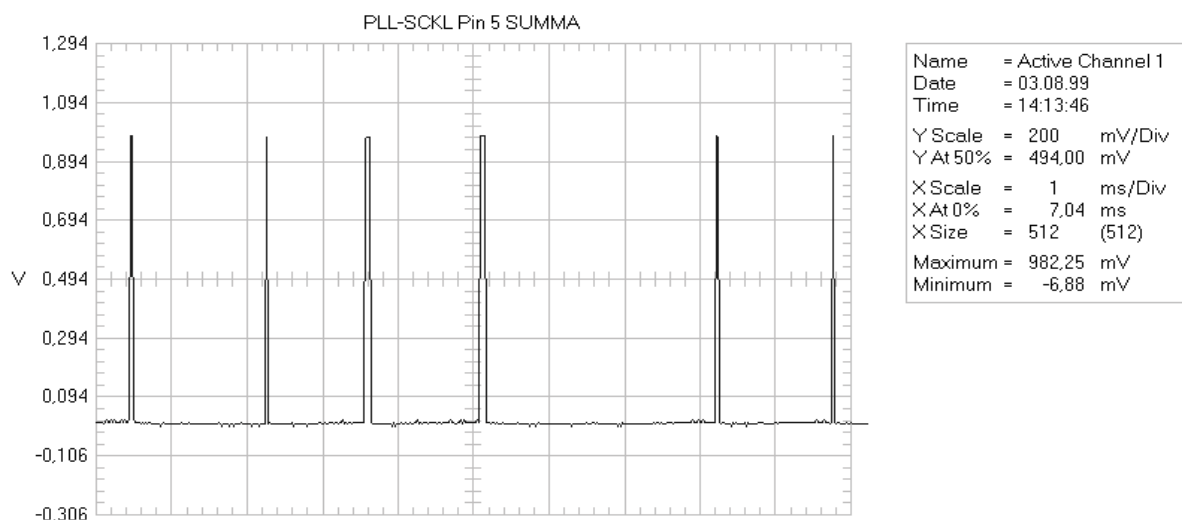
Figure 7: PLL-SCKL Signal

- check the 13MHz reference frequency pin 15 N700. (No frequency deviation higher $\pm 50\text{Hz}$ is allowed!)
- check the power supply voltage VRX_2 2,8V DC pin 35 N600
- check the incoming IF 71MHz pin 37,38 N700
- check the 13MHz IF on pin 30(out),25, 26(in) N700 . The attenuation between input and output are $\approx 20\text{dBm}$
- check the control-lines for the PLL pin 5, 6, 7 from N700 (see the diagrams below)
- check the incoming VHF_LO frequency 464MHz pin 8 N700 if the 13MHz IF are deviated or not exist measurable level approximate -20dBm !
- Check the synth. power supply 2,8V DC pin 9, 19 N700 and VCC G700, G702
- Check the VCP 5V DC pin 13, 22 N700
- Check the control voltage for the UHF and VHF oscillator (UHF pin 21 control voltage is channel dependent, pin12 2,2V DC on N700)
- Check the soldering of N700 or change it
