# Troubleshooting Torque Converter Clutch Cycling on Dodge Trucks

*Easy Solutions for a Common Problem*

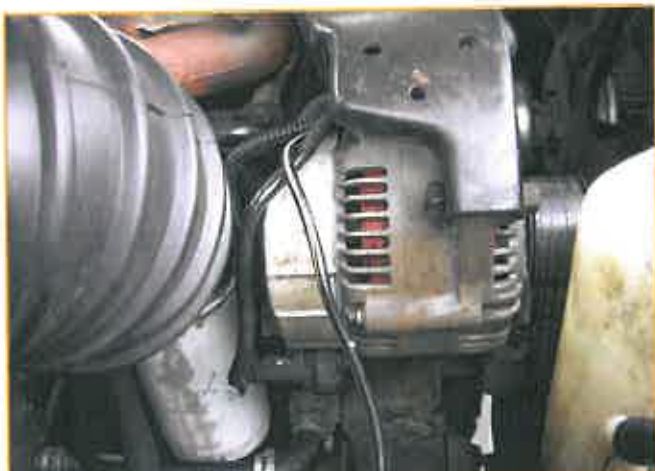
Figure 2: If the generator is suspect, disconnect and tape off all of the wires on the back of the generator to disable it.

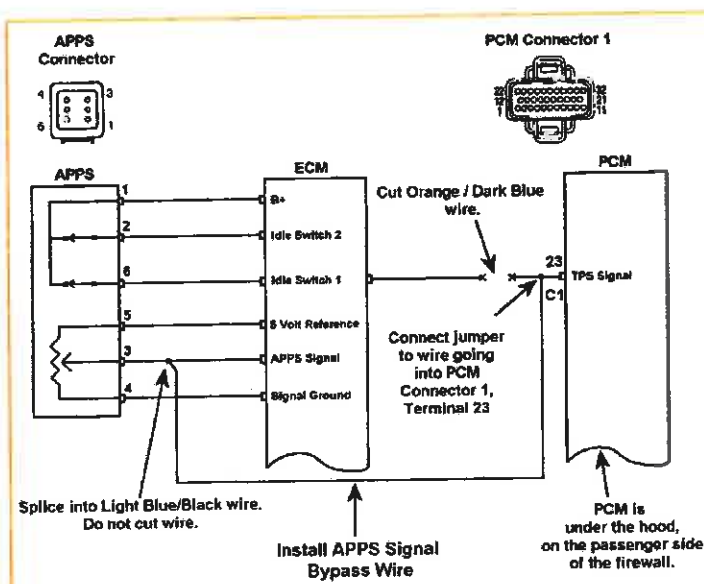
The problem is, with some particularly stubborn trucks, the APPS signal coming from the ECM may not be clean enough. The solution is to bypass the ECM and run the APPS signal straight to the PCM (figure 3). Don't cut the wire going from the APPS to the ECM, as the ECM still needs this signal. Here's how to bypass the factory wiring:

Figure 3: The APPS signal can be jumpered directly to the PCM on the 1998–2003 Diesel applications.

- Tap into the APPS signal wire at the APPS (Terminal 3, Light Blue/Black wire).
- Run a jumper wire to the PCM.

- Cut the wire at the PCM (connector 1, Terminal 23, Orange/Dark Blue wire).
- Connect the jumper to the PCM.
- Fold the abandoned signal wire back and tape it into the PCM harness.

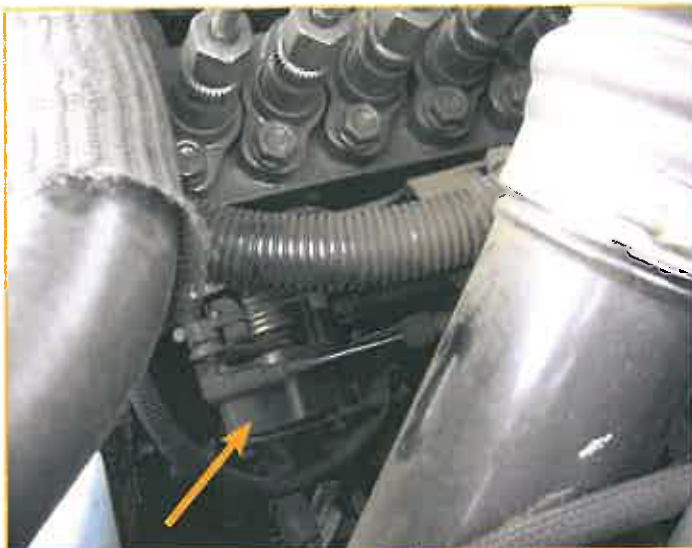
A common problem specific to these trucks is low TPS signal voltage. When the vehicle is driven at a normal cruise, the TPS signal voltage can actually be on the threshold of closed throttle. This causes the PCM to toggle the throttle assessment between closed and part throttle, and to cancel and reapply the torque converter clutch accordingly.

The TPS on this earlier diesel configuration is mounted on the injector pump linkage in the engine compartment (figure 4). The injector pump/TPS linkage becomes worn and causes the TPS signal voltage to be skewed lower than normal. The solution is either to adjust the TPS, or repair or replace the linkage to restore the correct TPS voltage.

Figure 4: Check for low closed throttle TPS signal voltage on 1997 and earlier diesel applications. TPS is on the injector pump.

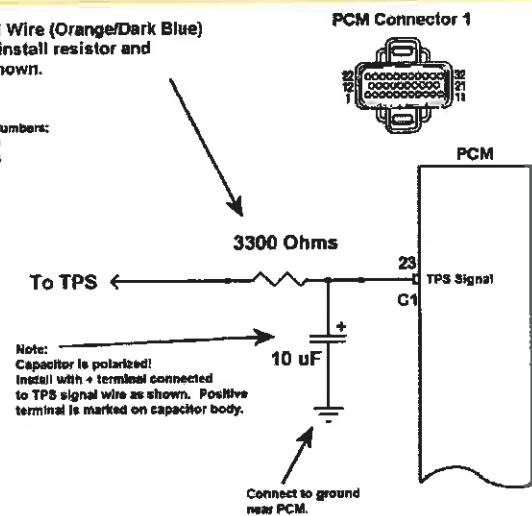
## TPS Low Pass Filter Modification

Figure 6: For stubborn trucks a low pass filter can be added to reduce noise on the TPS circuit.

On some stubborn gas engine applications, you can install a simple low pass filter into the TPS signal circuit at the PCM to clean up the signal (figure 6); here's how:

- Cut the TPS signal wire at PCM

- connector 1, terminal 23 (Orange/Dark Blue wire).
  - Install a 3.3K $\Omega$  resistor and a 10 $\mu$ F, 16-volt capacitor as shown. You can use Radio Shack P/N 271-1328 for the resistor, and Radio Shack P/N 272-1436 for the capacitor. The capacitor is polarized, so be certain to connect the + terminal (marked with a stripe on the capacitor body) to the TPS circuit, and the negative terminal to ground.
  - Weatherproof all of your connections with shrink tubing and electrical tape.
- TCC shuttle is a common problem on these trucks. By looking at the particular problems that affect the truck you're working with, you'll narrow down the possibilities, and be that much closer to fixing the problem. After all, time is money!

Cut TPS Signal Wire (Orange/Dark Blue) near PCM and install resistor and capacitor as shown.

Radio Shack Part Numbers:  
Resistor: 271-1328  
Capacitor: 272-1436

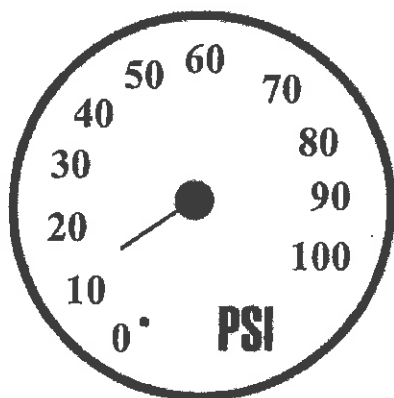
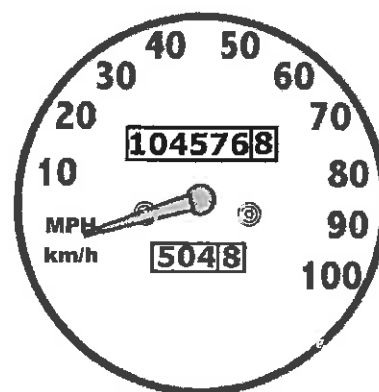
**FIGURE 15:** *Second gear start...*

Figure 15 is an example of what would be observed with a 2nd gear start complaint due to a defective governor pressure sensor (Transducer). To make this diagnosis, what should be noticed is that the pressure gauge indicates 10 to 12 psi at 0 miles per hour. This amount of governor pressure will keep the 1-2 shift valve stroked in an up shifted 2nd gear position. Comparing this chart to the one seen in Figure 12, it is noticed in Figure 15 that with 10 pounds of governor pressure the sensor is sending to the computer a 0.66 volt reading. This indicates to the computer that there is 0 psi in the circuit when actually there is 10. At 10 pounds of pressure, approximately 0.9 volts should be observed as seen in Figure 12. With the computer thinking that it controlled the governor solenoid to produce 0 psi due to faulty data produced by the sensor, it did not attempt to energize the solenoid any further. Changing the sensor will solve this complaint.

*Example of a 2nd Gear Start due to a defective transducer*

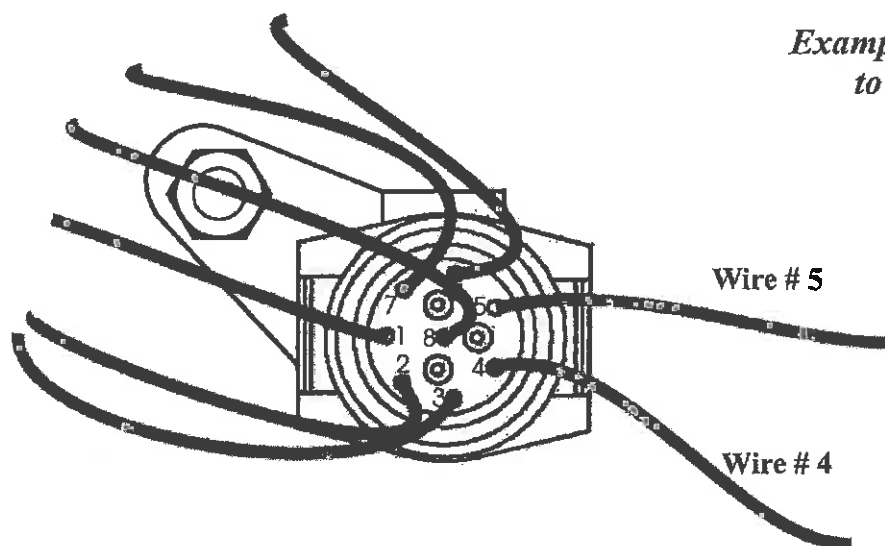
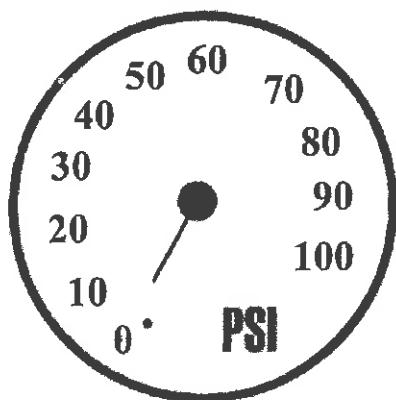
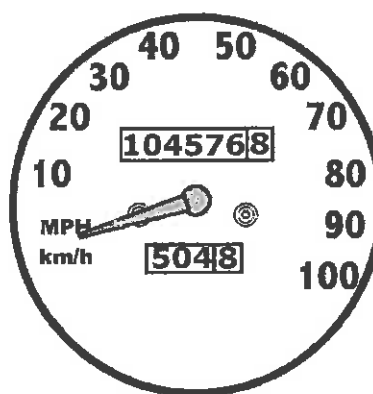
**FIGURE 16:** *Second gear start...*

Figure 16 is an example of what would be observed with a second gear start due to a stuck 1-2 shift valve. Notice that there is 0 psi of governor pressure and the sensor indicates the same in voltage (0.66). The only way a second gear start could be possible is a 1-2 shift valve stuck in a stroked position.

*Example of a 2nd Gear Start due to a stuck 1-2 shift valve*

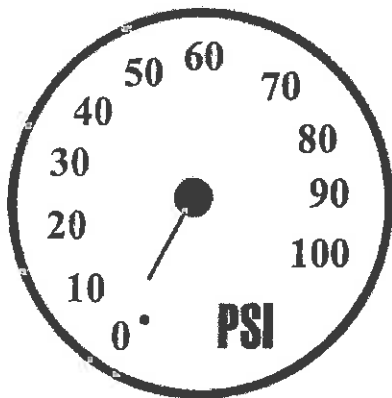
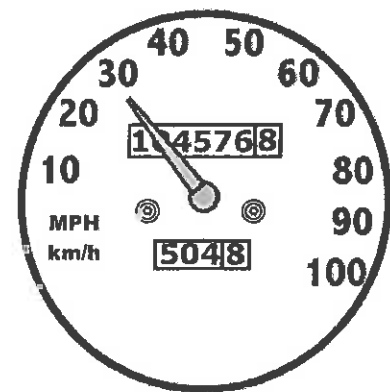
Figure 17

*Example of a no up shift condition  
due to a leak in the governor  
circuit or a clogged inlet port  
to the solenoid*

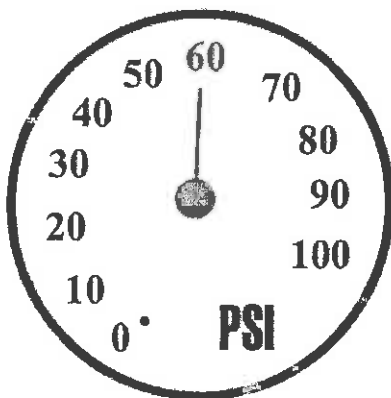
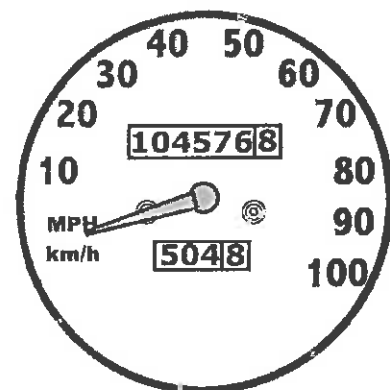
Figure 18

*Example of a 3rd Gear Start due to a defective solenoid mechanically*

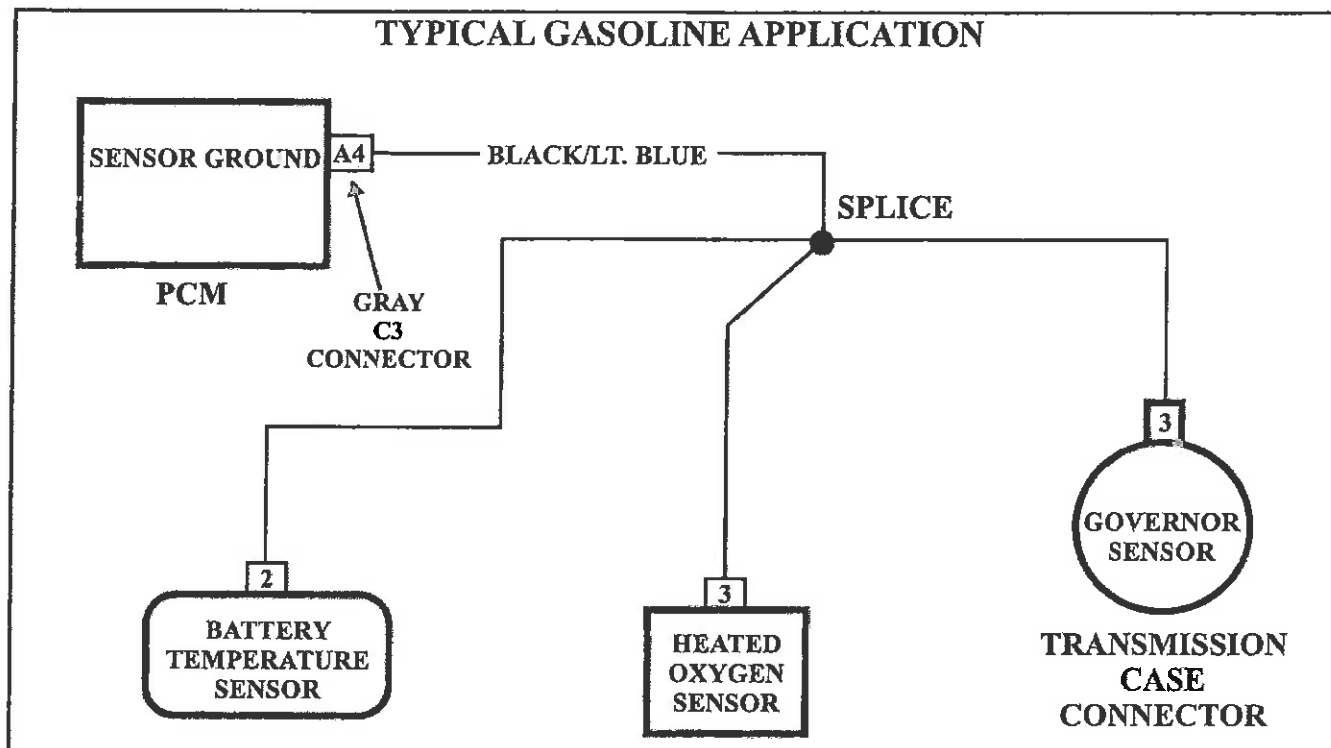
Figure 1

1. One cause could be that the ground circuit for the governor pressure sensor has been compromised (See Figures 1 and 2).
  - a. Faulty governor pressure sensor
  - b. Faulty battery temperature sensor
  - c. Faulty heated oxygen sensor(s)
  - d. Faulty wiring, splices, other shared sensors or the PCM
2. Another cause could be that line pressure is running above factory specification. This could be the result of a valve body modification or a valve body malfunction.
3. A malfunctioning alternator producing voltage spikes or high charging voltage would be another consideration.

**NOTE:** Code P1763 sets when 4.89 volts or higher is seen on the governor pressure sensor circuit for 8 seconds or more. If this was caused due to high pressure, this indicates that governor pressure was between 90 to 96 psi or higher while in drive.

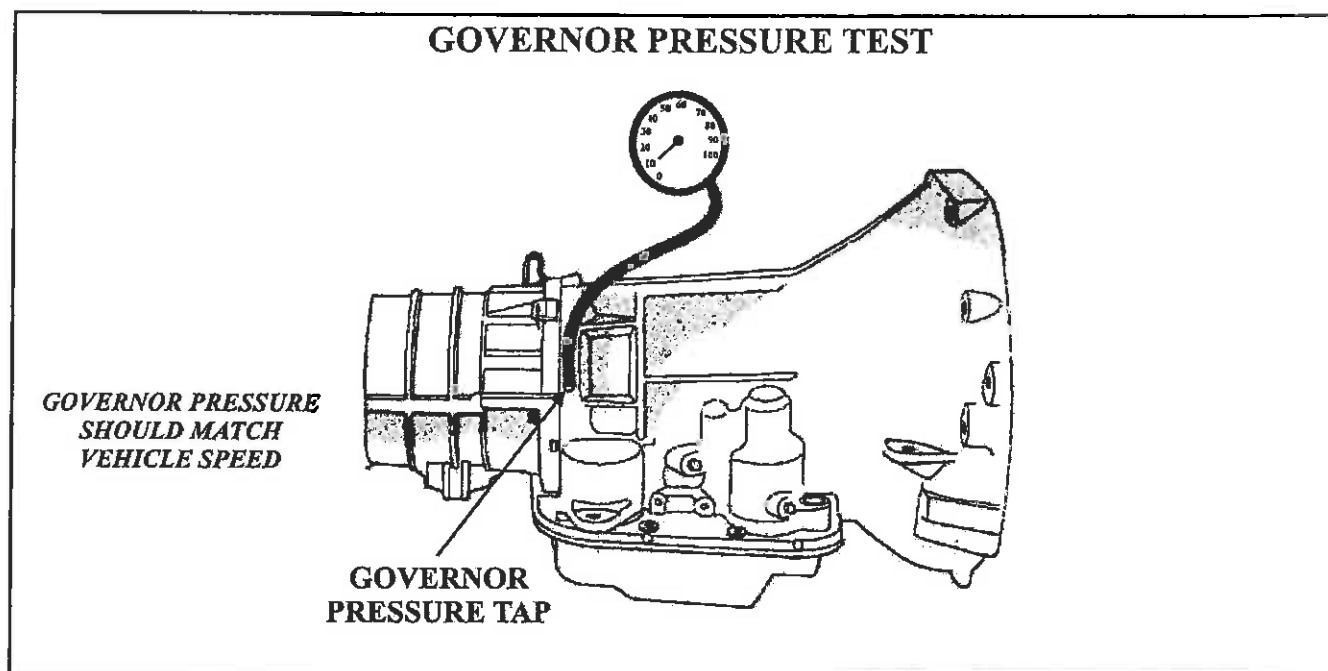
Figure 1

**CAUSE:** Decrease pressure supplied to the pressure regulator valve throttle plug which is used to prevent line pressure from exceeding approximately 100 to 120 psi at wide open throttle (See Figure 1).

**Note:** For 1996 and later vehicles drilling this hole may cause an erroneous code P1763 "Transmission Governor Pressure Sensor Volts Too High." This can be overcome by re-flashing the PCM according to Chrysler bulletin 21-04-00 which re-calibrates the JTEC Powertrain Control Module with new software (calibration change 96Cal18, 97Cal18, 98Cal12, and 99Cal14).

Another option would be to carefully solder a 150 ohm 1/4 watt resistor into the governor sensor signal circuit which will desensitize the P1763 code setting concern. Radio Shack part #271-1312

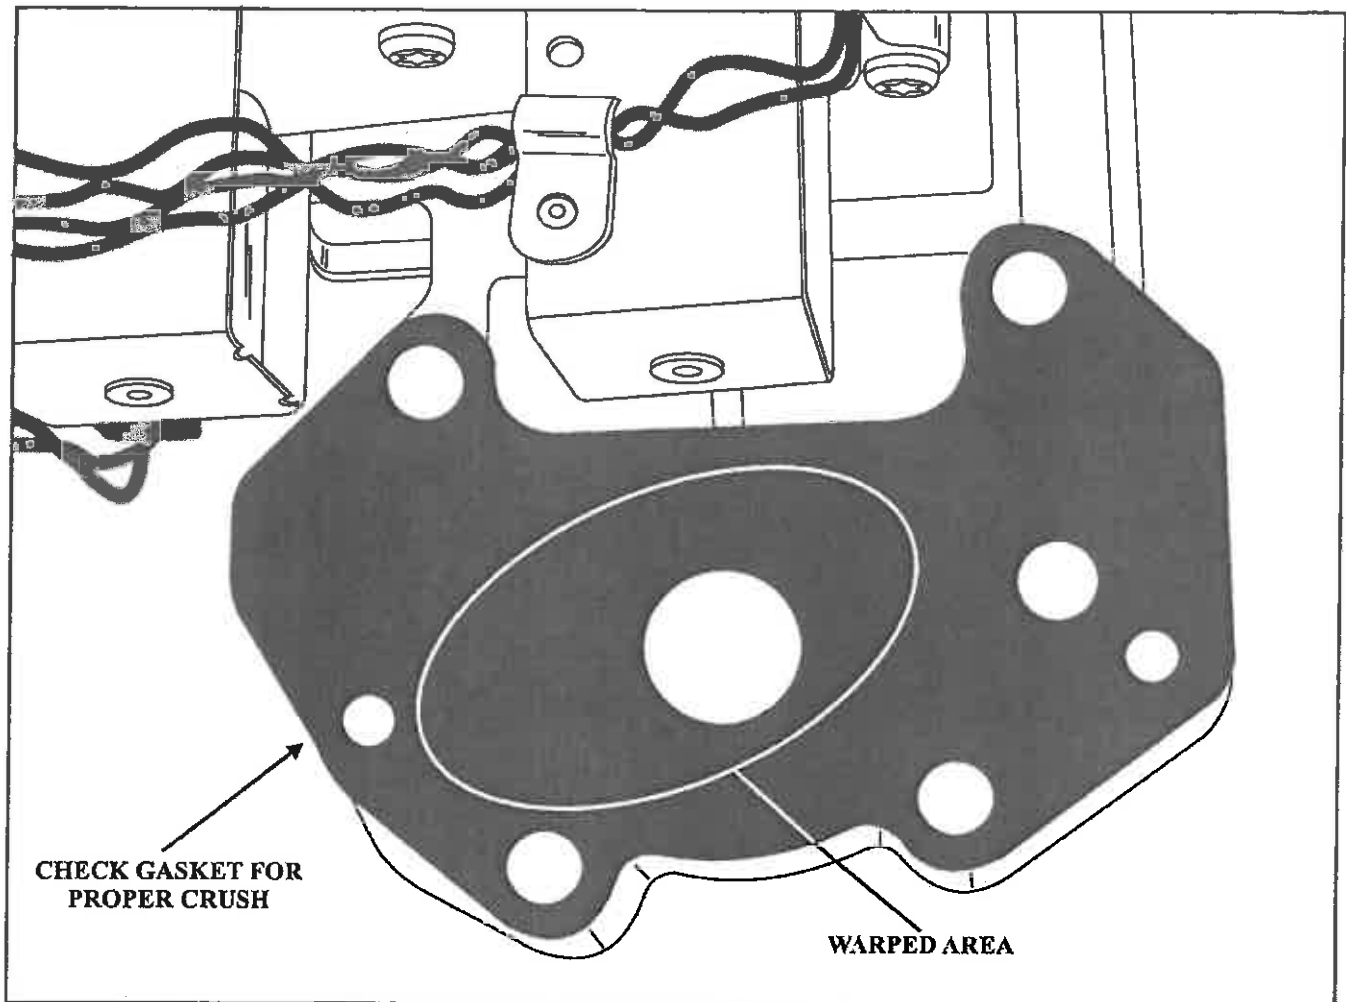
Figure 1

**CAUSE:** The area of the valve body where the governor pressure control solenoid and the governor pressure sensor are located is warped (Refer to Figure 1).  
When this area is warped governor pressure from the solenoid to the sensor is leaking causing erratic governor pressure which causes the erratic sensor signal voltage (See Figure 2). This results in oil at the tip of the sensor to vary which causes the sensor to vary the signal voltage. The PCM will react by varying the solenoid operation which will result in erratic governor pressure.

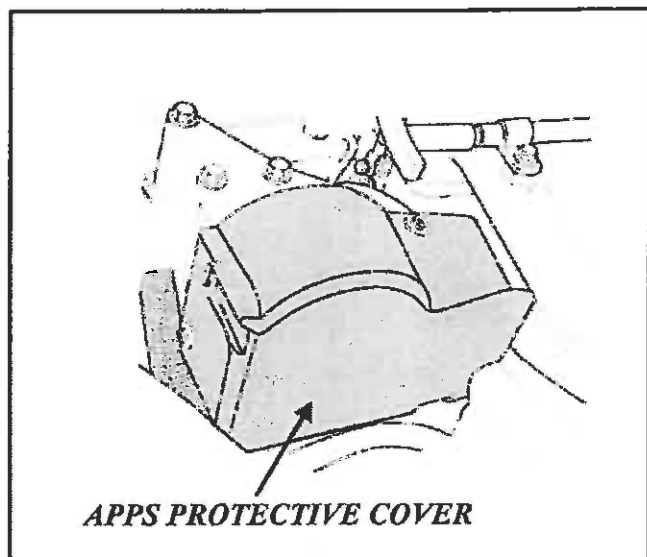
Figure 1

**CAUSE:** There are many possibilities such as a malfunctioning brake switch or brake support bracket. Temperature sensors, alternators, throttle position sensors, vehicle speed sensors to name a few. Chrysler has even issued a reprogramming procedure (Bulletin #18-02-99) for 1996 and later vehicles which compensates for alternator or TPS noise correcting this complaint. Reports of TCC shuttle has also occurred while driving with a scanner attached to the data link connector. Unplug the scanner and the problem goes away. One other possibility that may go overlooked is a defective ECM with 1998 and later vehicles. These vehicles are equipped with an Accelerator Pedal Position Sensors (APPS) rather than a TPS. The APPS sends a typical TPS signal to the ECM and the ECM sends that signal to the PCM. Should the ECM malfunction, the incorrect signal is received by the PCM causing the shuttle shift complaint (See Figure 1).

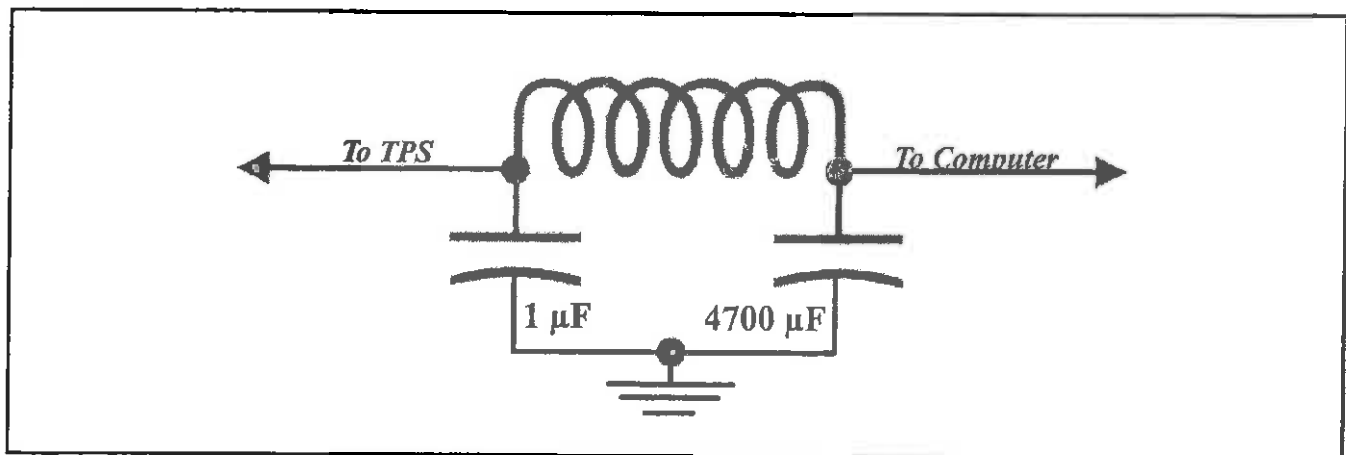
Figure 1

**CAUSE:** Possibly noise on the TPS signal wire.

**CORRECTION:** There are many causes for electrical noise. We most strongly recommend that you repair the SOURCE of the noise rather than filtering the noise. Often the source can be elusive, or repairing the source expensive. In these cases, the noise may be filtered out of the signal using an L-C type "pi" filter on the TPS signal line. These filters are readily available at any car stereo installation shop, and many retail electronics outlets (Echlin RD-13 or equivalent). It is fairly simple to assemble your own as well.

Solder the parts together as shown in the schematic in Fig 1, and the pictorial in Figure 2. Install the filter by cutting the TPS signal wire and feeding that signal through the blue wire in the filter (the 1  $\mu$ F side to the TPS and the 4700  $\mu$ F side to the computer), then ground the black ground wire to a good ground (the better the ground, the cleaner the signal) as shown in figure 3.

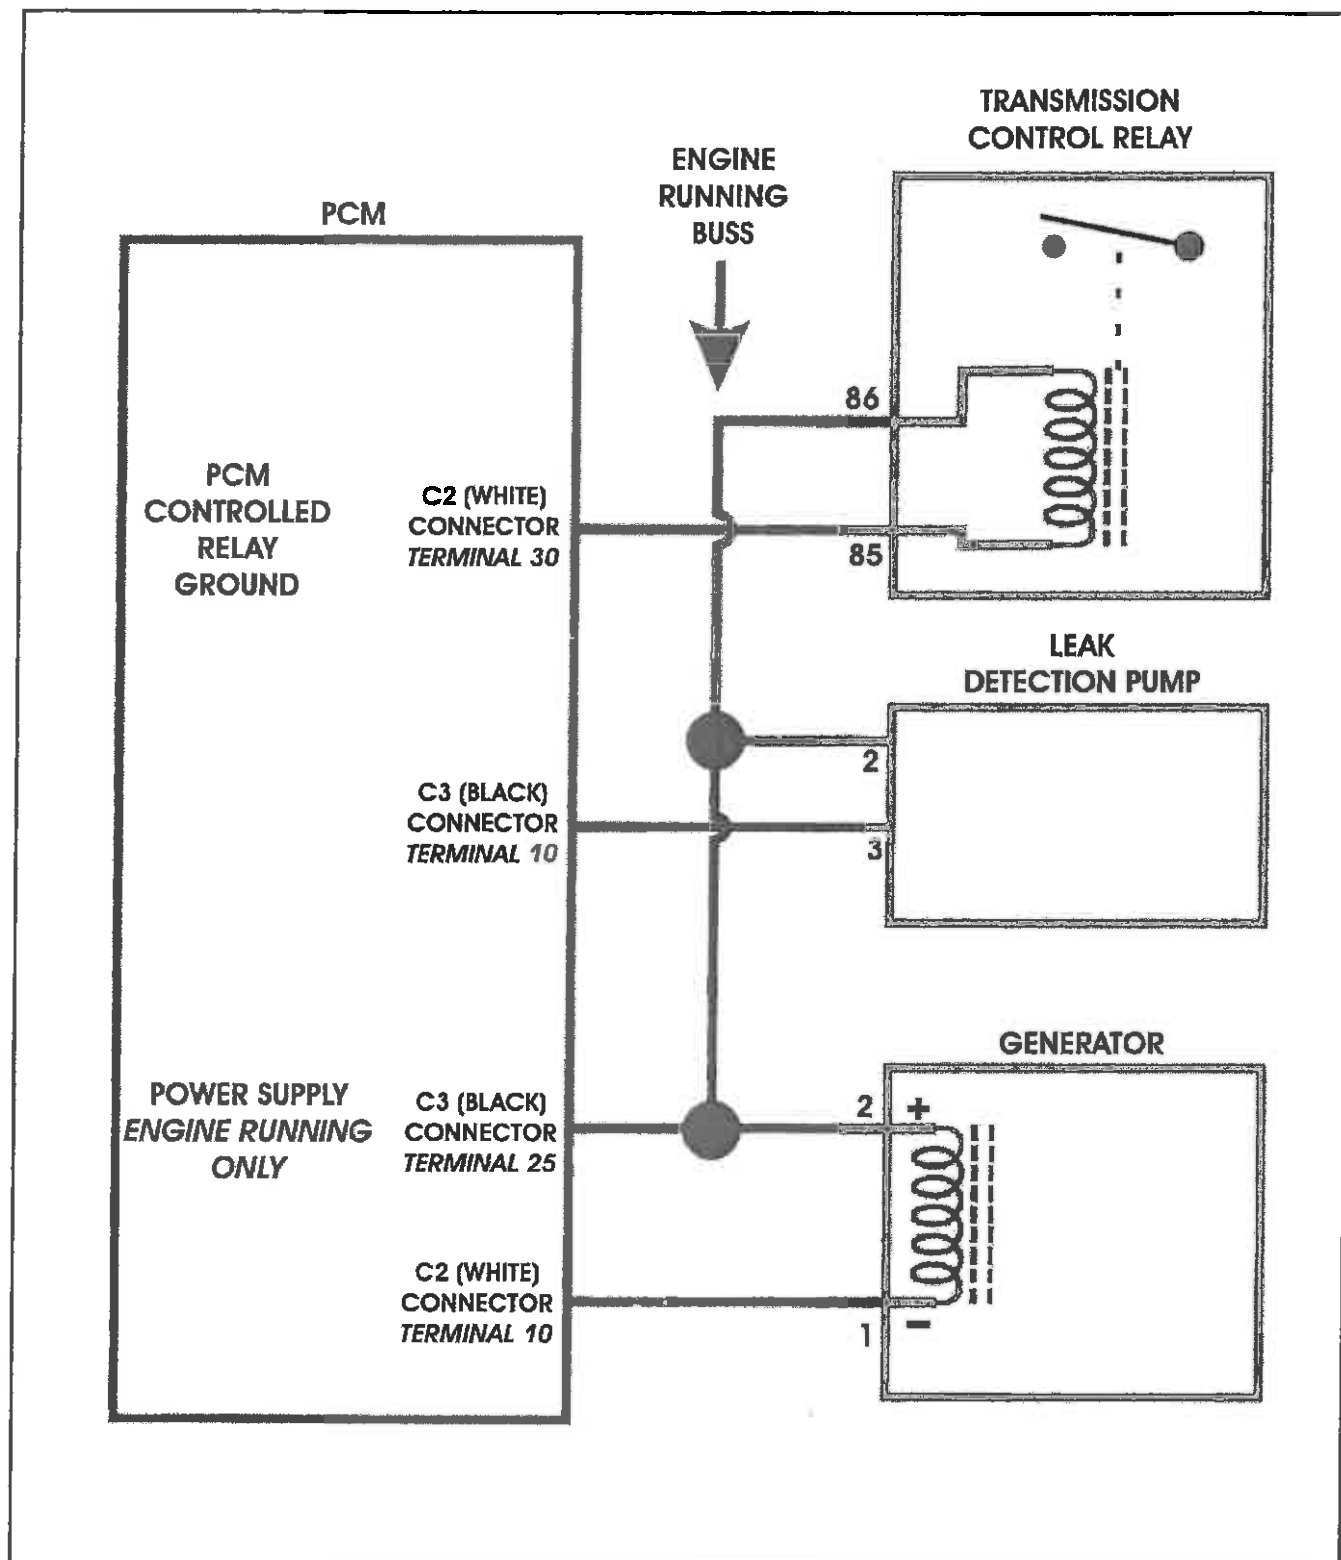
Figure 1

**NOTE:** In all wiring diagrams that were used for the information contained here within, the generator field winding is incorrectly identified. The positive and negative terminals are labeled backwards. Generator terminal 2, which leads to the generator source pin at the PCM is the positive terminal. Generator terminal 1, which leads to the generator field driver terminal at the PCM is the negative terminal as illustrated in Figure 1.

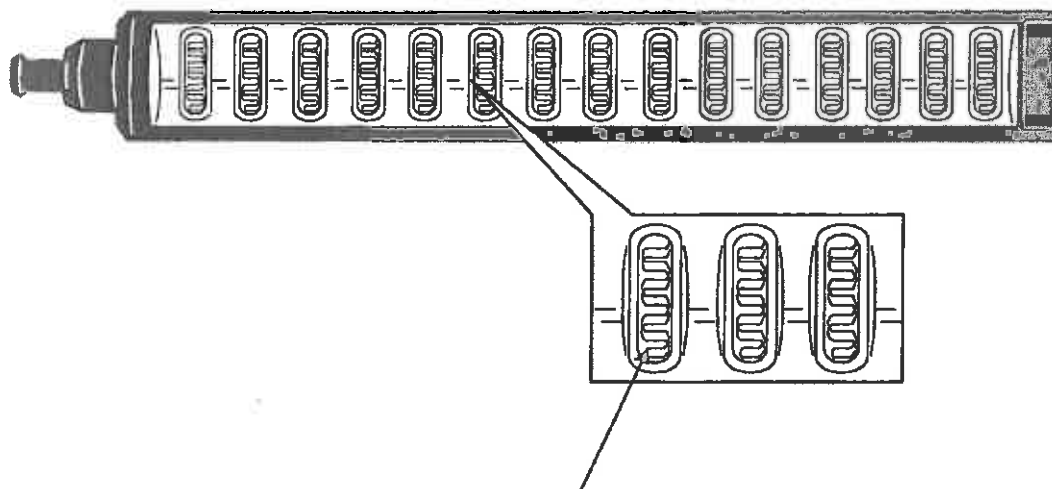
Figure 1

**CAUSE:** The cause may be, a restricted Auxillary Transmission Cooler. *NOTE:* During the "flushing" process, this may be overlooked because of a "Bypass" tube, as shown in Figure 1, that connects the two cooler lines together, mis-leading the technician into thinking that the Auxillary Transmission Cooler is clear. The Auxillary Transmission Cooler can not be flushed very easily because of its fin type construction, as shown in Figure 2 (*Note: the Auxillary Cooler has a thermal bypass that does not open until the fluid or cleaning solvent is at temperatures around 160° F*). This can also cause valves to hang as well as continual clogging of the Governor Solenoid Screen.

**AUXILLIARY TRANSMISSION COOLER CUT-AWAY**

***THE AUXILLARY TRANSMISSION COOLER HAS  
A FIN TYPE CONSTRUCTION WHICH MAKES  
COOLER FLUSHING ALMOST IMPOSSIBLE***

**CORRECTION:** Replace the Auxillary Transmission Cooler as needed.

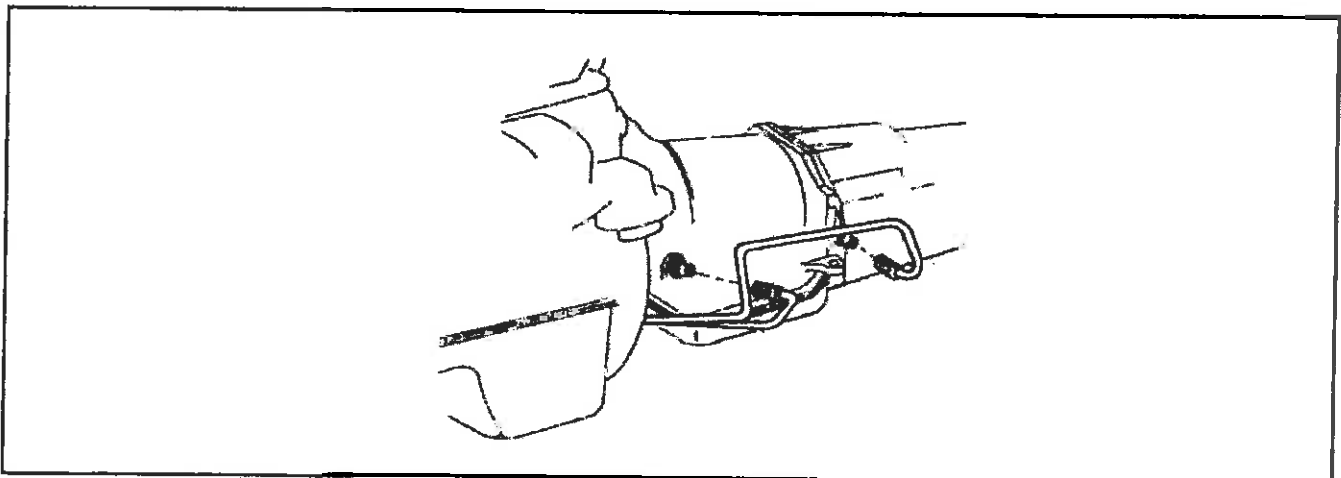
Figure 1

**CAUSE:** RWD transmissions behind diesel engines are the most common to experience this complaint after heavy trailer towing or reverse to drive rocking situations. This causes the front cooling line (which is the line out to the cooler) to be the recipient of the high fluid temperatures produced by the converter. The front quick disconnect clip assembly suffers greatly under these conditions.

**CORRECTION:** Replace the transmission quick disconnect fittings with threaded fittings that will not melt. This will require 2 cooling lines with the appropriate attaching fittings, 2 case fittings to accommodate the case threads and line fittings plus, approximately 2 feet of flexible hydraulic lines to attach the new lines to the existing lines.

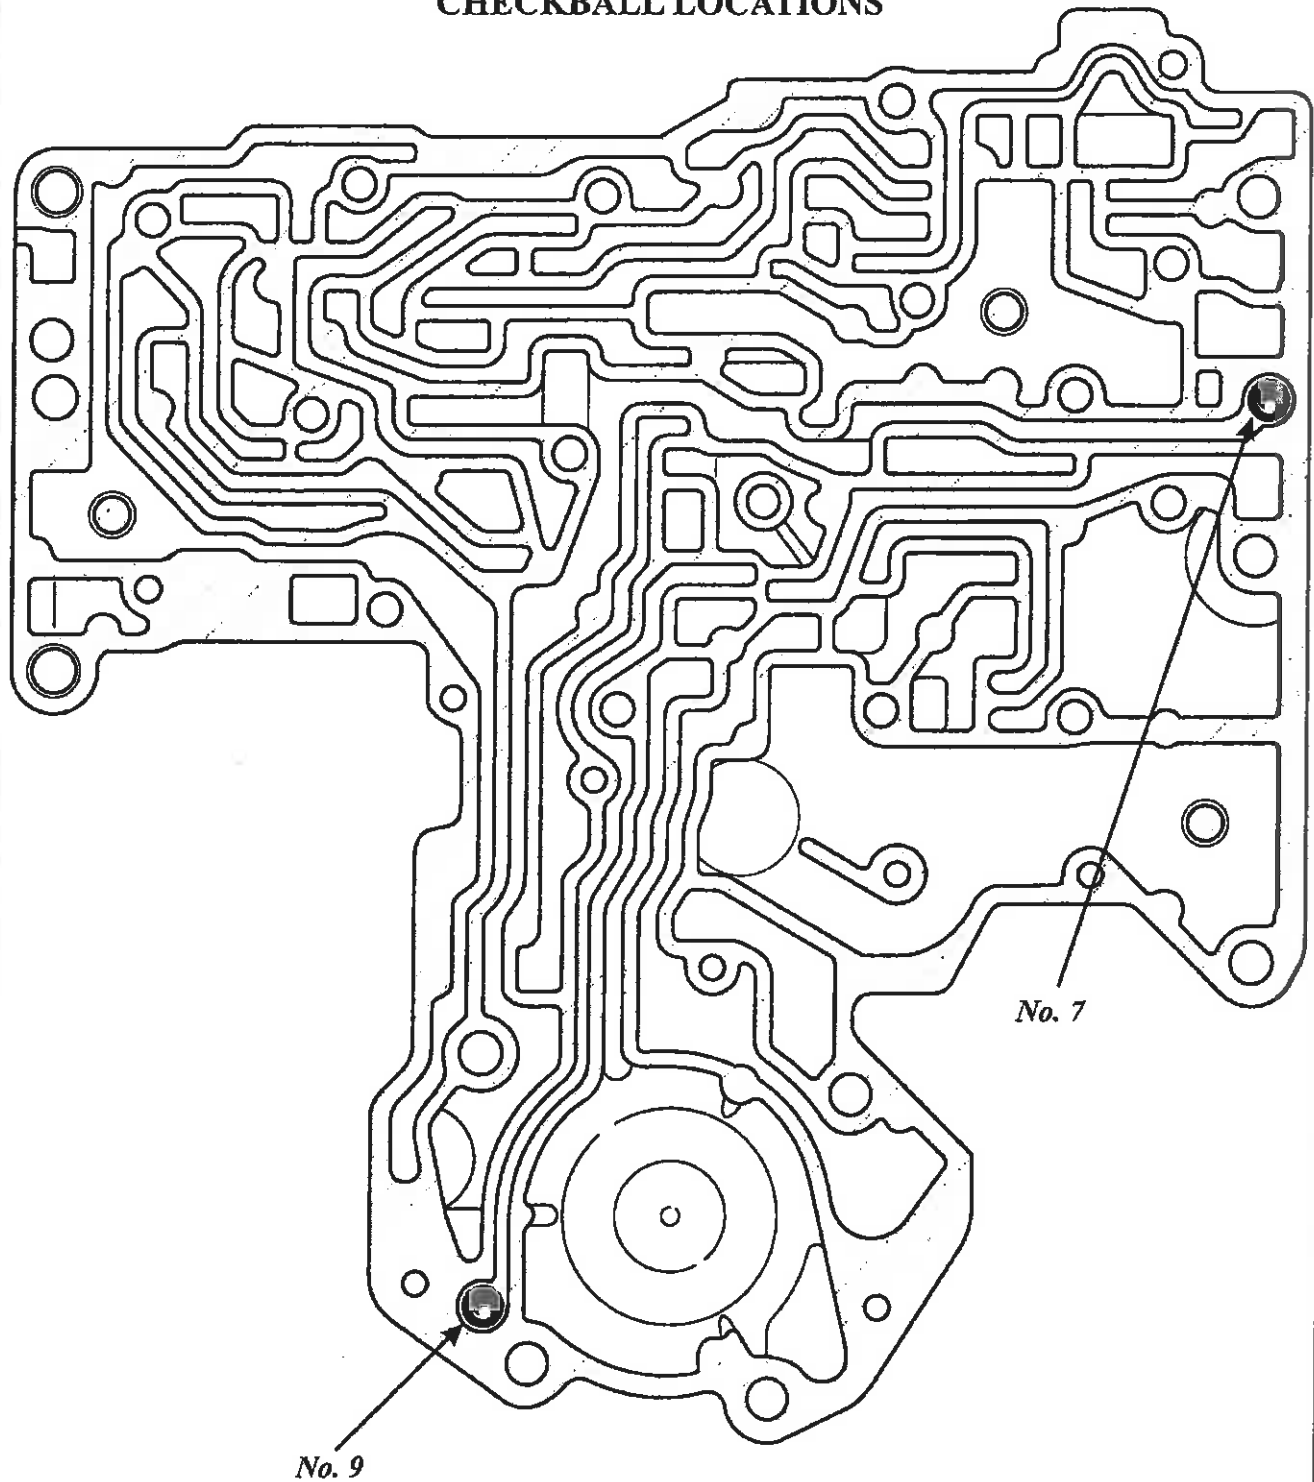
Figure 1

**CAUSE:** One cause may be, that the number 9 checkball has distorted the separator plate and can no longer seat correctly, allowing excessive apply pressure into the reverse servo apply passage.

**TRANSFER PLATE "UPPER SIDE"  
CHECKBALL LOCATIONS**

**CORRECTION:** On both 42RE and 46RE the steel number 9 checkball should be replaced with a torlon checkball. (See figure 1) Replace the separator plate on the 42RE (See Figure 2) and the 46RE (See Figure 3). Chrysler has issued a bulletin (21-01-00) for 1999-2000 vehicles equipped with either a 42RE or a 46RE with this complaint.

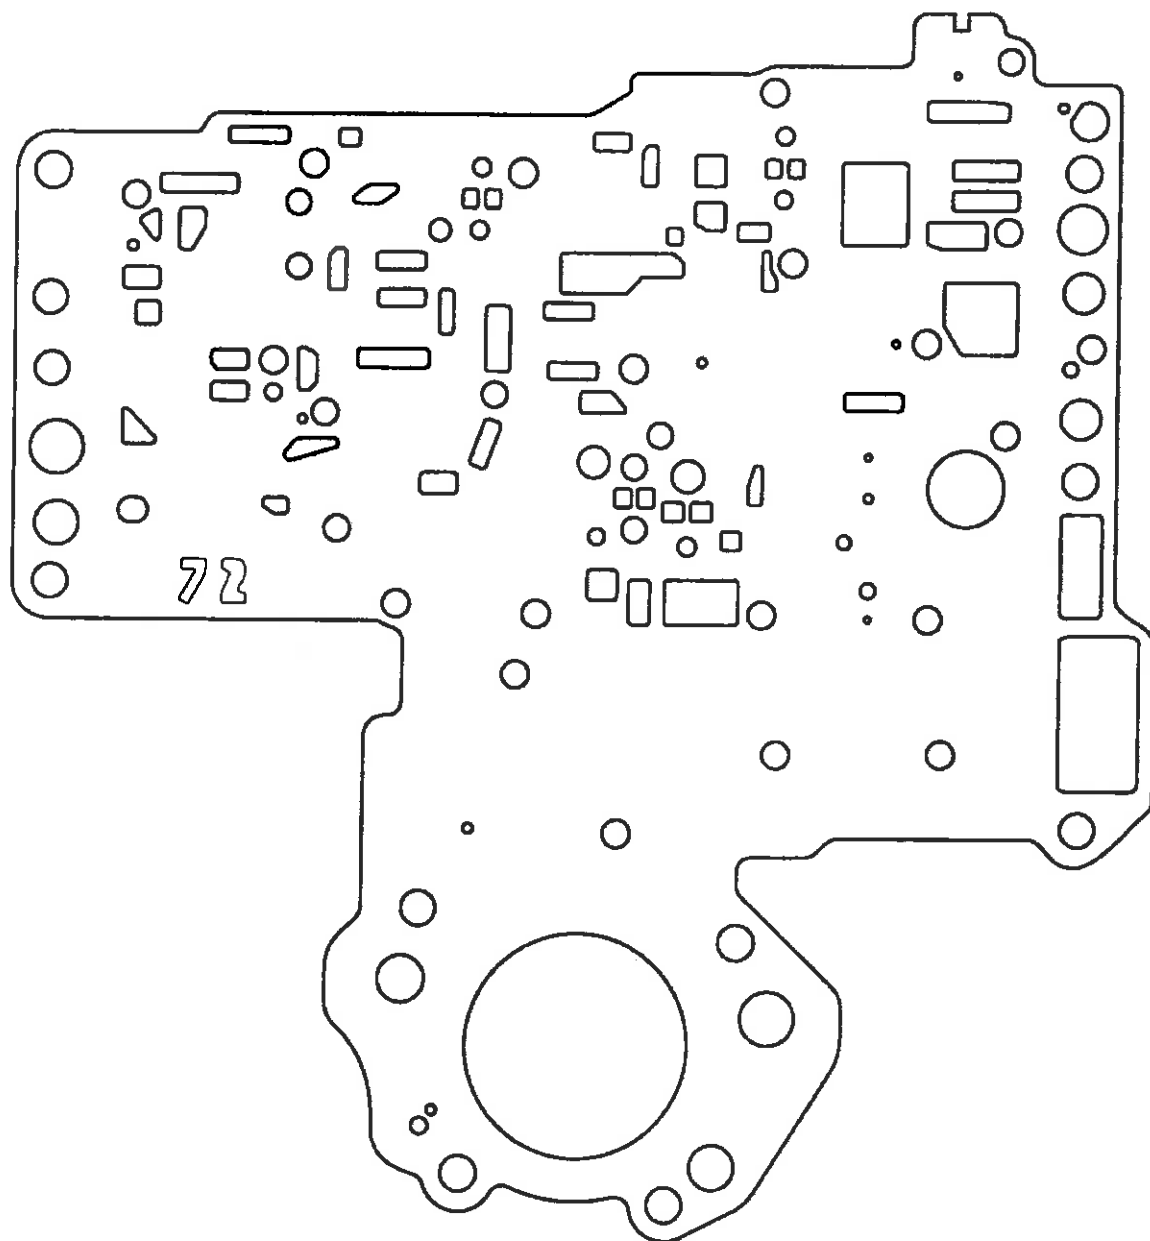
Figure 2

**42RE SPACER PLATE**

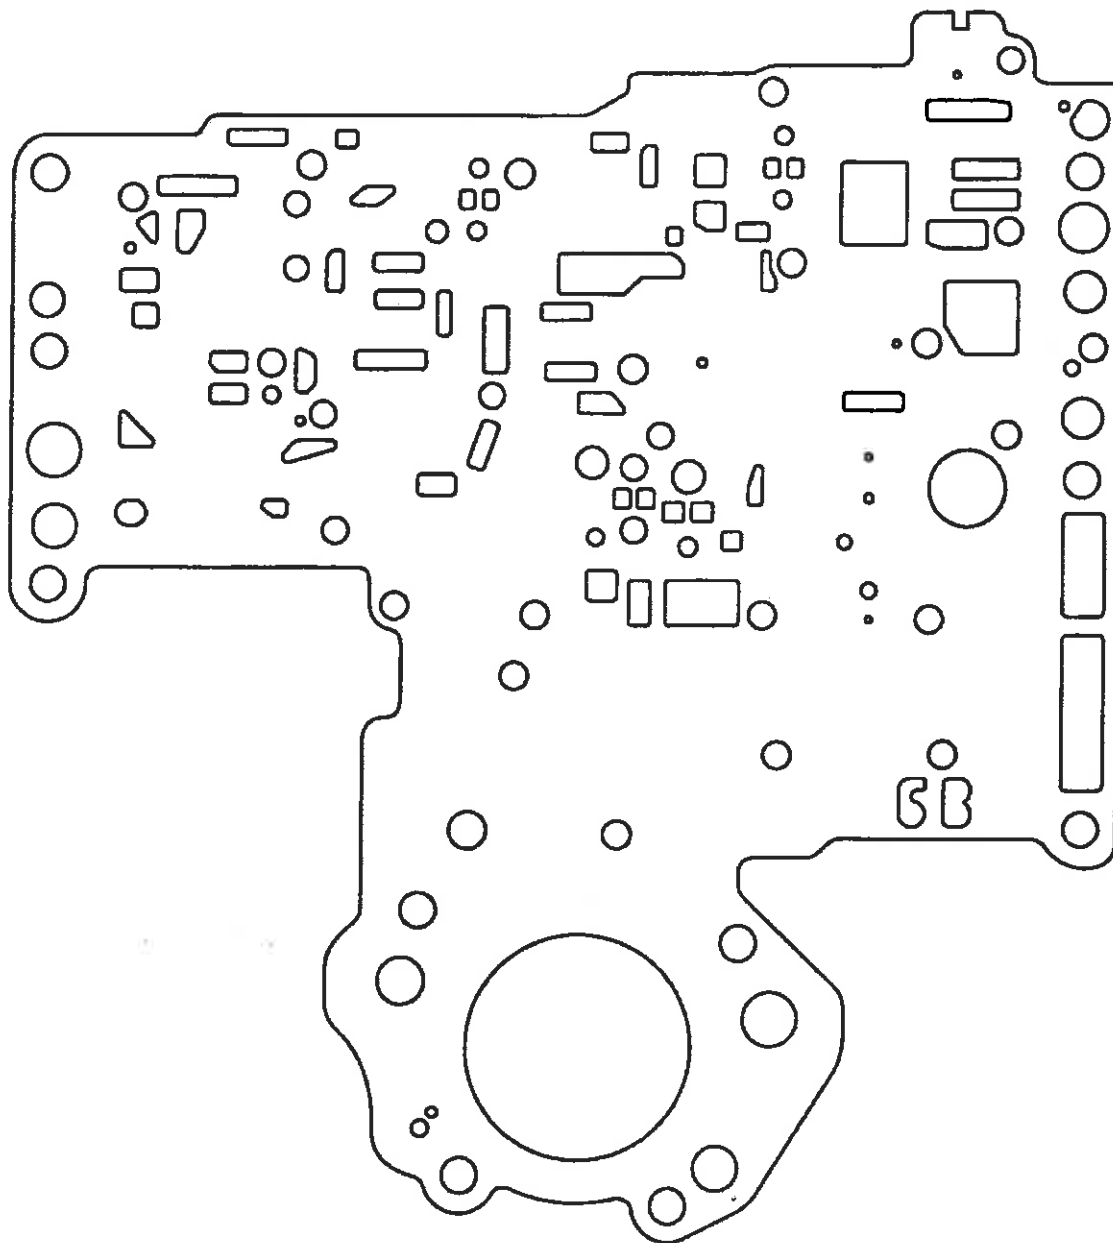
Figure 3

**46RE SPACER PLATE**

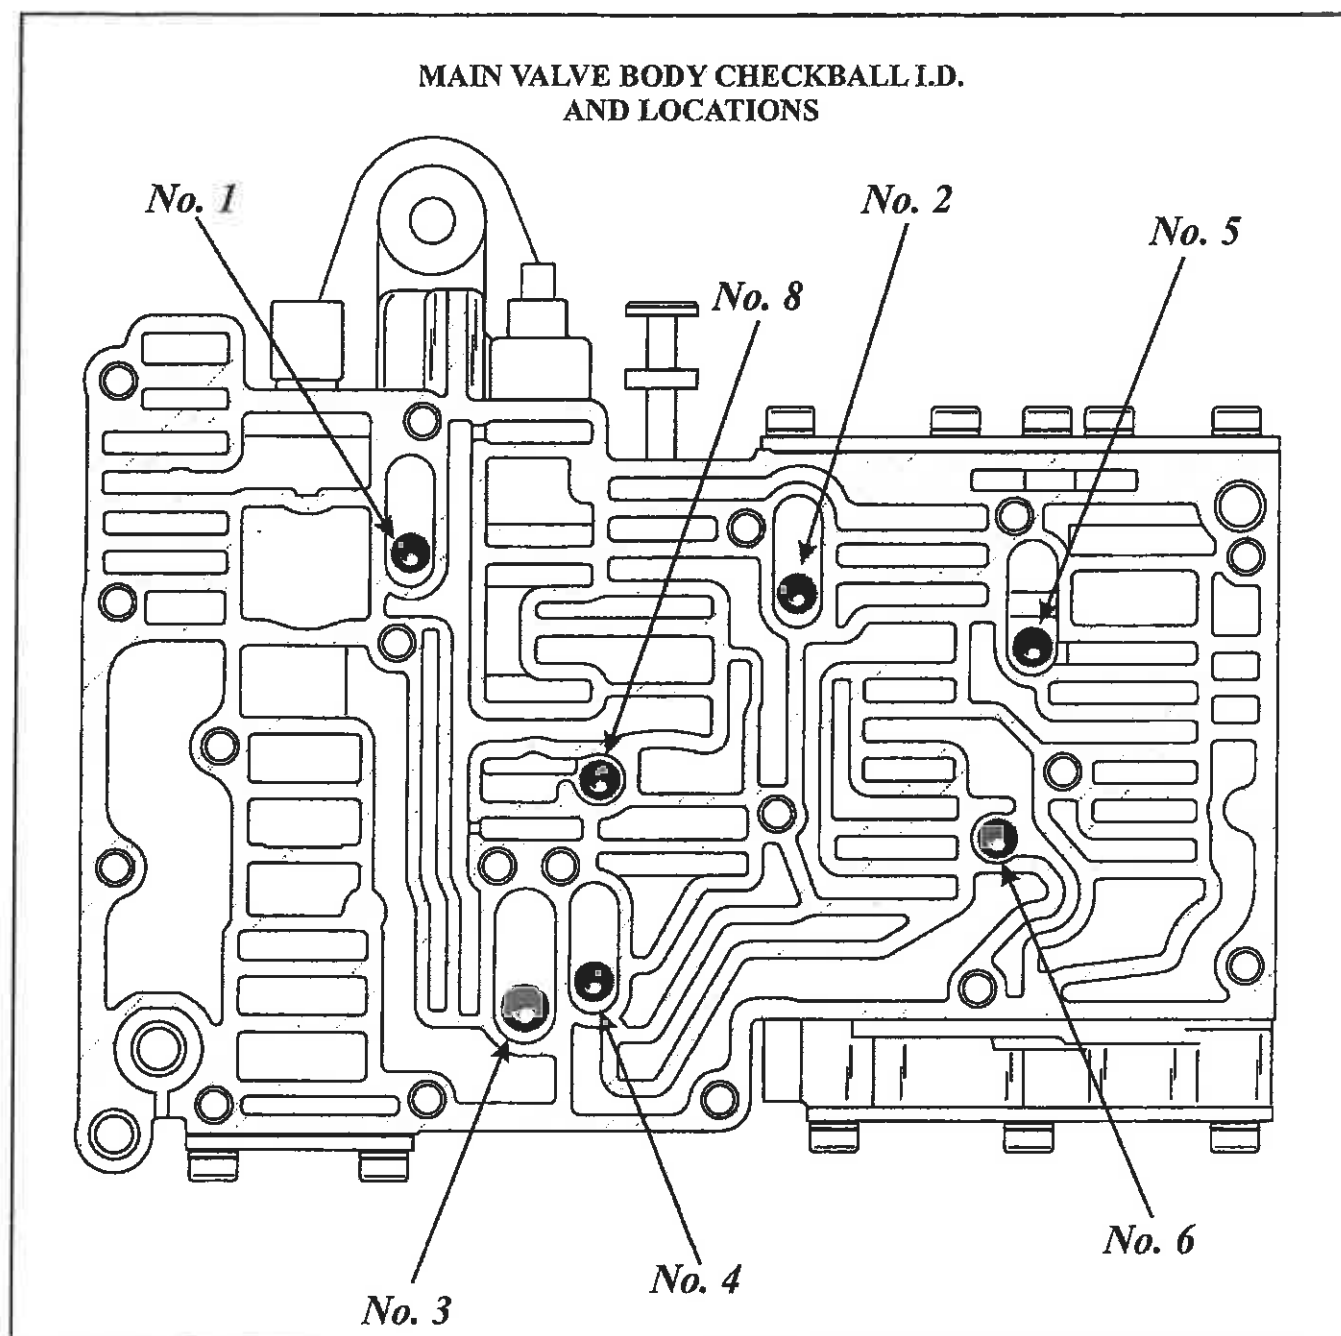
Figure 1

- CAUSE:** One such cause may be a cross leak between spacer plate and channel plate near the # 3 check ball seat area (See Figures 1 & 2). The cross leak may be the result of an incorrectly aligned spacer plate to channel plate. This misalignment may allow minimal 3rd gear oil pressure to cross over and intrude into the low/reverse band circuit after a 2-3 shift has occurred. This minimal pressure is enough to make the band drag on the low drum while driving in third and forth gear causing the premature failure of the band.

- CORRECTION:** If the band is destroyed the unit will obviously need to be removed for service. During the transmission repair procedure, disassemble the valve body and carefully flat sand the channel plate to ensure that the channel plate will mate flat to the spacer plate. When assembling the valve body, there are two holes that are to be used to properly align the spacer plate to the channel plate as seen in Figures 2 and 3. Place the spacer plate onto the channel plate and install the two bolts one in each alignment hole by hand. Then put the tension plate in place and tighten to 35 inch pounds to secure the spacer plate to the channel plate (See Figure 4). Remove the two bolts used to align the plate and re-use the same bolts to align the valve body and torque all the attaching bolts to 35 inch pounds. After the unit has been repaired and installed into the vehicle, attach a pressure gauge to the low/reverse pressure port (See Figure 5) and ensure that 0 psi is present while in third and forth gear.
