# Troubleshooting Torque Converter Clutch Cycling on Dodge Trucks

*Easy Solutions for a Common Problem*

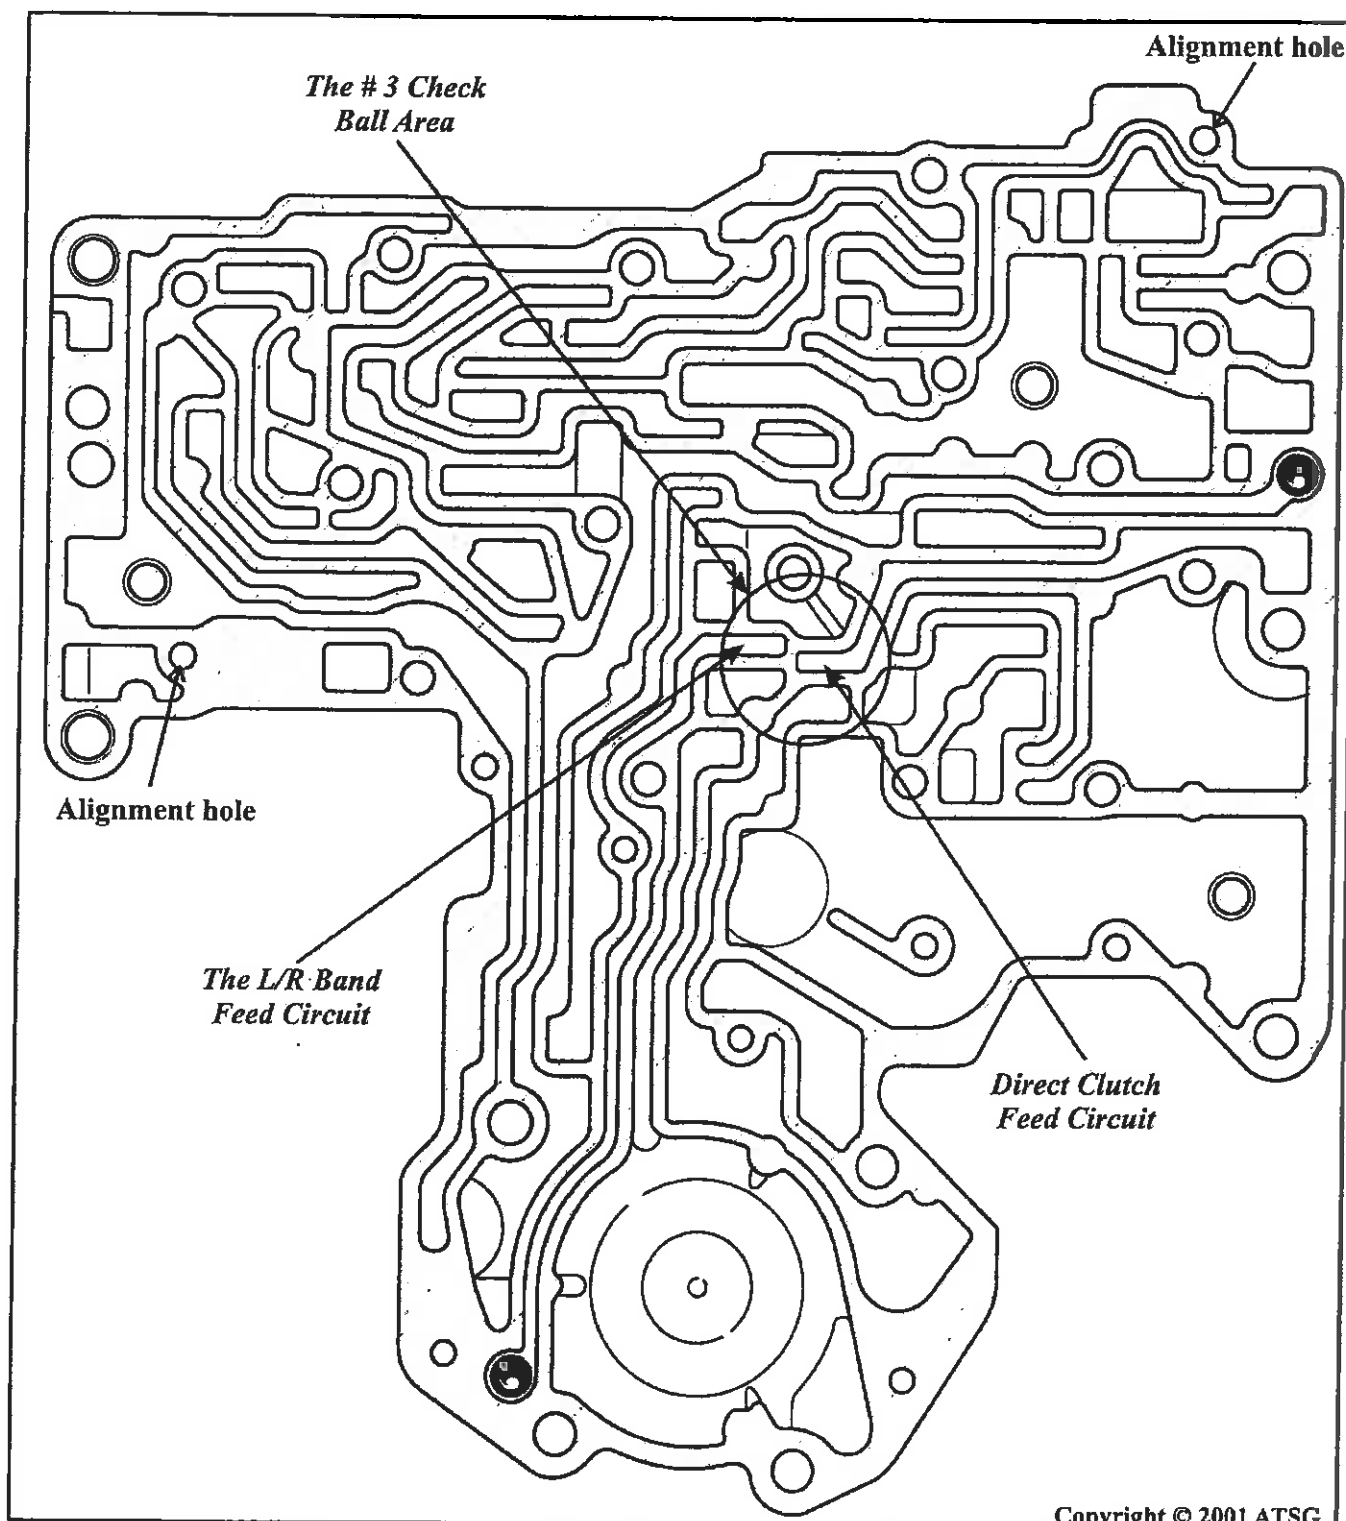
Figure 2

- CAUSE:** One such cause may be a cross leak between spacer plate and channel plate near the # 3 check ball seat area (See Figures 1 & 2). The cross leak may be the result of an incorrectly aligned spacer plate to channel plate. This misalignment may allow minimal 3rd gear oil pressure to cross over and intrude into the low/reverse band circuit after a 2-3 shift has occurred. This minimal pressure is enough to make the band drag on the low drum while driving in third and forth gear causing the premature failure of the band.

- CORRECTION:** If the band is destroyed the unit will obviously need to be removed for service. During the transmission repair procedure, disassemble the valve body and carefully flat sand the channel plate to ensure that the channel plate will mate flat to the spacer plate. When assembling the valve body, there are two holes that are to be used to properly align the spacer plate to the channel plate as seen in Figures 2 and 3. Place the spacer plate onto the channel plate and install the two bolts one in each alignment hole by hand. Then put the tension plate in place and tighten to 35 inch pounds to secure the spacer plate to the channel plate (See Figure 4). Remove the two bolts used to align the plate and re-use the same bolts to align the valve body and torque all the attaching bolts to 35 inch pounds. After the unit has been repaired and installed into the vehicle, attach a pressure gauge to the low/reverse pressure port (See Figure 5) and ensure that 0 psi is present while in third and forth gear.

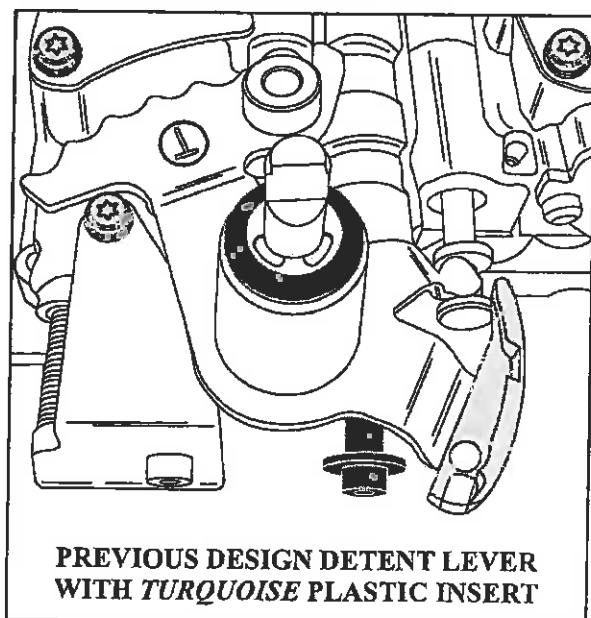
Figure 1

- COMPLAINT:** After a valve body exchange, the vehicle does not start or the detent lever cannot clear the safety neutral switch.
- CAUSE:** The safety neutral switch and the valve body detent lever changed for the 2000 model year. The switch is longer and the detent lever dimensionally changed to accommodate the new switch. Figures 1 and 2 show the dimensional differences between the previous and current design detent levers. Figures 3 and 4 illustrate the correct and incorrect assembly using the short switch. Figure 5 shows the correct assembly using the long switch.

- CORRECTION:** The detent lever with the *red* plastic insert goes with the *long* safety neutral switch. The detent lever with the *turquoise* plastic insert goes with the *short* safety neutral switch.

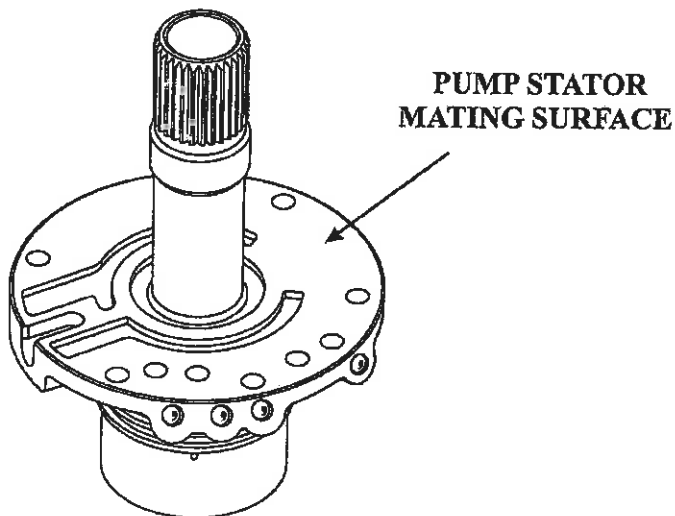
Figure 1

**CAUSE :** The cause may be, that the mating surface, as shown in Figure 1, between the Pump Body and the Pump Stator is not flat, causing a loss of line pressure and Torque Converter apply pressure. Refer to Figure 2 for port identification of the Pump Body and Pump Stator.

**46RE PUMP STATOR**

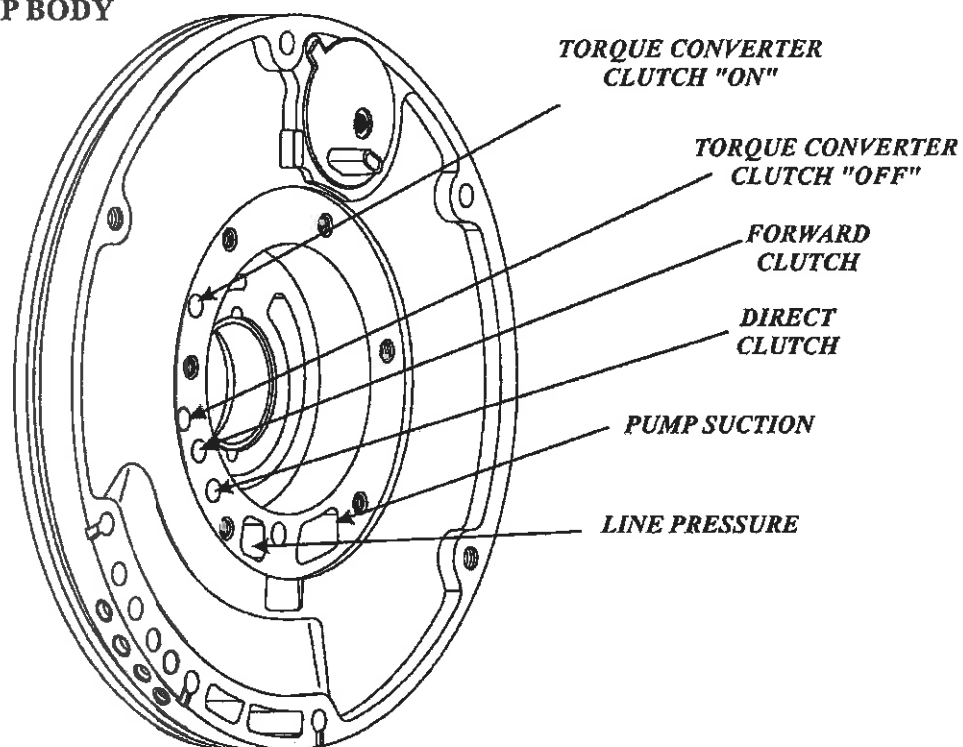
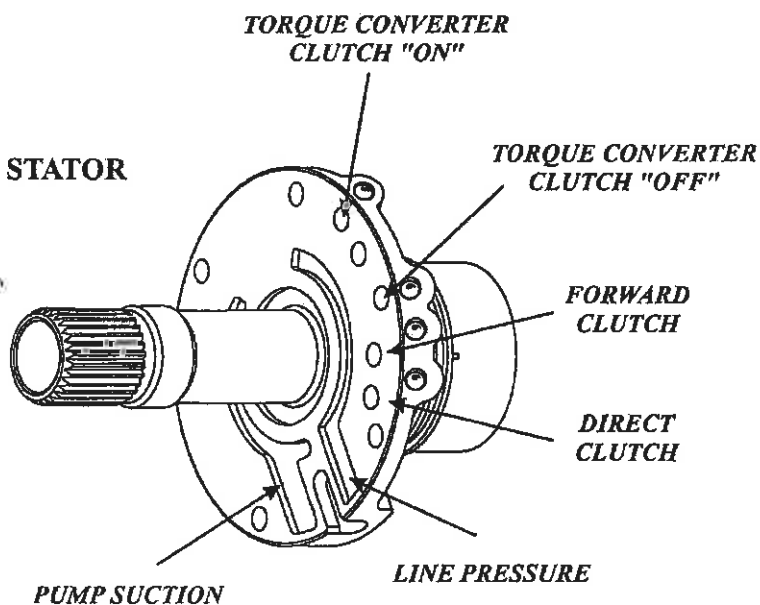
Figure 2

### 46RE PUMP BODY AND STATOR PASSAGE IDENTIFICATION
