EXHAUST SILENCERS

Subject: exhaust silencers

Model: Brevia 750

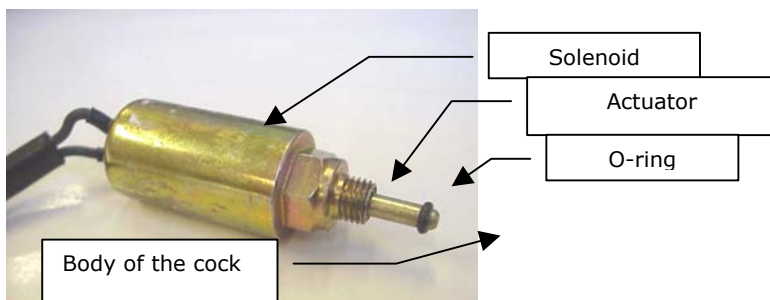
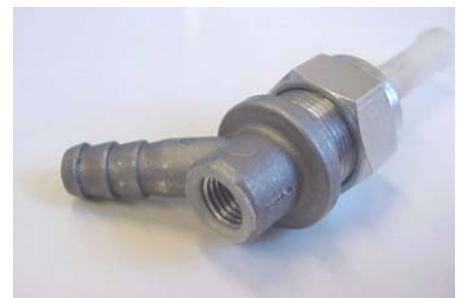
- body of the cock
- electric actuator (this is in turn made up of a solenoid and of mechanical actuator provided with an O-ring at the end)

To unlock the cock, simply loosen the solenoid by one/two turns in relation to the body of the cock. It is recommended to remove the solenoid and replace the O-ring, which is available as spare part with 90706020 code.

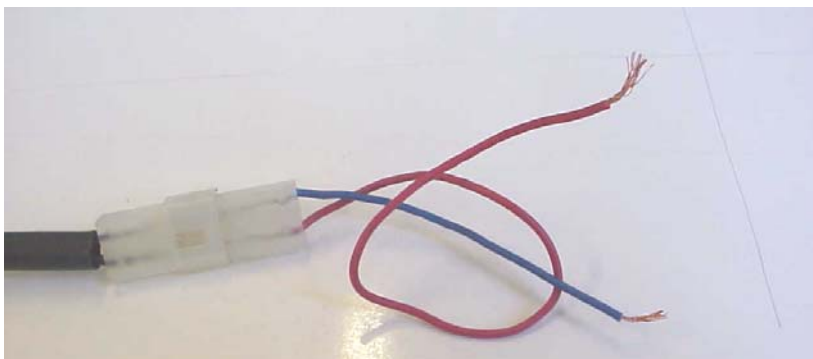
In order to carry out the test easier, connect a wired counterpart to the cock connector.

Connect a multimeter between the two wires and place the multimeter in Ω mode (resistance measurement).

The resistance should be $33 \pm 2 \Omega$

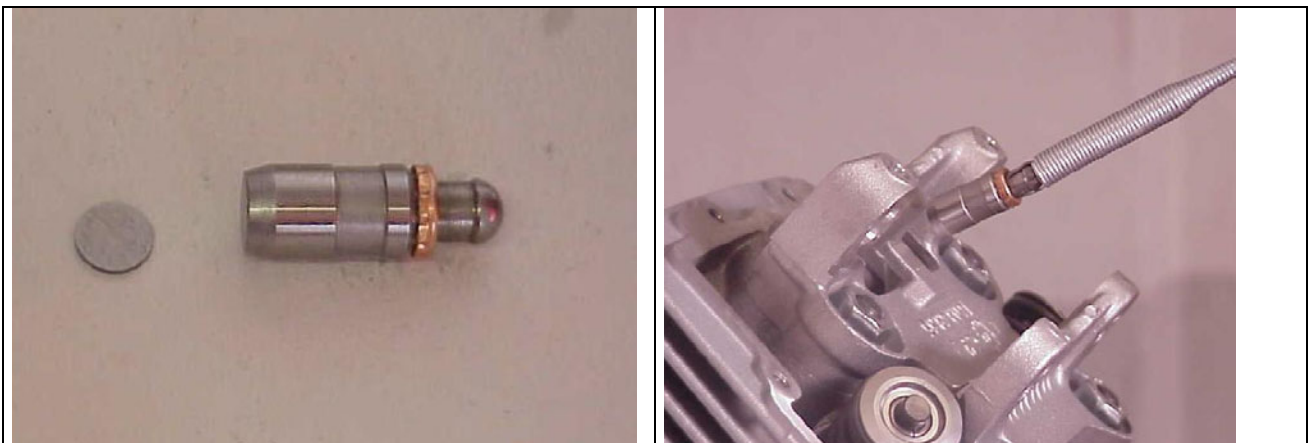
5

IN THIS CASE, ATTACH THE CALIBRATED PAD TO THE TAPPET (BOTTOM PART), GREASING IT WITH ENGINE OIL IN ORDER TO STICK IT TO THE TAPPET AND TO EASILY INSERT THE TAPPET WITH THE CALIBRATED PAD INTO THE CLOSING.

BY USING A LIGHT SOURCE, CHECK THAT THE CALIBRATED PAD IS FITTED INTO THE CLOSING.

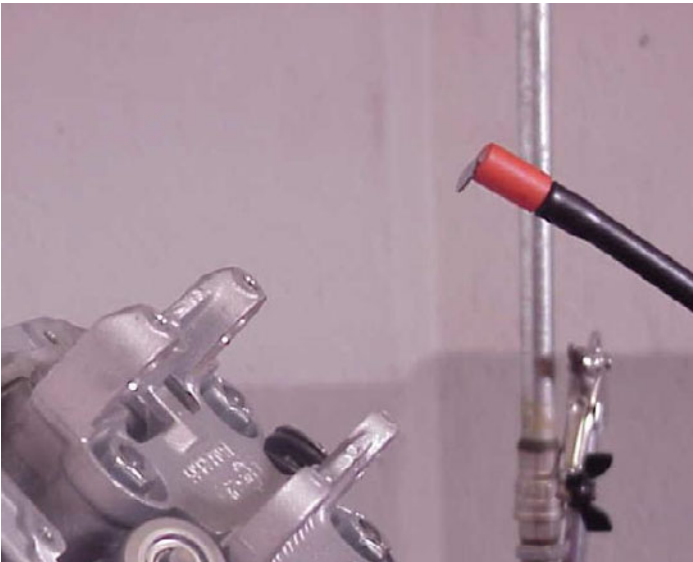
7

IF > 1.1 mm THE CLEARANCE IS CORRECT, LEAVE THE CALIBRATED PAD IN POSITION

IF < 1.1 mm REMOVE THE CALIBRATED PAD (USE A MAGNET; SEE PHOTOGRAPH)

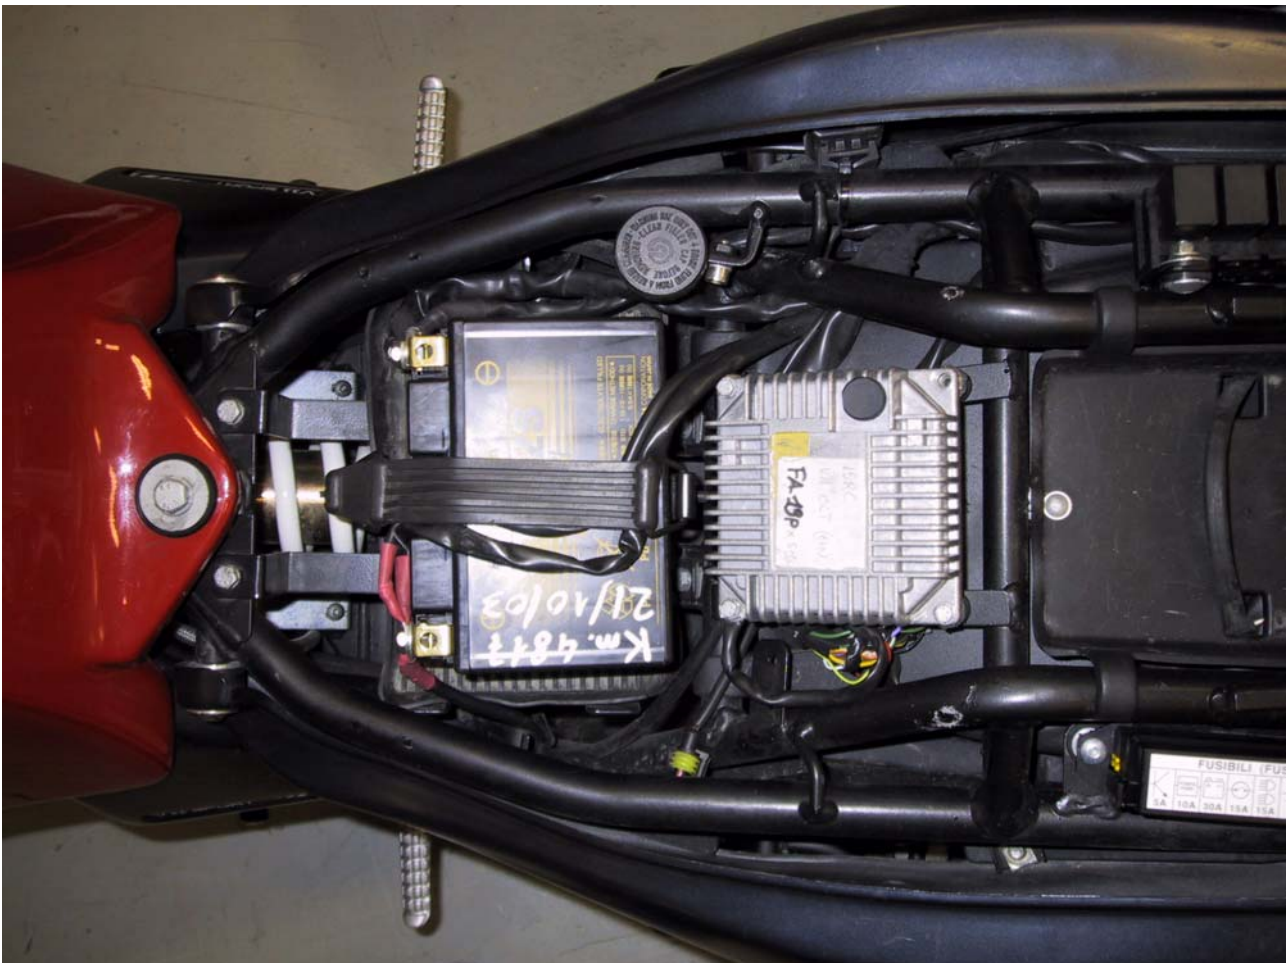
short life-span of the presently fitted battery due to fluid leakage (**30 Ah EXIDE standard type** (29.52)).

the **YUASA YTZ12S** battery will be fitted (comes from Yuasa already filled with fluid).

In production is fitted a new wiring while on bikes with present wiring it is possible to fit the battery and re-route the cables.
