HP LaserJet printer product update

March 2004 • Volume 23

HP LaserJet 4200 printer—torn fuser film service note

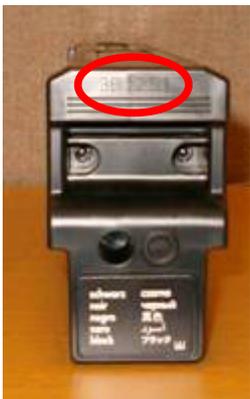
Lot code location

- Toner is bound in the print cartridge. This is most likely to occur if the print cartridge was exposed to high temperatures during transport.
- The motor on the T-cartridge drive assembly is not working properly, either electrically or mechanically.
- The toner outlet on the bottom of the print cartridge did not open properly when it was installed in the printer, or the outlet is otherwise blocked.
