# Patch 86241-06 For Rapier Switches

## Introduction

This patch release note lists the issues addressed and enhancements made in patch 86241-06 for Software Release 2.4.1 on existing models of Rapier L3 managed switches. Patch file details are listed in Table 1.

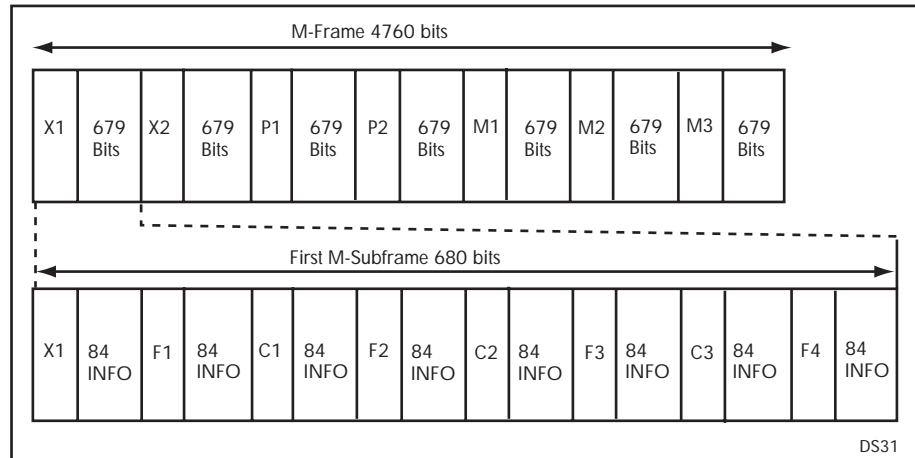
Figure 1: DS3 Framing Structure.

into 8 blocks of 85 bits with 84 bits available for payload, and one bit for framing overhead. The frame structure is shown in Figure 1 on page 23.

The switch with the DS3 interface is called the *near end*. The entity the switch connects to is called the *far end*. X1 and X2 are set to 1 if the near end is receiving an *Alarm Indication Signal (AIS)*, a *Loss Of Frame (LOF)*, or a *Loss Of Signal (LOS)*. This allows the near end to indicate to the far end that it is experiencing a problem and is known as *Far End Receive Failure (FERF)*.

P1 and P2 form the *P-bit channel*. They provide parity information for the preceding M-frame.

The three C-bits in M-subframe 4 are designated as FEBE bits. The FEBE bits are returned to the far end to indicate the occurrence of a framing error or CP-bit parity error. If none occur, the FEBE bits are set to all ones. One or all of the FEBE bits are set to zero if a CP-bit parity error or an error in the F or M bits is found.

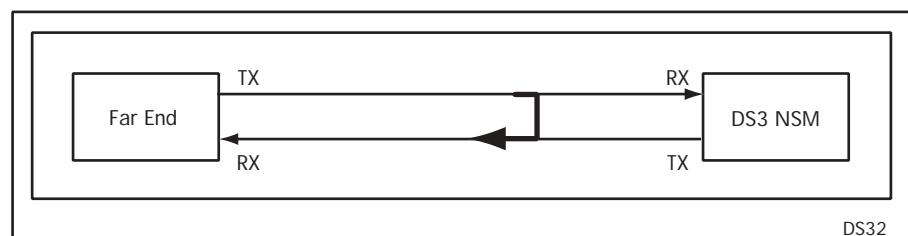
Figure 2: Line Loopback.

Line loopback is shown in Figure 2 on page 24. In this loopback mode the receive signal is looped straight to the transmit signal.

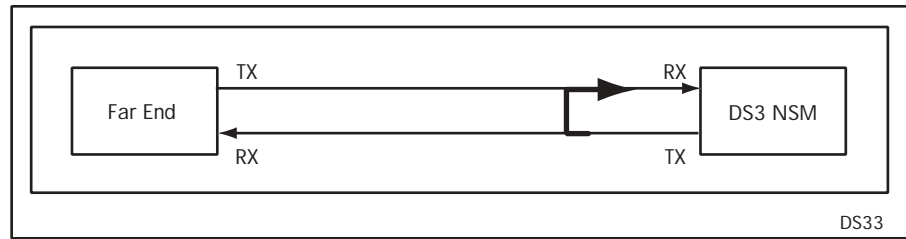
Figure 3: Diagnostic Loopback.

Diagnostic loopback is shown in Figure 3 on page 25. In this loopback mode the transmit signal is connected straight to the receive signal.

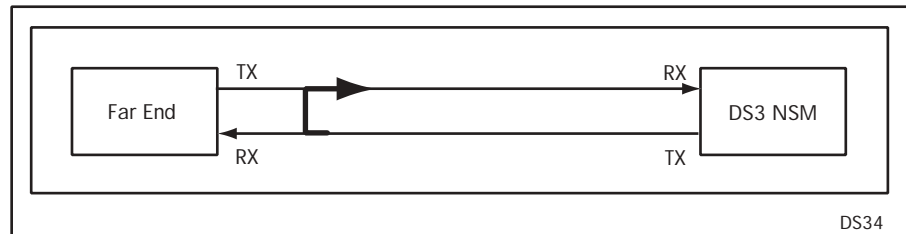
Figure 4: Remote Loopback.

In C-bit parity mode it is also possible for the switch to request a loopback at the far end. This is shown in Figure 4 on page 25. This is achieved using the FEAC channel. The switch can also respond to remote loopback requests via the FEAC channel from the far end. This results in a near end Line Loopback (see above).

Note that it is possible to configure near end local and remote loopbacks at the same time.
