# Dell™ PowerEdge™ 1855 Systems

## Information Update

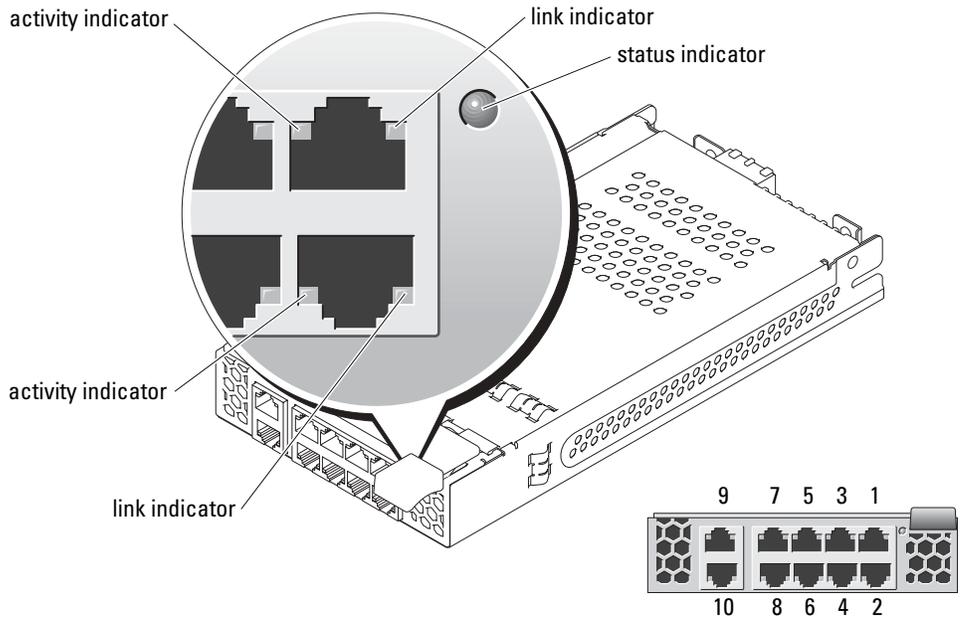
**Figure 1-1. Gb Pass-through Module Indicators and Features**

Figure 1-1 and Table 1-3 describe the functions of the indicators on the Gb pass-through module.

Indicator Type	Activity Indicator	Indicator Code
Link indicator/activity indicator	Green/amber blinking	The Gb Ethernet connector is linked to the server module and there is network activity.
	Green/off	The Gb Ethernet connector is linked to the server module and there is no network activity.
	Off/amber blinking	The Gb Ethernet connector is not linked to the server module and there is network activity.
	Off/off	The Gb Ethernet connector is not linked to the server module and there is no network activity.
