Cisco uBR10012 Universal Broadband Router Troubleshooting Guide

October 2004

Text Part Number: OL-1237-01

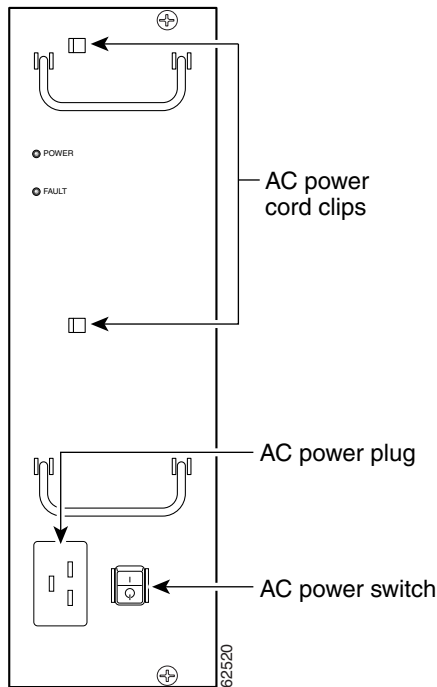
Figure 2-1 AC PEM Front Panel

[Figure 2-1](#) illustrates the AC PEM and its indicators. [Table 2-1](#) describes the indicators.

LED	Color	Description
Power	Green	The PEM is on, is receiving power from the AC power source, and is providing power to the Cisco uBR10012 chassis (normal operations).
Fault	Yellow	Indicates that AC-input power is being received by the PEM, but that the PEM is not supplying power to the chassis, typically because the PEM's power switch is turned to the standby position. If the Fault LED is lit when the power switch is in the ON position, the PEM is not operating correctly.

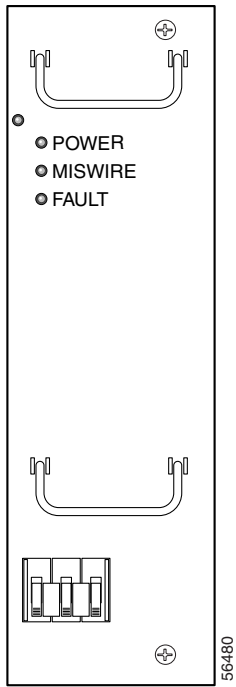
Figure 2-2 DC PEM Front Panel (original model, UBR10-PWR-DC)

- [Figure 2-2](#) shows the front panel of the original DC PEM (UBR10-PWR-DC) that was initially produced for the Cisco uBR10012 router.
- [Figure 2-3](#) shows the front panel of the DC PEM that is currently being produced for the Cisco uBR10012 router. The new model of the DC PEM (UBR10-PWR-DC-M) is identical in form and function to the first version, except that it includes a connector on the front panel for connecting to the alarm status connectors on the optional 2400-watt AC-input power shelf.

LED	Description
Power (green)	PEM is powered on and is operational.
Fault (yellow)	PEM is not operating correctly or the circuit breaker is in the OFF position.
Miswire (yellow)	Input DC power cables are wired incorrectly and should be reversed.

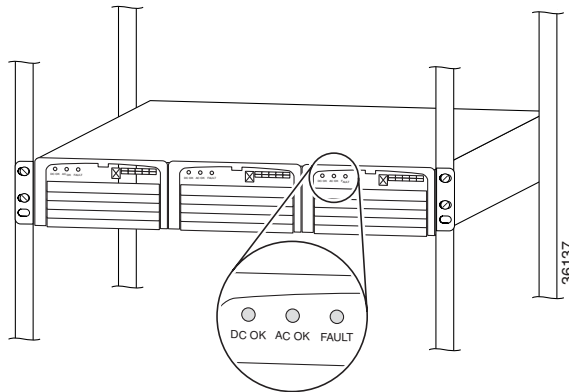
Figure 2-4 AC-Input Power Shelf Front Panel

Figure 2-4 illustrates the AC PEM and its indicators. Table 2-5 describes the indicators.

LED	Color	Description
AC OK	Green	The AC-input power to the power module is present and is within the proper range.
DC OK	Green	The power module is producing DC output power in the proper range.
FAULT	Red	This particular power module has failed and must be replaced. The 2400W AC-input power shelf can continue operating with only two out of the three power modules installed, but the failed module should still be replaced as soon as possible.

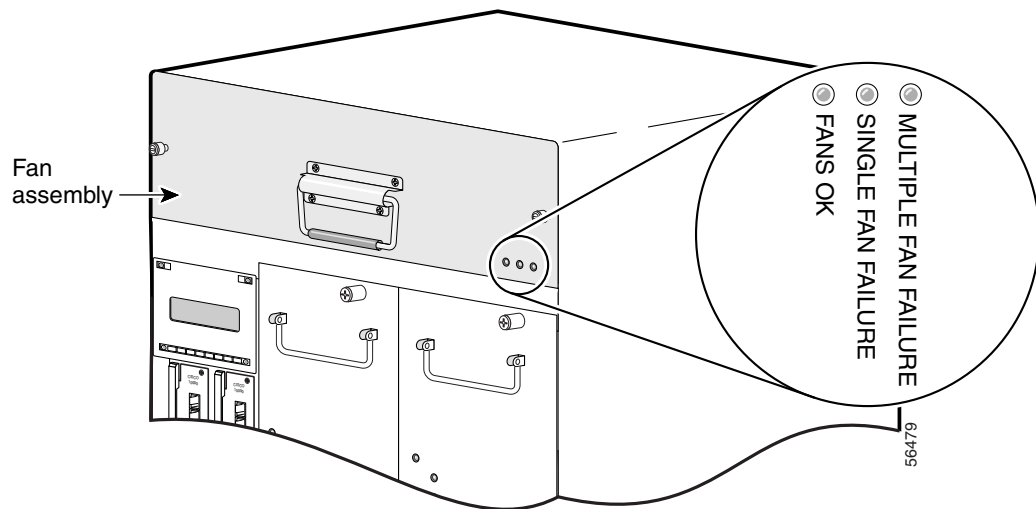
Figure 2-5 Fan Assembly Module

Figure 2-5 shows the fan assembly module front panel and its LED indicators.

The Cisco uBR10012 fan assembly module contains four fans in a redundant configuration. One fan can fail without affecting system operations. If more than one fan fails, however, the fan assembly module must be replaced immediately to avoid overheating the system.

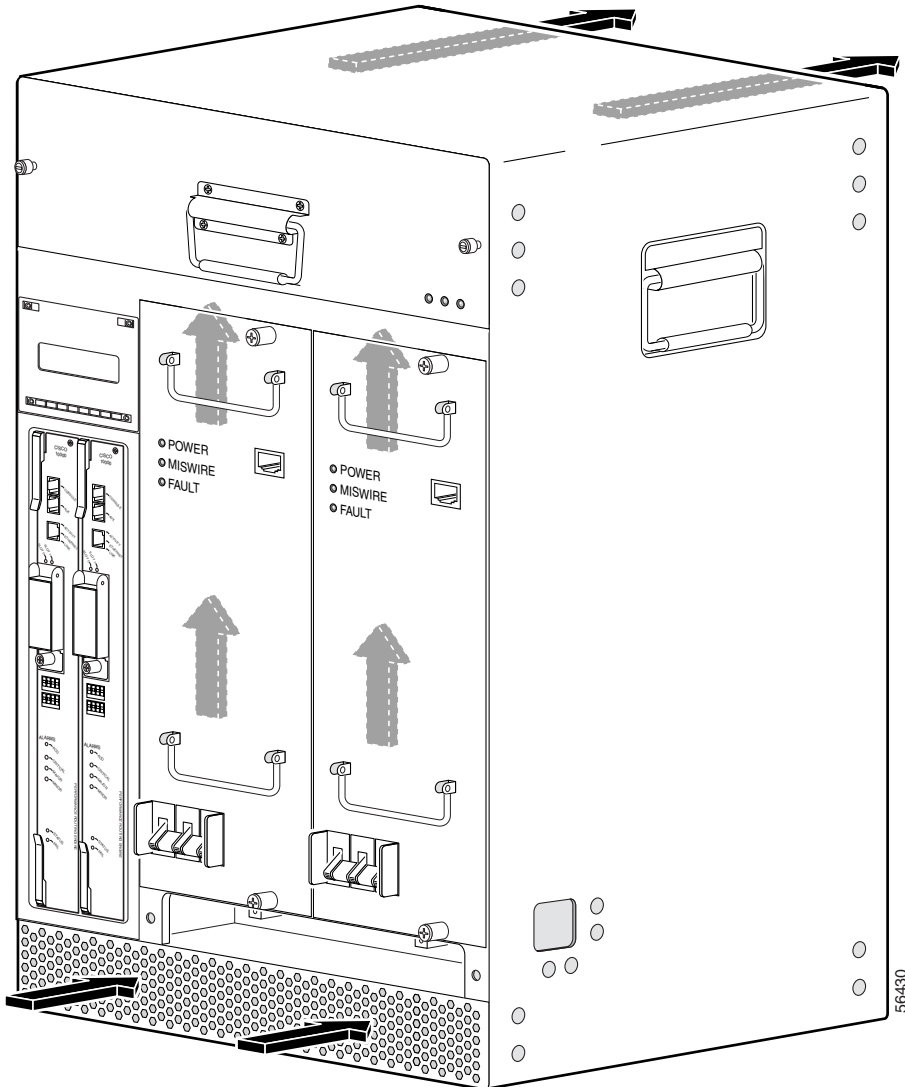
Figure 2-6 Fan Assembly Air Circulation Pattern

The fan assembly module draws air in from the bottom front of the Cisco uBR10012 router, through the air filter at the bottom of the front bezel. The air is drawn up through the line cards, and then exits through the vents at the top rear of the router.

Figure 2-6 shows the air circulation pattern of the Cisco uBR10012 router when two DC PEMs are installed. The air flow when two AC PEMs are installed is similar. The front bezel is not shown for clarity.

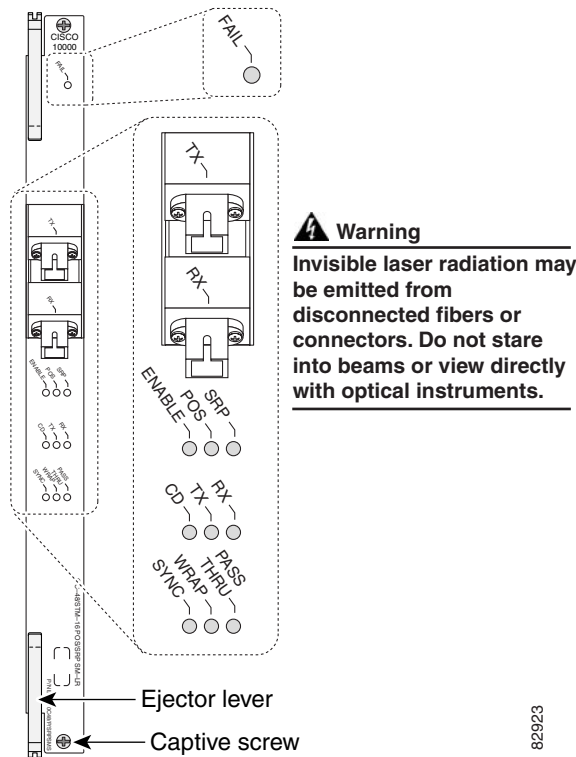
Figure 4-4 Cisco OC-48 DPT Interface Module Faceplate

The Cisco OC-48 DPT/ POS interface module has a pair of OC-48c, fiber-optic standard connector (SC) duplex ports that provide an SC connection for either the single-mode short-reach or single-mode long-reach version. Figure 4-4 shows the faceplate on the Cisco OC-48 DPT/ POS interface module, and Table 4-7 describes each LED.

LED	Status	Description
FAIL	Yellow	Line card is disabled
	Off	Line card is operational
ENABLE	Green	Port is enabled
	Off	Port is disabled
POS	Green	Operating in POS mode
	Off	Not operating in POS mode
SRP	Green	Operating in SRP mode
	Off	Not operating in SRP mode
CD	Green	Carrier detected
	Off	No carrier detected
TX	Green	Packets transported
	Off	No packets transported
RX	Green	Packets received
	Off	No packets received
