Star Chromatography Workstation Version 6

LC Control Release Notes

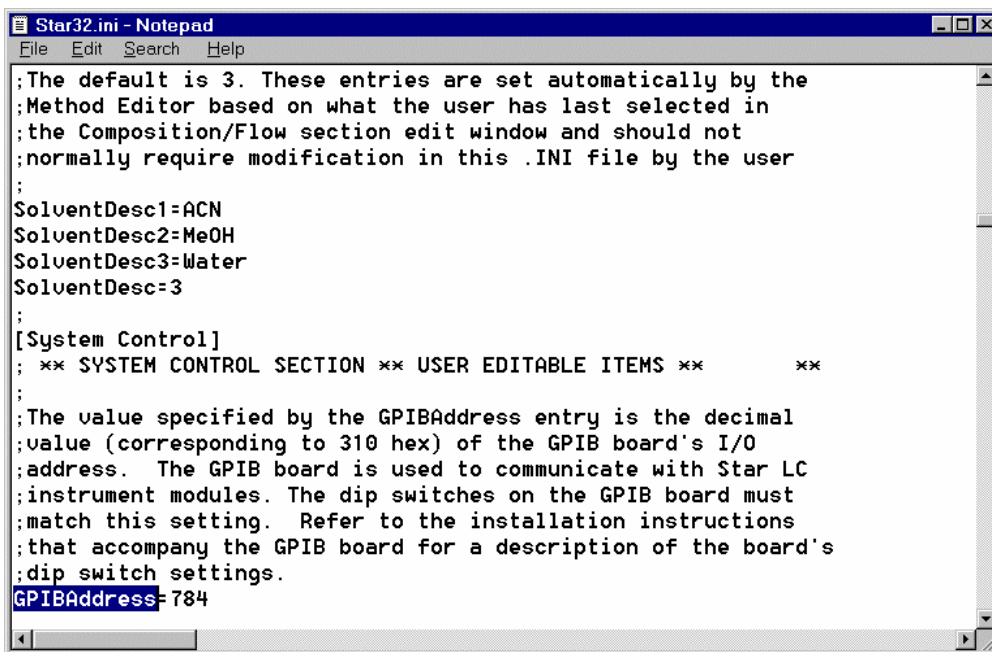
```
Star32.ini - Notepad
File Edit Search Help
;The default is 3. These entries are set automatically by the
;Method Editor based on what the user has last selected in
;the Composition/Flow section edit window and should not
;normally require modification in this .INI file by the user
;
SolventDesc1=ACN
SolventDesc2=MeOH
SolventDesc3=Water
SolventDesc=3
;
[System Control]
; ** SYSTEM CONTROL SECTION ** USER EDITABLE ITEMS **      **
;
;The value specified by the GPIBAddress entry is the decimal
;value (corresponding to 310 hex) of the GPIB board's I/O
;address. The GPIB board is used to communicate with Star LC
;instrument modules. The dip switches on the GPIB board must
;match this setting. Refer to the installation instructions
;that accompany the GPIB board for a description of the board's
;dip switch settings.
GPIBAddress=784
```

The default GPIB address used by the Star Workstation for the ISA card was changed in Version 5 to avoid conflicts with common PC peripherals such as sound cards. The new default address is 784 decimal (310 Hex). If you are upgrading from an existing Star Workstation earlier than version 5, chances are good that your GPIB board is set to 816 decimal (330 Hex). Before operating Version 6, you need to change the address that the Star Workstation uses to find your GPIB board by following these steps.

1. Use Notepad and open the file STAR32.INI located in your Windows directory.
2. Click on the Search menu and choose *Find ...*
3. Enter GPIBAddress and click on *Find Next* until you see the line **GPIBAddress=784** highlighted.
4. Change the value 784 to 816 and save the STAR32.INI file.
