SoftLogix Controllers, Version 21

Catalog Numbers 1789-L10, 1789-L30, 1789-L60

This publication describes SoftLogix 5800 controllers, version 21.03.00.

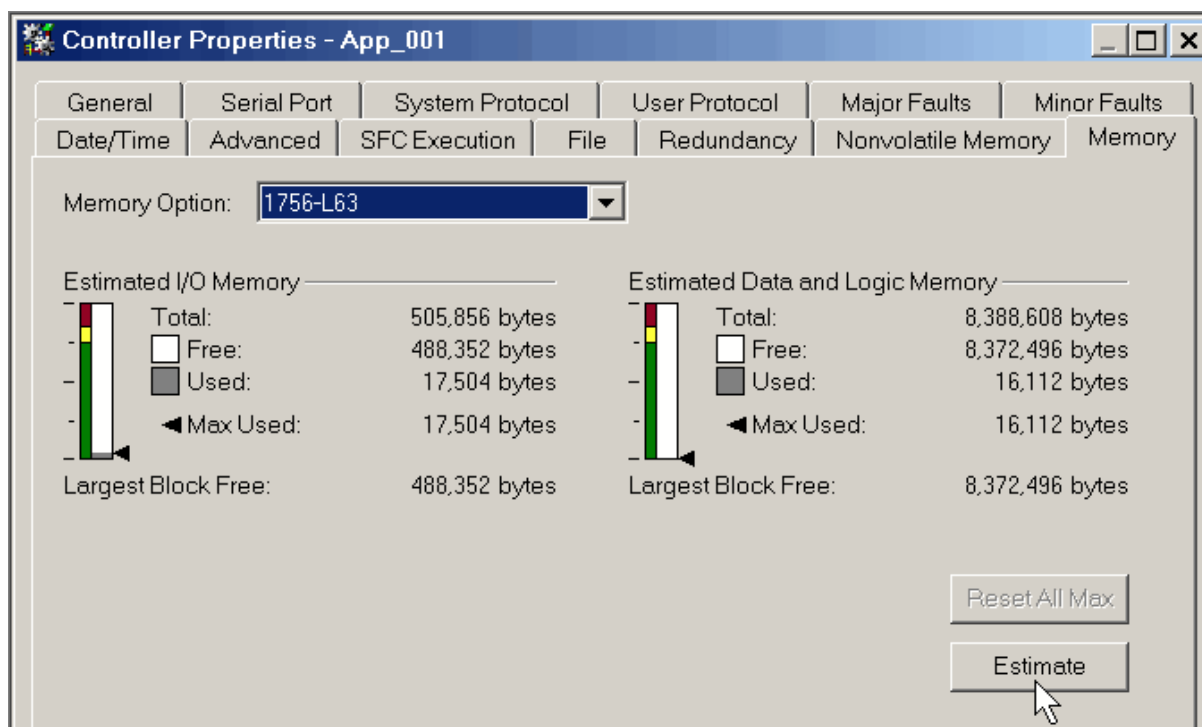
Use the Estimate Tool

To estimate the amount of memory required by your application, convert the project to the controller version desired and use the Estimate tool available in the Memory tab of the Controller Properties.
