EPROM Upgrade Kit for CentreCOM™ AT-6870 and AT-6875 Bridges User Manual

Bridge EPROM Upgrade Kit

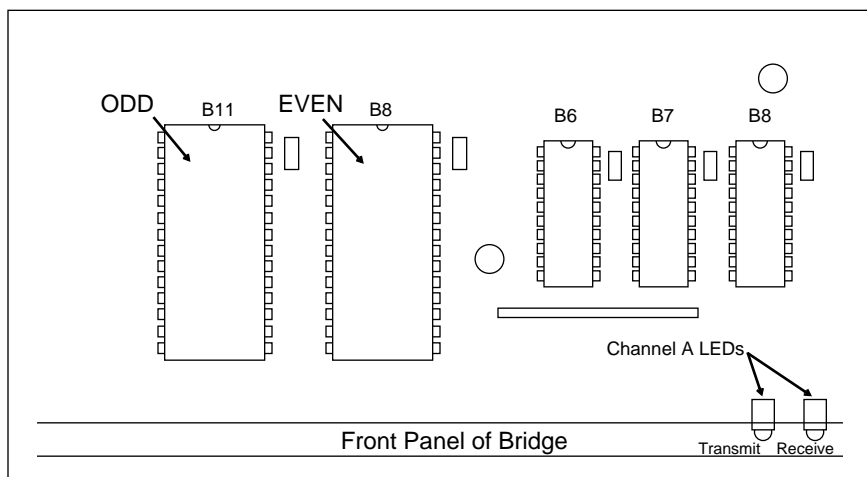
Figure 1: Location and Orientation of the EPROMs on the AT-6870/6875 Logic Board

1. Make sure the power to the bridge is OFF.
2. Remove the two screws on each side of the bridge that hold the top cover in place.
3. Remove the top cover. The cover fits tightly, and it may be necessary to use a screwdriver to initially dislodge it.
4. Orient the unit with the front towards you. The power supply should be on the left, and the port LEDs should be on the right. See Figure 1.

The EPROM marked ODD goes on the left and the EPROM marked EVEN goes on the right. Place EPROMs in the correct sockets and orient them correctly or damage may result.

6. Referring to Figure 1, observe the orientation of the two EPROMs. Insert the EPROM marked "ODD" in the socket on the left, B11 on the Printed Circuit Board (PCB) silkscreen. Insert the EPROM marked "EVEN" in the socket on the right, B8 on the PCB silkscreen. The notched end of the EPROMs' ceramic cases go toward the back of the logic board. When inserting the EPROMs in their sockets, carefully line up the pins with the socket contacts, and exert just enough insertion force to slide the pins into the contacts evenly and completely.
7. Replace the cover and secure it using the four screws.
