IMPORTANT PRODUCT INFORMATION

Product: IC693CPU364 CPU Module with Ethernet Interface

IC693CPU364-AC with Firmware Release 9.10

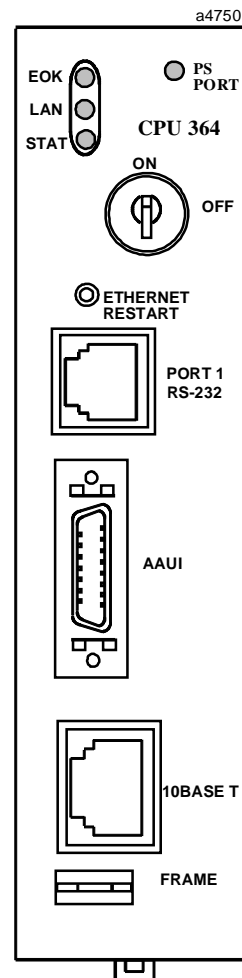
Note: On some modules the LED labeled "PS PORT" may say "SNP" instead; otherwise, the modules are identical.

CPU Type	Single slot CPU module with embedded Ethernet Interface
Total Baseplates per System	8 (CPU baseplate + 7 expansion and/or remote)
Load Required from Power Supply	1.1 Amps from +5 VDC supply
Processor Speed	25 MegaHertz
Processor Type	80386EX
Ethernet fuse, replaceable	2.69x2.69x6.1 mm, 125V, 1A, slow acting
Operating temperature	0 to 60 degrees C (32 to 140 degrees F) ambient
Typical Scan Rate	.22 milliseconds per 1K of logic (Boolean contacts)
User Memory (total)	240K (245,760) Bytes. Note: Actual size of available user program memory depends on the amounts configured for the %R, %AI, and %AQ configurable word memory types (described below).
Discrete Input Points - %I	2,048
Discrete Output Points - %Q	2,048
Discrete Global Memory - %G	1,280 bits
Internal Coils - %M	4,096 bits
Output (Temporary) Coils - %T	256 bits
System Status References - %S	128 bits (%S, %SA, %SB, %SC - 32 bits each)
Register Memory - %R	Configurable in 128 word increments, from 128 to 16,384 words with DOS programmer, and from 128 to 32,640 words with Windows programmer Ver. 2.2 or VersaPro version 1.0.
