# PACSystems\* RX3i

## IC695CPU315

### Central Processing Unit

GFK-2586

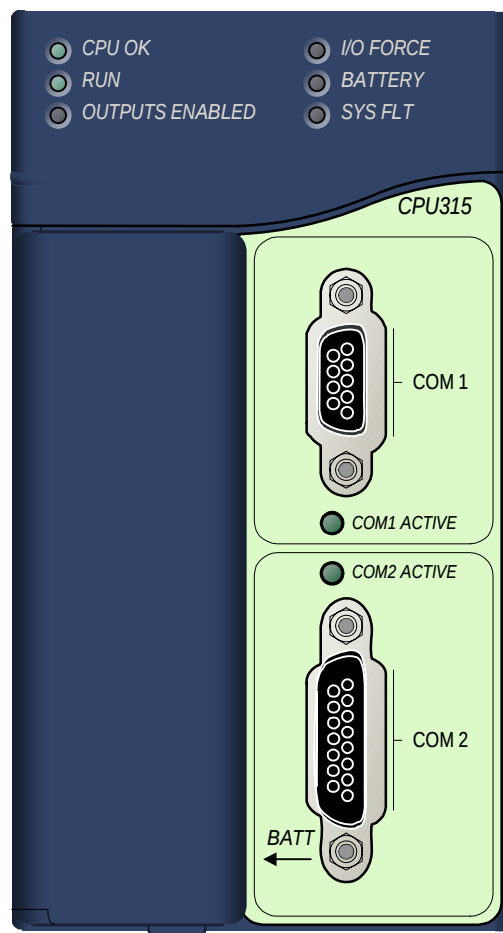
The RX3i CPU can be used to perform real time control of machines, processes, and material handling systems. The CPU communicates with the programmer and HMI devices via a serial port using SNP Slave protocol. It communicates with I/O and smart option modules over a dual backplane bus that provides:

- High-speed PCI backplane for fast throughput of new advanced I/O.
- Serial backplane for easy migration of existing Series 90\*-30 I/O.
