PACSystems™ RX3i

IC695CPU310

Central Processing Unit

GFK-2329AA
March 2010

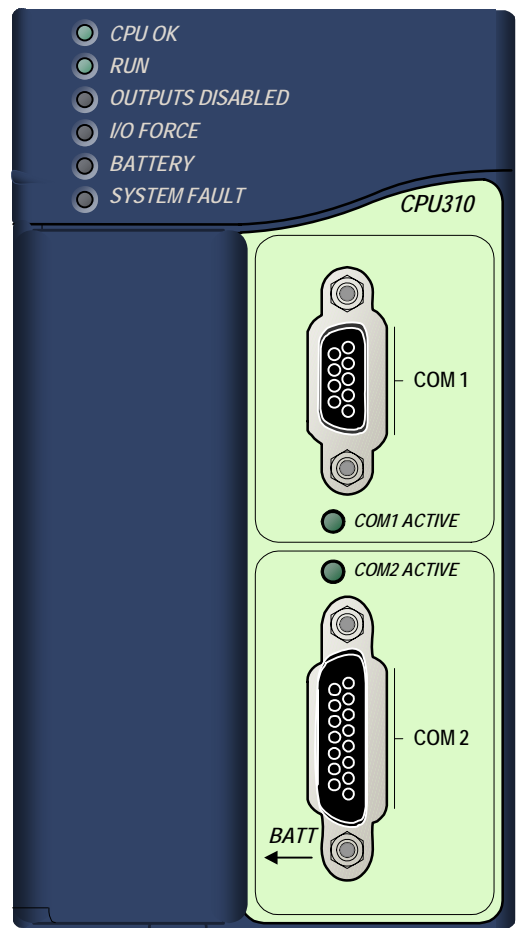
- In-system upgradeable firmware.
 - Two serial ports: an RS-485 serial port and an RS-232 serial port.
- Ethernet communications via the rack-based Ethernet Interface module (IC695ETM001). For details on Ethernet capabilities, refer to *TCP/IP Ethernet Communications for PACSystems User's Manual*, GFK-2224.
