PACSystems™ RX3i

IC695NIU001

GFK-2419C
May 2006

Ethernet Network Interface Unit

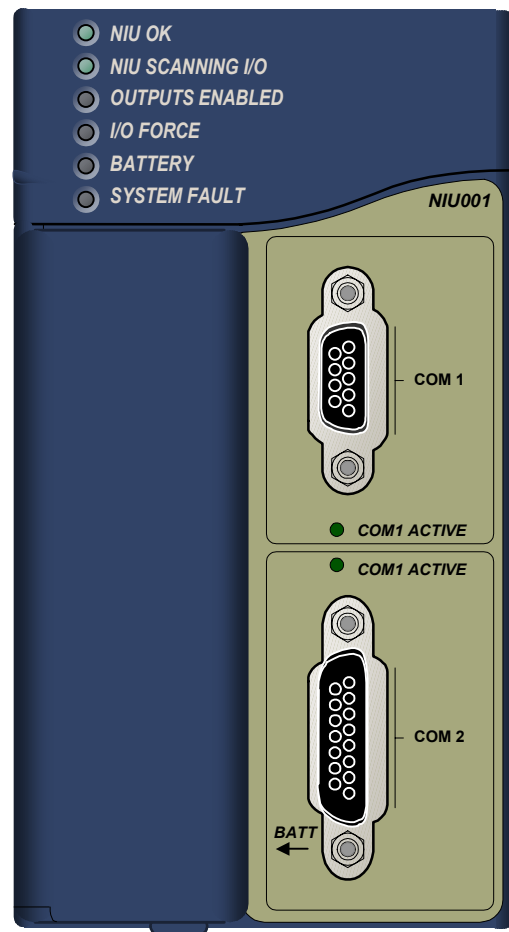
- 20Kbytes of optional local logic. Supports all languages except C programming.
- 10 Mbytes of battery-backed CMOS RAM memory for local data storage.
- 10 Mbytes of built-in flash memory for local user data storage. Use of this flash memory is optional.
- Battery-backed calendar clock.
- In-system upgradeable firmware.
- Two serial ports: an RS-485 serial port and an RS-232 serial port.
- Supports Ethernet communications via the backplane-based Ethernet Interface module (IC695ETM001)
- Data exchange using Ethernet Global Data (EGD)
- TCP/IP communication services using SRTP
- Comprehensive station management and diagnostic tools

- Supports operation with redundant controllers
- PACSystems RX7i and RX3i controllers can send selected COMMREQs to the RX3i ENIU via Ethernet Global Data. The ENIU executes the COMMREQs and returns the results to the controller.
- During EGD configuration, RX3i Ethernet interfaces are identified by their Backplane/Slot location.

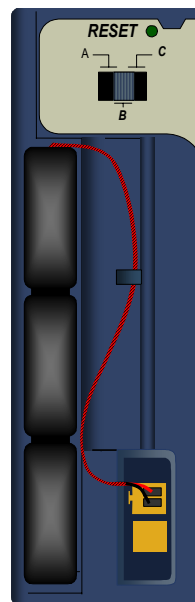
Battery

To avoid loss of RAM memory contents, routine maintenance procedures should include scheduled replacement of the NIU's lithium battery pack. For information on estimating battery life, refer to the *PACSystems NIU Reference Manual*, GFK-2222.

Subject	Description
Battery installation	When installing a new battery, if no battery is currently installed, the new battery must be installed while the ENIU has power. Failing to follow this procedure could result in the ENIU not powering up. Recommendation: remove the battery, power-cycle the ENIU, then re-install the battery.
Ethernet Disconnect During Word for Word Change	If the Ethernet connection is broken during a word-for-word change, the programmer may not allow a subsequent word-for-word change after reconnecting. Recommendation: go offline and then back online again.
Simultaneous Clears, Loads and Stores Not Supported	Multiple programmers may not change ENIU contents at the same time. The programming software may generate an error during the operation. Simultaneous loads from a single ENIU are allowed.
Power Cycle During Write to Flash	The ENIU is configured to power up from flash and if is power-cycled while writing to flash, a fault is generated on power up.
