# PACSystems\* RX3i IC695NIU001 PLUS

## Ethernet Network Interface Unit

GFK-2598A

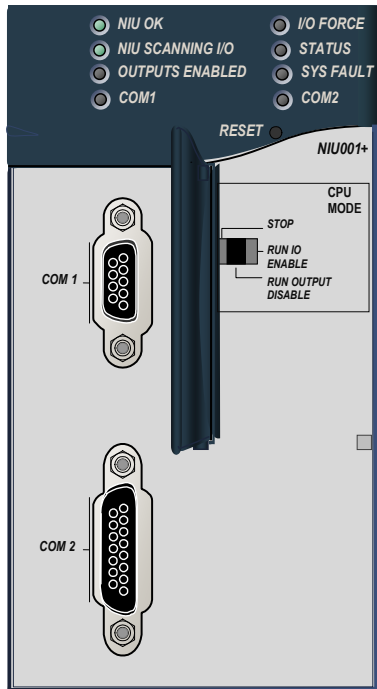
Front View

### NIU Plus Battery and Switch Locations

The Ethernet NIU Plus has two switches. The Reset switch is not used. The three-position Run/Stop switch is located behind the protective door, as shown above.

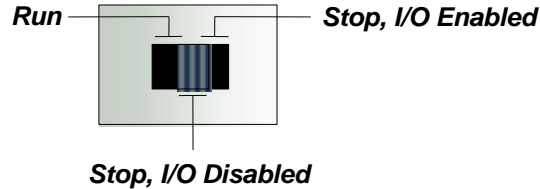
Unlike the Run/Stop switch on a CPU module, on an Ethernet NIU the use of this switch is disabled by default. If the switch is to be used to control the Run or Stop mode operation of the NIU, clear faults, and/or prevent writing to program memory or configuration, it must be enabled on the Settings Tab of the Ethernet NIU configuration in the folder, and stored to the ENIU.
