PACSystems™ RX3i

IC695NIU001-CJ

GFK-2419H
February 2008

Ethernet Network Interface Unit

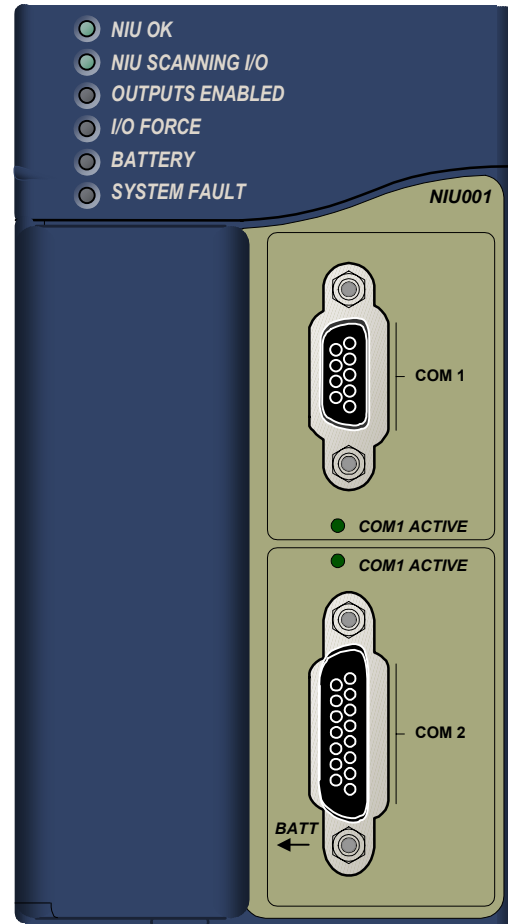
The PACSystems RX3i Ethernet NIU, IC695NIU001, makes it possible to use PACSystems RX3i and Series 90-30 I/O remotely on an Ethernet network. Once set up by configuration, data exchange is completely automatic. System control can be provided by any GE Fanuc master device capable of exchanging Ethernet Global Data. The Ethernet NIU automatically provides the controller with status information in each exchange. The application program logic in the controller can monitor this status data, and issue appropriate commands to the Ethernet NIU.

An RX3i Ethernet NIU station consists of:

- an RX3i Universal Backplane (IC695CHS0xx)
- an RX3i power supply (IC695PSxxxx)
- the RX3i Ethernet NIU (IC695NIU001)
- one or more RX3i Ethernet modules (IC695ETM001)
- proprietary application software
- Optional Series 90-30 expansion backplanes.
- PACSystems RX3i and/or Series 90-30 modules, as appropriate for the application.

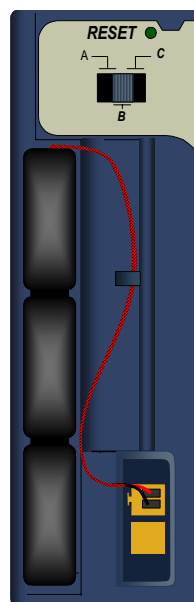
Battery

To avoid loss of RAM memory contents, routine maintenance procedures should include scheduled replacement of the NIU's lithium battery pack. For information on estimating battery life, refer to the *PACSystems NIU Reference Manual*, GFK-2222.
