ControlLogix® Redundancy System Revision 13

Cat. No. 1756-CNB/D, 1756-CNBR/D, 1756-ENBT, 1756-EWEB, 1756-L55, 1756-L55M12, 1756-L55M13, 1756-L55M14, 1756-L55M16, 1756-L55M22, 1756-L55M23, 1756-L55M24, 1756-L61, 1756-L62, 1756-L63, 1757-SRM

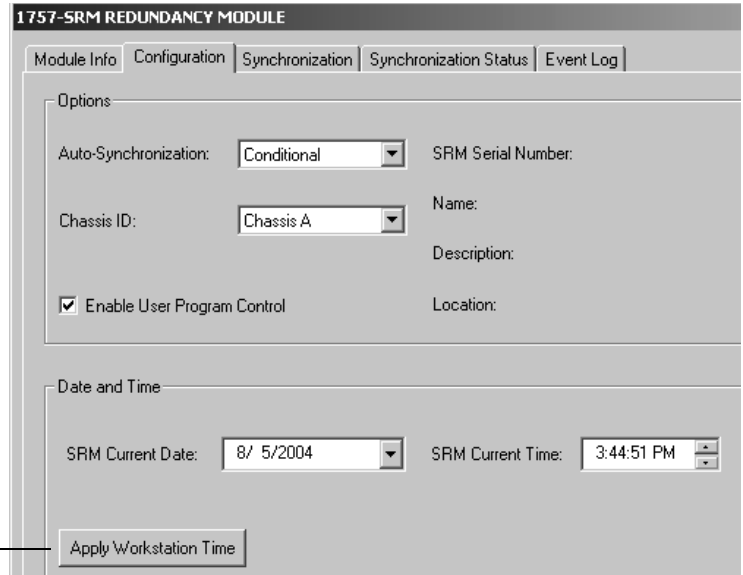
To send the currently running workstation (PC) time to the SRM module, click this button.

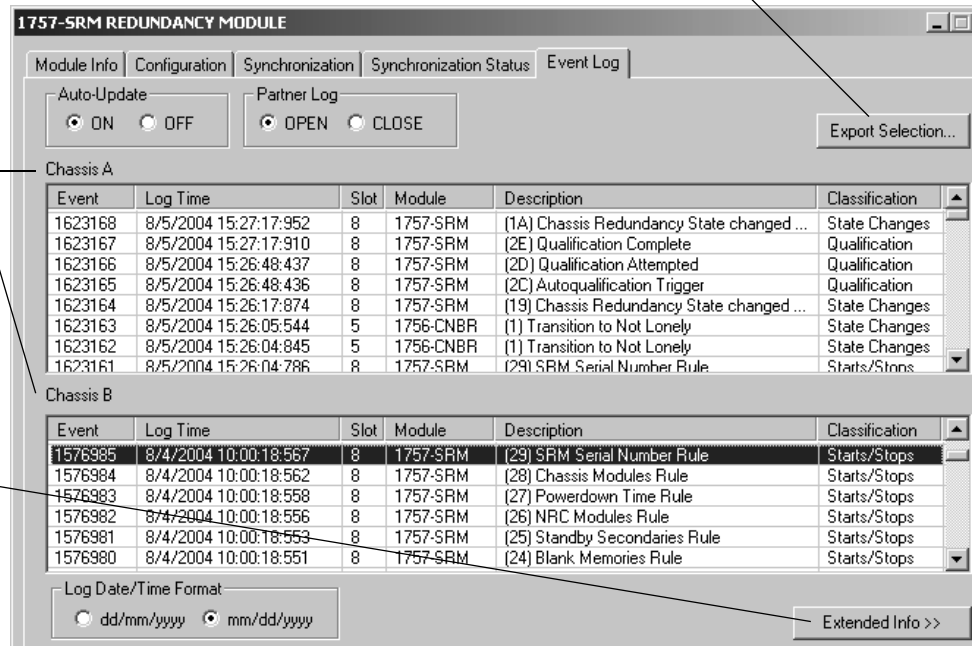
See events in both SRM modules at the same time

See extended information in text format
