## Aircraft Repair --The Missing Manual

by John Schwaner

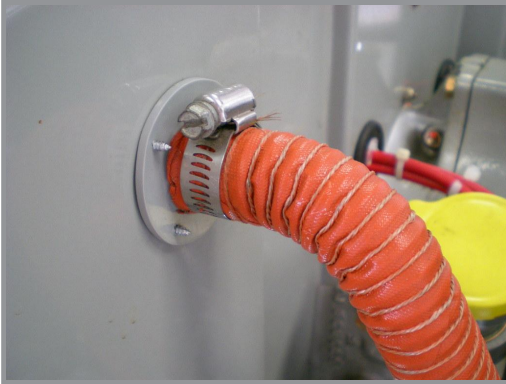
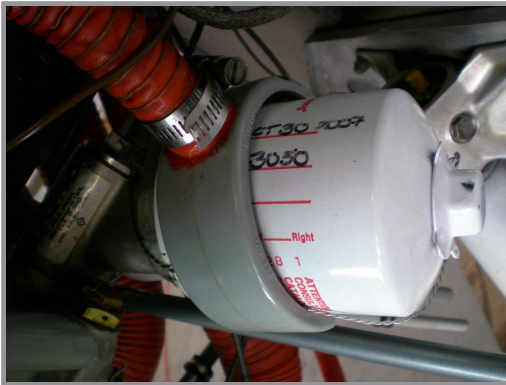
Hi John,  
Here are the photos of my home made oil cooler for the Continental O-300. It actually takes about 15 degrees out of the oil on these hot summer Texas days.

Take a close look. This is a Rapco vacuum pump cooling shroud!

This customer installed the Rapco vacuum pump cooling shroud around his oil filter. Neat idea and it reduced oil temperature by 15 degrees!

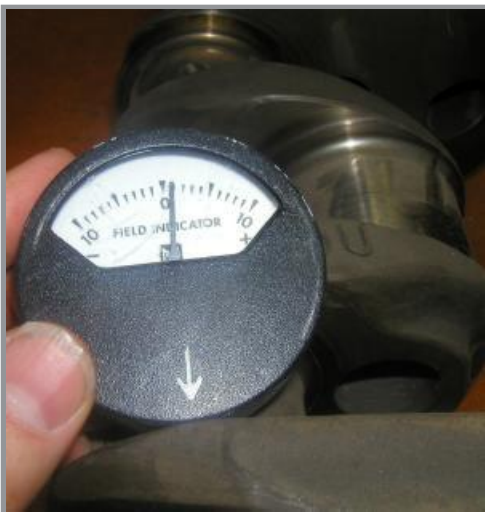
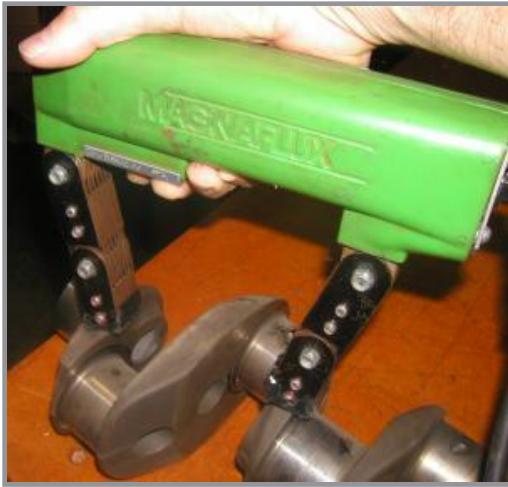
The degausser will eliminate artifical magnetic fields in metal structures. If that is your compass problem, then yes it works very well.

The concept of the process is to use a meter to identify the field location and then use the degausser to eliminate it, and then use the field to verify the effectiveness. Very easy,

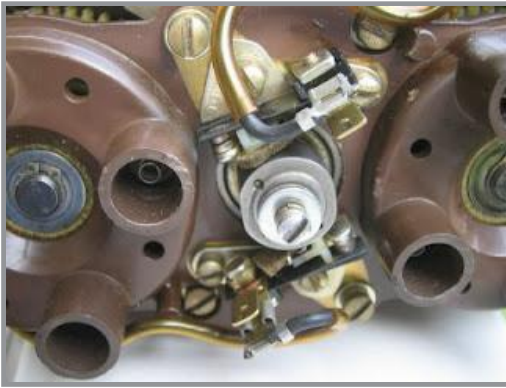
*The investigation did show, that the screw (Fig 1-14 D-3000 Magneto manual ) was loose*

*and so the cam breaker could turn on the cone.*

The problem here is that the mechanic did not order a new cam screw and re-used the old one. You loosen this screw when you adjust internal timing. This screw is a self-locking screw that uses a nylon patch on the threads. The locking effectiveness is poor if re-used. Continental says to replace it with a new one. Follow the factory instructions - accept no deviation or alternative methods of compliance.

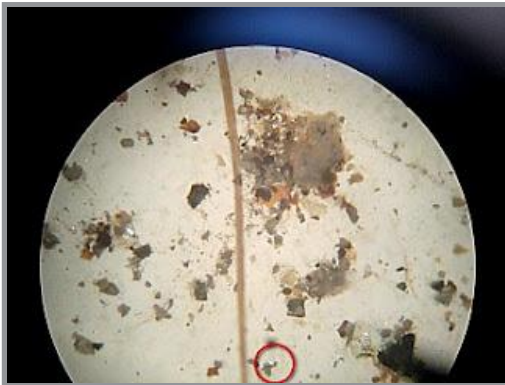
I threw in a hair (ouch!) for reference:

The vast majority of the material appears to be non-metallic junk (silicates, carbon, or whatever). I was able to see only a couple of very tiny magnetic bits using a magnet. You would never have seen them move with the naked eye. I next did a trial of drano with some aluminum filings so I'd have something as a reference. Bubble and fizz as advertised. I then applied the drano solution to the washings. I was able to locate only 2 or 3 microscopic fizzies out of the whole lot. Not much aluminum in there. What is notable, and you can see it in the photo immediately above, is that there is a scattering of metallic looking particles (red circle). These are mostly the width of a hair and smaller. They are

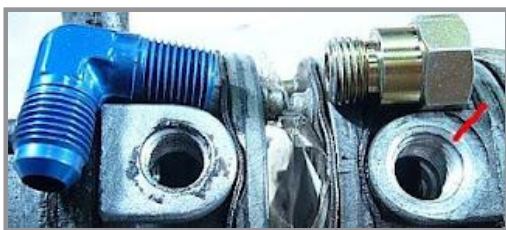
In non-aircraft applications ports are mostly straight thread "ORB" O-ring Boss. The automotive industry (heck I don't know what to call you guys - "race industry", is that better) has plenty of adapters to adapt AN to the port - pictured below. There is no AN number for this adapter. It does not exist in the AN series - for good reason - it is not needed in aircraft. In aircraft, the traditional straight threaded boss is called a "AND" port (AND10050 or MS33656) and doesn't require an adapter fitting. This should be the end of the story for us aircraft people but it isn't.

Some automotive style components with ORB ports are being used in aircraft. These require the adapter shown above. So now us aircraft people must be able to look at the port and tell what kind it is.

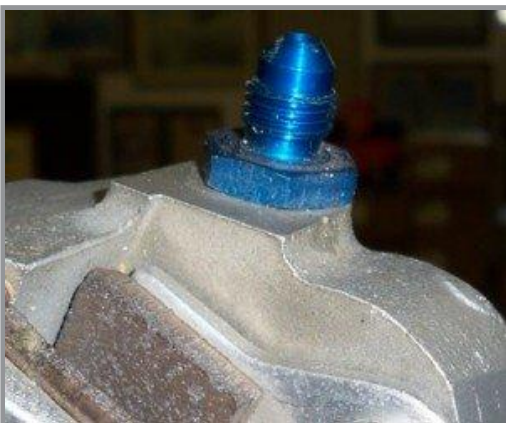
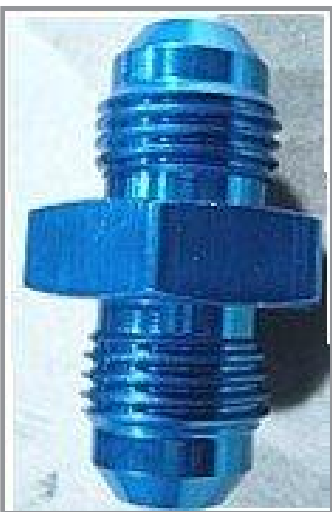
Is it a tapered pipe thread port (NPT), an ORB port or a AND style port? Curse you automotive people for bringing us your ORB crap! NPT is bad enough!

Here is a aircraft brake caliper with a male AN nipple sticking out of the port. It looks like out adapter above. But it's not. Here is a picture of the entire fitting. Notice that this is a standard AN fitting. Below is a picture showing how it installs with a boss o'ring.

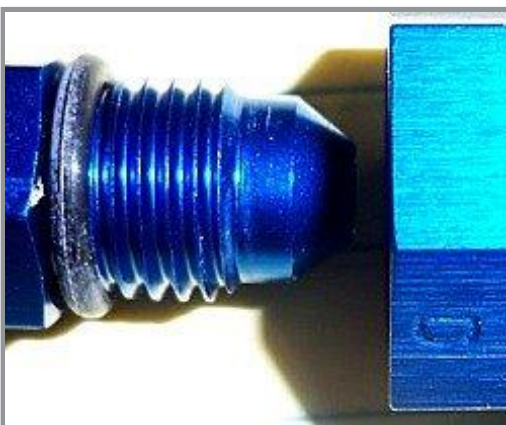
Simple, just install a a boss O'ring onto the end of a standard AN nipple fitting and screw into the port. You can also use a bulkhead fitting and special nut for high-pressure hydraulic applications.

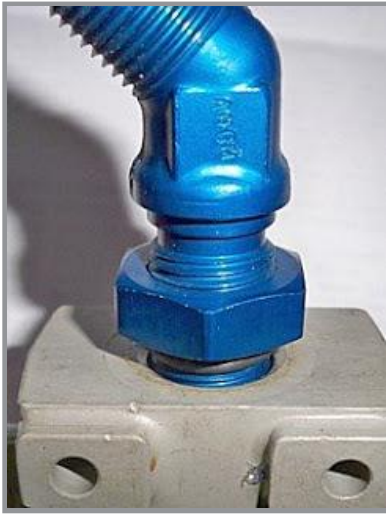
Here is a picture below.  
This port (AND10050 - MS33656) has stronger (greater shear strength) threads (class 3 versus class 2). and can accomodate the extra length of the nipple. It is adaptable to a wide range of AN fittings and pressures.

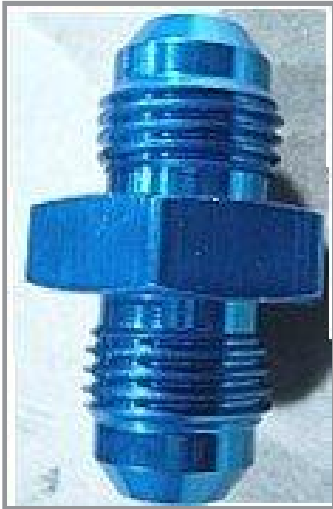
AN fittings that can be screwed into AND ports are what the drawing calls a Type E style and can be used to seal on the flare OR seal on the nut with an O'ring. Not all AN nipple fittings are Type E. Below is a non-type E fitting. Notice that there is no nut hex and no circumferal groove above the last thread. If you wish to use a Type E angle fitting then use the bulkhead series with a nut. You can now point the fitting any direction you wish.

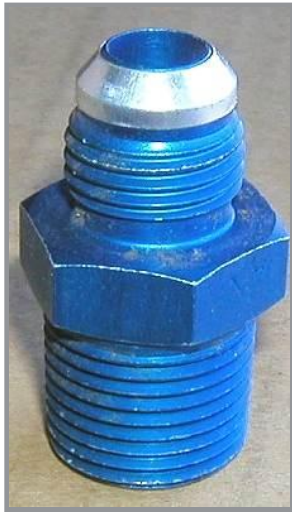
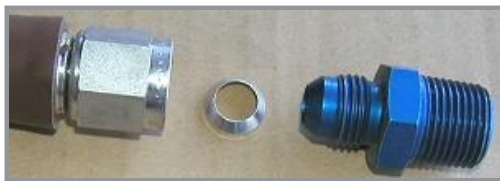
An "aluminum crush washer" or conical seal is sometimes placed between the flare surfaces. These are mechanic band-aids to be used when you have a leaking connection and no replacement fittings. The usual problem is using a new hose fitting against an old male nipple whose sealing surface has been damaged. It's easier to drop a conical seal into the hole than to replace the damaged fitting. Going back 10-15 years no one had ever heard of them.

Conical seals getting more popular now, in my opinion, because of the increased usage of steel on steel mating surfaces. Traditionally, AN plumbing mating surfaces were aluminum to aluminum or steel to aluminum. To seal any surfaces, one or both surfaces must conform (yield) slightly under pressure to seal any microscopic gaps between the surfaces. It helps if one or both surfaces are relatively

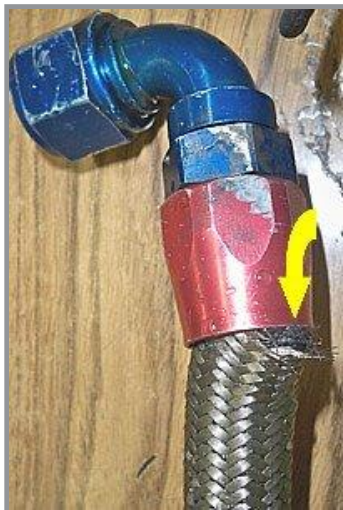
So the hoses fail. Look carefully at the hose to the left and you can see that the hose pulled out of the socket. The hose was only engaged into the socket 1/4 inch or so. This is why he had a hose leak - it wasn't assembled properly to begin with.

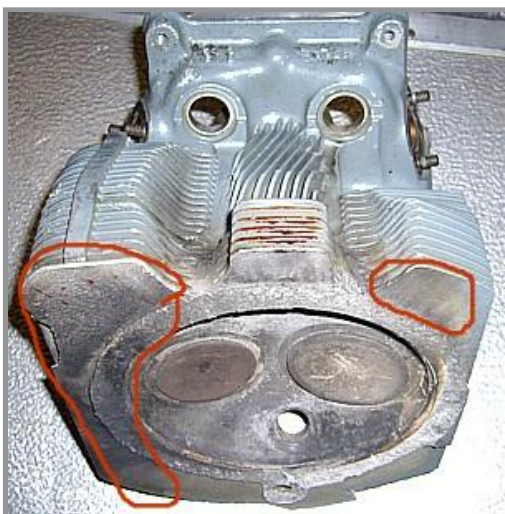
inspections without much additional time or expense. Lets discuss both of these inspection methods and introduce a third method of my own making: Both inspection methods presented in the AD only detect cracks that extend completely through the wall and large enough to pass gas. That is one big crack and on the verge of outright fly-apart fracture. Lets look at a cylinder for what it is: a pressure chamber that gets pressurized and de-pressurized with very hot corrosive gasses 20 times a second. If a flight is 1 hour long you have one "thermal cycle" but 72,000 pressure cycles! **Pressure test:** There is nothing unusual in the requirement that if during a compression test, gas is leaking from the pressure chamber (and it's not going past the valves, and, its not going past the rings) then you need to start looking for cracks in the cylinder head. Well that's something you should do anytime you suspect your cylinder has a hole in the head and won't hold air. Only inconvenience is you have to do a compression check each 50 hours per the AD. **Staining Inspection ("black combustion leakage")** This inspection is much more interesting and anyone can do it with just a mirror and small flashlight. Pressure Vessel Breach The picture above shows staining from gas leakage out a crack in a Lycoming

cylinder. At each 50 hour oil change you can look at the fins for staining. It just takes a few minutes of eye-ball time. This crack didn't get detected so lets see the end result:

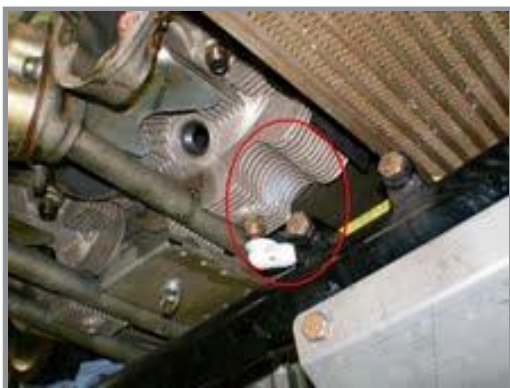
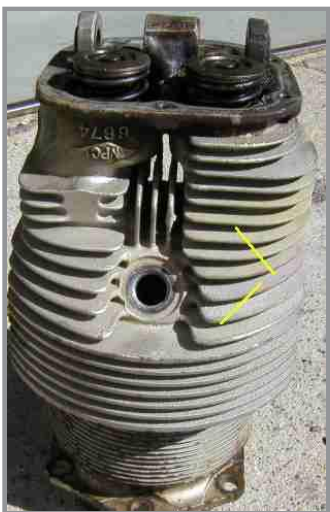
Lets take a more hidden example: See anything wrong with this O-200 cylinder below? Well, you're not going to at this angle. You're not looking at the right angle nor in the right places. There's gas leakage and a crack right there between the yellow lines. Here is how you should look at the cylinder - look between the fins! That's where the crack penetrates - not at the end of a fin but at its base. Same cylinder but different view: See the dark staining between the fins. Do you see the crack? Back in the 1980's we did some experiments with gas or oil leakage, especially leakage between the barrel and head. We'd take cylinders that had oil and

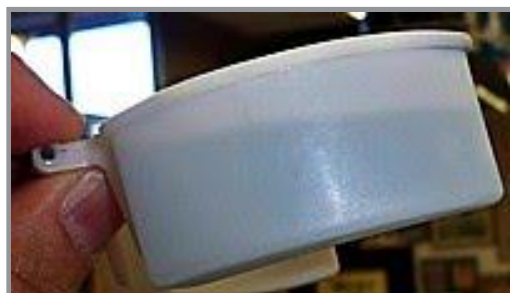
This is the old style float. Notice that the float is half filled with fuel!

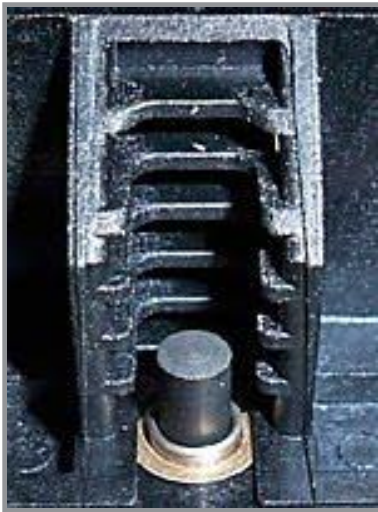
A close-up of the K-3822 block showing ribs.

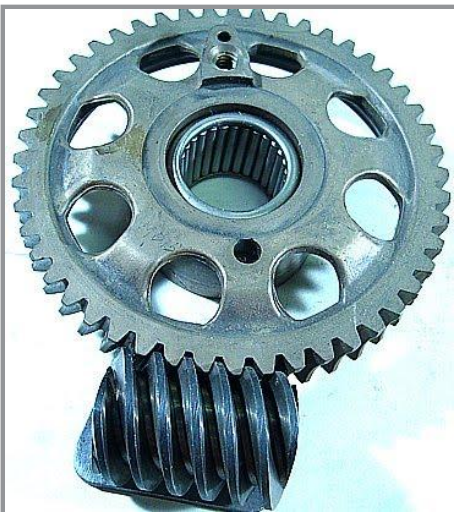
This is a close-up of the Continental worm and gear. Mounted on the back is the clutch spring and drum that disengages the starter when the engine starts. When it works it works well, but there are lots of parts that have the potential of failing and releasing bits of metal into the engine.

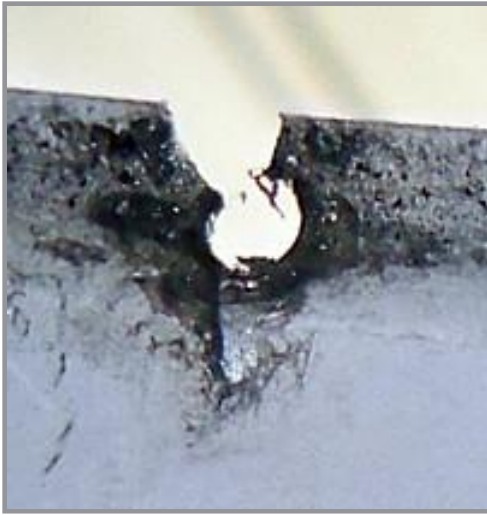
### **Fatigue crack in aircraft skin from rivet hole**

Strength starts to decrease when the distance from the center of the hole to the edge

gets below 2 times the hole diameter (2D)  
 If your edge margin is below 1.5 then the joint is critical for tear-out of the material or fatigue cracking.  
 Read more about rivet edge distance...

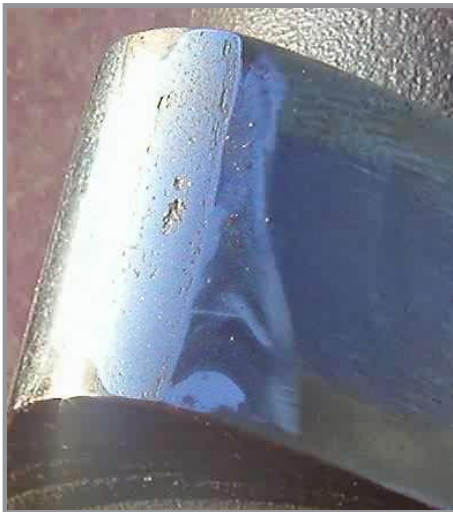
From previous articles I've written on inspecting camshaft lobes, one point that possibly wasn't stated clearly is that the typical camshaft lobe failure is not a lubricant failure. Signs of lubricant failure show surface sliding damage such as scuffing, scoring, and metal transfer across the surfaces. Not that this doesn't occur, especially, in later stages of lobe disintegration, but often the primary failure that starts the whole process is not related to lubrication.

If you look at the initial damage on a camshaft lobe what you see is a good engineered surface with irregular shaped potholes. A pothole is a good analogy as both a camshaft with a follower rolling on it and a road surface are both non-

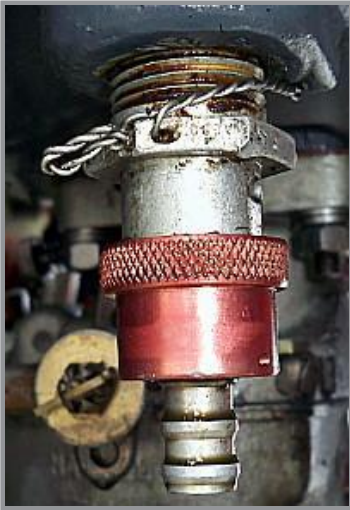
## What's wrong with Aircraft Drain Valves?

### **Each quick drain becomes another point of failure and another maintenance expense**

Fuel drain valves are often a necessary evil as they allow checking and purging fuel tanks of water and sediment. But oil quick drains are not necessary and one should be aware of both the advantages and disadvantages.

Replacing a drain plug with a valve doesn't come without a price. Drain valves require maintenance and a handy supply of spare seals as you never know when they are going to leak. Oil drain valves can stick as sediment and sludge get trapped between the moving parts.

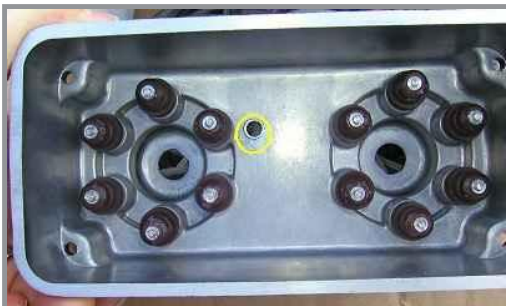
D-3000 magneto cap showing capacitor mounting towers

Scrape away the paint from the harness cap (outside) where the capacitor mounts and this should solve your problem.

I have also seen the capacitors fail from the magneto getting too hot. In this case the rubber capacitor legs were toasted.

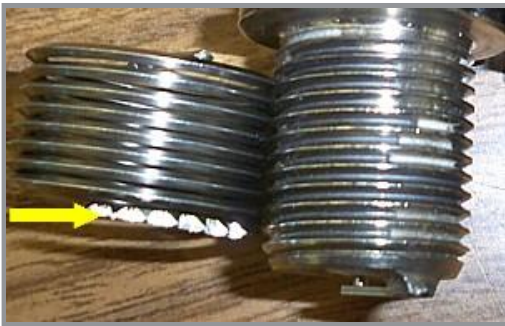
520112-3 Helicoil

Lycoming and Continental spark plug helicoils use a serrated teeth to lock the helicoil in place. Spark plugs come in "short reach" and "long reach". Shown here is the short reach plug with a Continental part number helicoil.

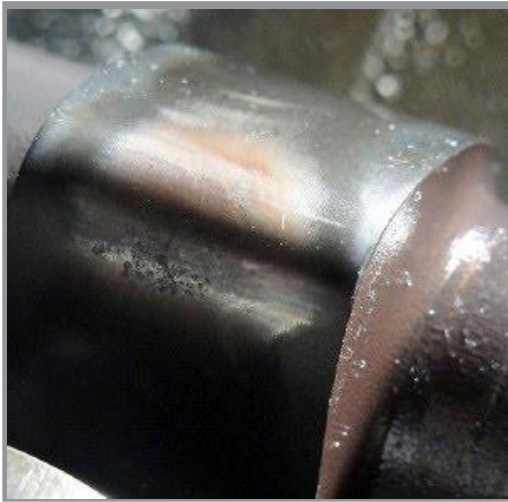
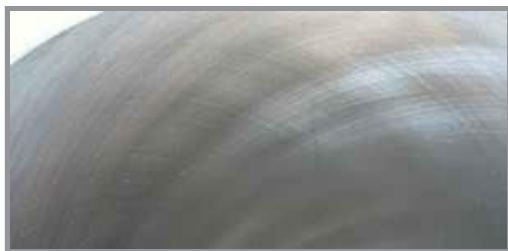
What does break-in look like? The picture below shows a slightly worn camshaft lobe. Now look at a close-up of the surface below. Notice the strips at the yellow arrows. These are called "shadow flats". Metal-to-metal contact has occurred at the light areas and no contact in the dark area. The reason they are lines is that when the cam lobe was ground the grinding wheel leaves microscopic gouges where the abrasive particles ploughed a trough into the surface. The surrounding high spots are not large enough to support the load from the follower and wear down. Can we avoid the break-in process by making parts with better surface finishes? There is a process that attempts to form a compatible surface finish during manufacturing, called "superfinish" but the process is both expensive and often severely abused by marketing huskers. You might conclude that a "superfinish" would be a perfectly smooth "mirror" finish as it provides the largest bearing area. In some areas, such as bearing journals, the smoother the surface, the thinner the lubricant can be before high spots on mating surfaces come into contact. However, it's hard to maintain a lubricant film on a perfectly smooth surface. In some areas, such as a cylinder wall, we require both a flat bearing area and surrounding low areas that provides a reservoir of oil to keep the surface lubricated. This is called a "plateau" finish. The picture below shows a honed finish on a Lycoming aircraft engine cylinder.

This is called a "cross-hatch" finish as the hone motion criss-crosses. The cross-cross pattern keeps the piston rings from spinning as might occur if the hone created a spiral pattern.

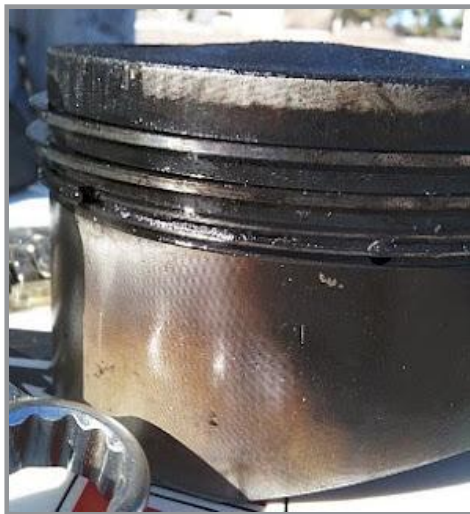
*Dear John, I have a TIO-540 in an Aero Commander and recently I had a stuck ring. I attached a photo of the piston/case and you can see a lot of buildup. The engines have about 650 since major and I change the oil (Aeroshell W100) every 25 hours. They run relatively cool and I usually run lean of peak at just under 65% power. I attached a recent oil analysis and everything is pretty normal except the dissolved solids are kind of high. We changed the cylinder but I am concerned that it will happen again. I have had no valve sticking issues. Is there anything I can do to remove/reduce the deposits and clean the ring grooves? How do you feel about MMO? How*

The dark staining below the ring is not normal and indicates gas past the piston ring belt. The oil control ring (lower ring) has black chunks between the rails. Top two ring faces have black staining indicating ring leakage.

You have combustion gas leaking past the ring belt - i.e. "low compression" due to faulty piston ring/cylinder(s). Everything else you mention is just a symptom. Hopefully, this is occurring in only this cylinder and will be corrected with the replacement cylinder. If the oil still turns black then the problem has not been corrected.

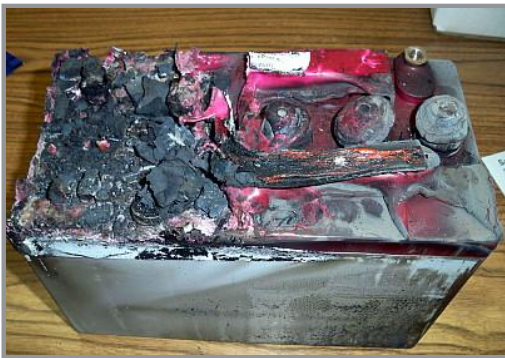
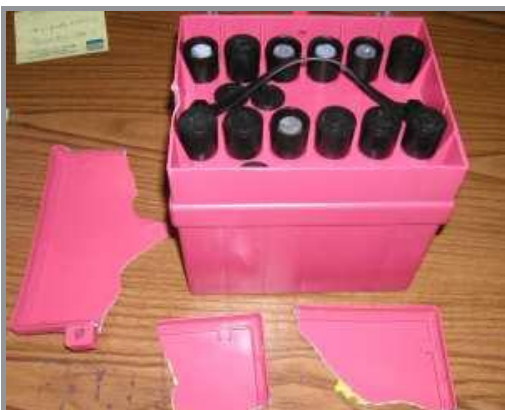
Aircraft Battery Explosion - How to prevent Hydrogen gas explosion. Note the battery is burned from the top down. This is a lead acid battery with vent caps - the kind you add water too. During charging explosive hydrogen gas is vented from the caps into the battery box. The box must be vented and have sufficient air circulation to prevent the build-up of hydrogen.

Also, rapid charging a discharged or "dead" battery generates large amounts of hydrogen gas. "Jump starting" a dead battery and then allowing the aircraft charging system to charge the "dead battery" can dump the full capacity of the aircraft alternator into the battery causing large amounts of hydrogen gas. One does not "jump start" an aircraft battery and then go fly the airplane for many safety reasons. This battery blew the lid off when hydrogen gas was not properly vented. Notice several black caps on top of the battery have blown their tops off exposing the lead vent plug.

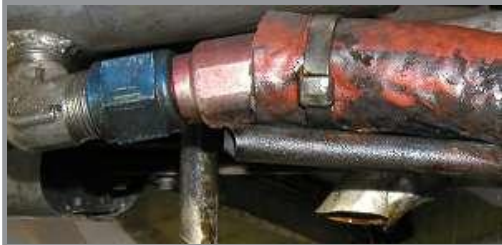
Each hose assembly adds 6 fluid connections:

1. Between hose and fitting x 2
2. Between hose fitting and attachment fitting x 2
3. Between attachment fitting and component x 2

Each fluid connection becomes a possible point of failure.

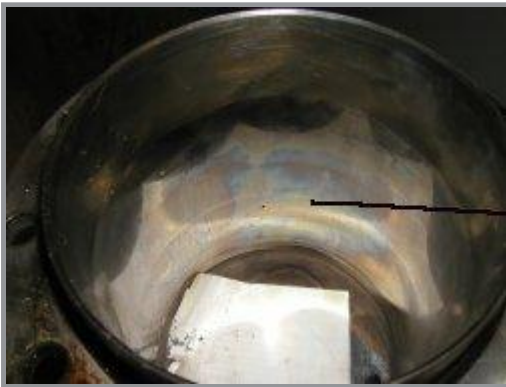
Here's some not uncommon cylinder barrels.

First notice I've placed a white piece of paper to reflect the light onto the barrel. Now you aren't looking down a dark hole.

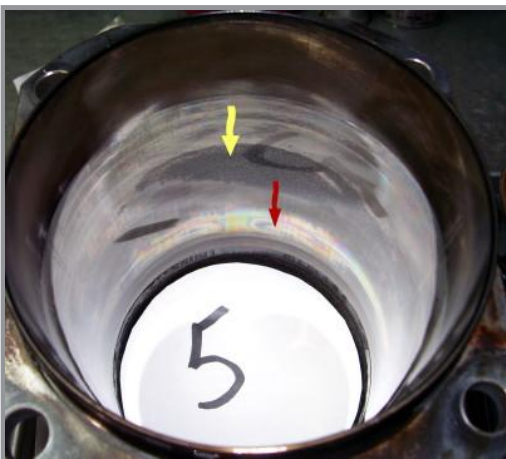
In the next picture the yellow arrow points to a dark patch. Dark patches are almost always areas of corrosion pitting. Next look at the red arrow. Notice two things; the rainbow colors and the shinny appearance. The rainbow colors is a heat tint that forms at approximately 500 degrees F. You should not see any hint tinting in a Lycoming or Continental cylinder barrel. The heat tint tells us the barrel at this spot got too hot. Notice that the heat is local. The heat is caused by blow-by of combustion gas past the piston rings.

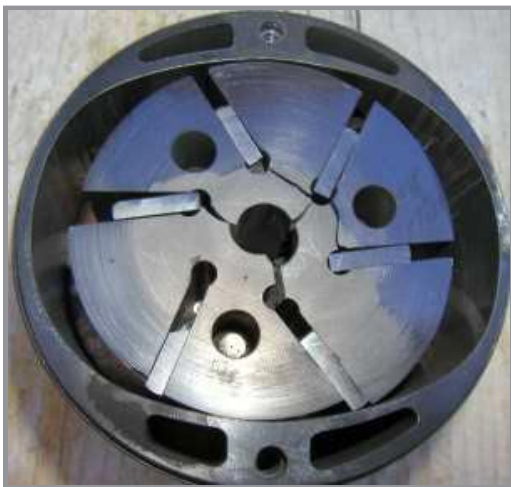
Inside view of a dry vacuum pump. The rotor and vanes are made from carbon. Notice that the top surface of the rotor is shiny or wet looking. This pump broke apart because oil got inside the pump. The oil mixes with carbon dust to form a sticky paste that will seize the rotor causing it to fracture.

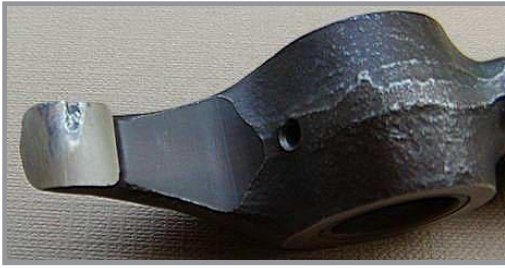
Pitted Continental Rocker Arm Face

When you purchase replacement cylinders the rocker arms are not included. Often they are placed aside until the new cylinders arrive and then installed. The rocker arm pictured above may wear out the valve guide very quickly. We have seen instances of 50-100 hours until the guide is worn sufficiently to cause valve leakage! If you then send out the cylinder for repair and then place the rocker arm back onto the cylinder you will repeat

the problem. Here is what the rocker arm is telling you:

Notice the pitting on the top edge of the rocker face in this picture? The rocker arm face is tilted in reference to the top of the valve stem. The face should lie flat if everything is in alignment. By "everything" I mean the following:

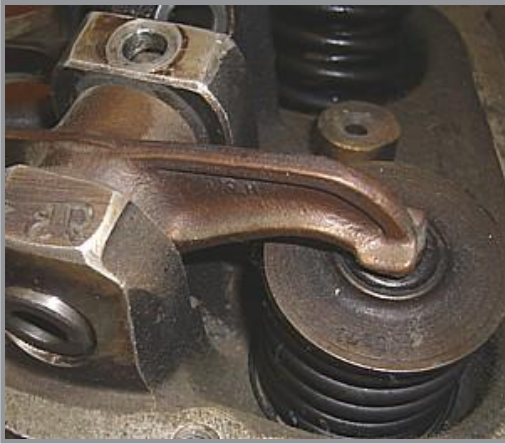
Quite a list isn't it. If any one of these are mis-aligned then the face doesn't sit flat onto the top of the valve stem. Here's the quick tip -- After installing the rocker arm carefully look at how the rocker face is sitting on the valve tip. If it is resting flat then you know that all the items on the list above are in alignment. This is a quick, easy, inexpensive, and informative inspection -- the kind I like!

Rocker arm should be flat against valve tip. What if it isn't flat? Then you have a problem; The valve guides will wear prematurely and the problem can be any of the above. The first thing to check is to see if the rocker face has been re-ground, "refaced". Refacing is an awful thing to do as it is often done by hand, and it ruins the geometry of the face. Even if alignment is retained the cycloid curve is often flattened and this causes the pressure on the valve tip to move off-center causing the rocker arm to push the valve stem into the guide.

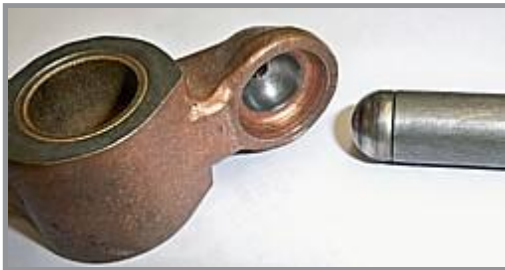
You can swap a suspect rocker arm with one that is resting flat from another cylinder to check if the problem is the rocker arm or the cylinder. If the rocker arm is bad, replace it. Another tip is to inspect the rocker arm socket for wear. This must form an oil seal with the push rod ball. It is good practice to make sure each push rod goes back into the same rocker arm. The wear surfaces know one another and are compatible. If you mix them up then the surfaces are strangers and must "wear in" and form compatible surfaces. Inspect rocker arm socket and push rod ball

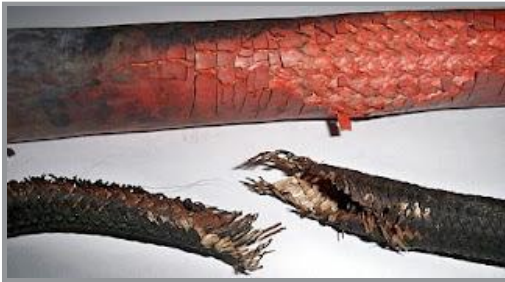
Aircraft Fuel Hose with Firesleeve Jacket Above This fuel primer hose was completely burnt. When the pilot primed the engine he squirted fuel into the firesleeve.

This rubber hose is rated for 250 degrees F (121 C) and was located 4 inches from the exhaust stack. Firesleeve DOES NOT increase the temperature rating. There were plenty of burnt deterioration on the firesleeve to alert the pilot during preflight or the mechanic that there was a temperature problem.

Firesleeve DOES NOT increase the temperature rating of the hose. Its sole purpose is to prevent flame penetration for a short period.

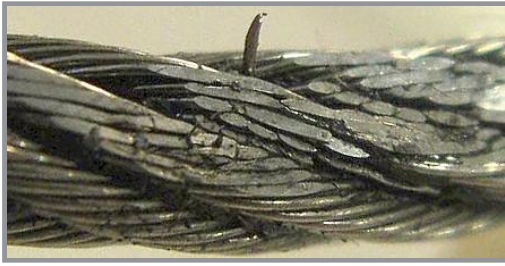
The inspection consisted of checking for visible wear (external wire wear). However, the NTSB found that the internal wires were 90% worn! Most notably was the loss of aileron control on another Boeing 737-100, Flight-1659. The NTSB found that existing inspection methods could not detect the breakage of 98 of the 133 strands in the cable! Did you detect the broken strands in the picture above? Here is another picture with the tension removed.

Aileron control cable failure on a Boeing-737-3TO on takeoff at Seattle, September 27, 1997 just six weeks after the cable was inspected for wear. Must have been a failed

inspection -- yes? Not so quick, the inspection was performed "by the book." The inspection technique and process was at fault, not the mechanics.

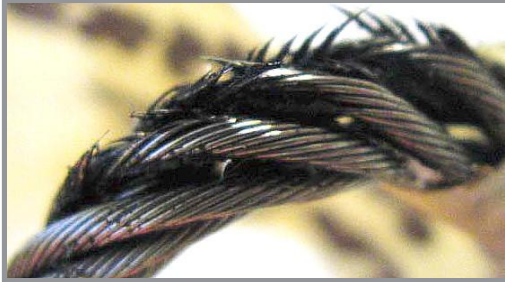
Same cable with tension released

The NTSB investigation found that using professional FAA approved maintenance inspection at the most professional level will not detect dangerous control cable conditions. The broken-strands were not detected using the prescribed method of

drawing a cloth rag over the cable. Only until tension was released from the cable were the broken strands detectable. Thus the need to release cable tension to better detect broken strands.

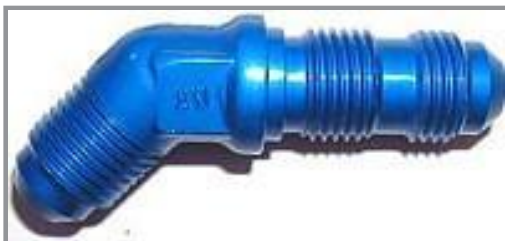
### AN837 Bulkhead Fitting Bulkhead Hole Size Chart for AN Fittings

Here is how bulkhead-hole-size is determined. Use the thread size as the outside diameter of the fitting. For example, a -4 bulkhead fitting has a 7/16-20 screw thread. The hole needs to be slightly bigger than 7/16 inch. A AN960 washer designed for a 7/16 thread has an internal hole size of .453 inch. So we make the bulkhead hole size the same size as the washer internal hole size.

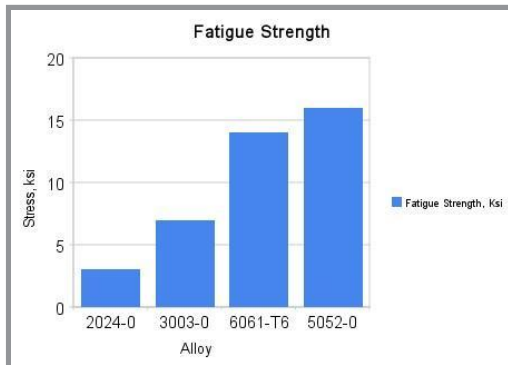
## Tube Fatigue Strength

Most tubing-failures on aircraft are caused by fatigue. Tubing on aircraft vibrates. How well your tubing endures when subjected to load reversals, impulses, and vibration is called "fatigue strength". Of the three popular tubing types (3003-0, 6061-0, 5052-0), 5052-0 has the best fatigue strength.

Originally aircraft used soft copper-tubing. There is even some of this still around. Although copper was strong enough, it was replaced with aluminum and stainless tube because of the high fatigue failures of copper. For lower pressures, 5052-0 became the tubing of choice because it has the best fatigue strength of any of the non heat-treat aluminum alloys. See "Fatigue Failures of Copper Alloy Fuel", AWB 28-007

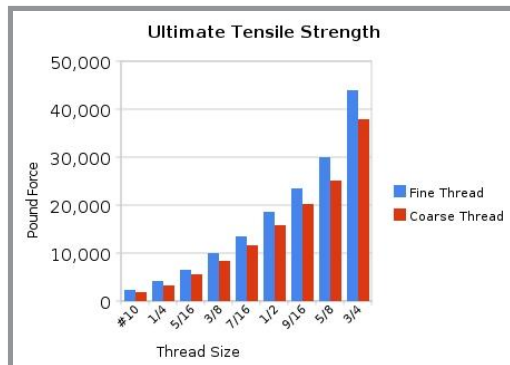
Thread Strength Comparison - Fine vs Coarse

Aircraft generally use fine thread fasteners due to their stronger strength. Coarse threads are used when threaded into aluminum or cast iron because the finer threads tend to strip more easily in these materials. The chart above is based on MIL-B-6812E Table II and 125,000 psi UTS.

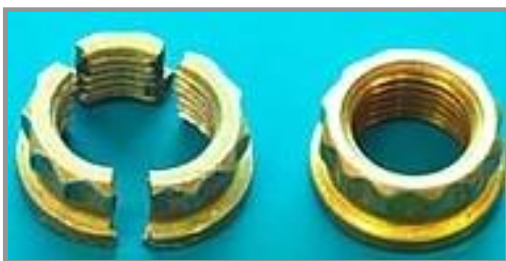
The baking process is critical. Shown above is a hydrogen embrittled nut failure on an aircraft engine. Even though controls were in place, the nuts still failed. Not only is oven temperature and time important, but also the distribution of heat throughout the batch of parts. Oven bake shall occur within four hours of plating and for types II and shall be done before application of supplementary coatings.

baked" during overhaul. Extreme caution is advised. A particular hazard of cadmium-plating high strength steels is the absorption of hydrogen into the base metal. This hazard is countered by baking the parts after plating.

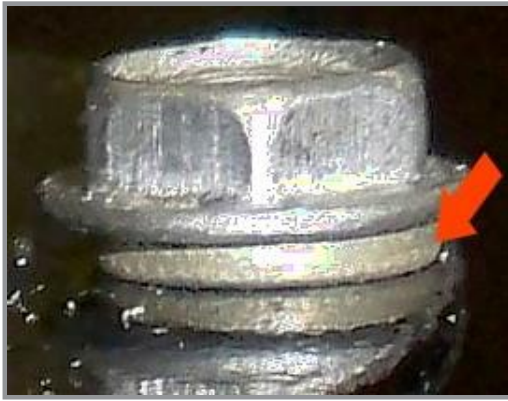
Washer compressive strength must be matched to the bolt/nut clamping force. WASHER compressive strength MUST be matched to the BOLT/NUT combination! Pictured above is a low-yield strength hardware store washer placed under a propeller bolt. Low-yield strength washers that score/crush in-service under high strength BOLT heads or NUTS, will relieve clamping force, eventually resulting in propeller detachment during operation.

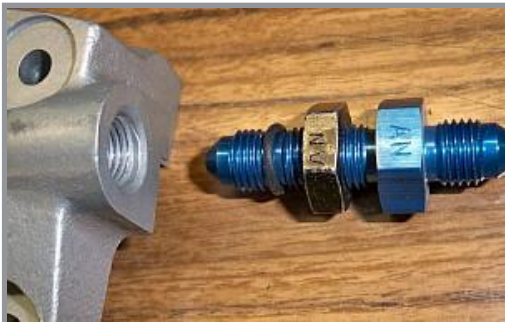
Aircraft AND10050 Port with Bulkhead Fitting **Low Pressure - Other Than Hydraulic and Pneumatic** 1. Assemble AN924 nut onto fitting end and run all the way back to clear fitting groove.

2. Coat male threads and O-ring sparingly with system lubricant.

3. Hold O-ring firmly against the top of the threaded section of the fitting and run nut down until it contacts the O-ring.

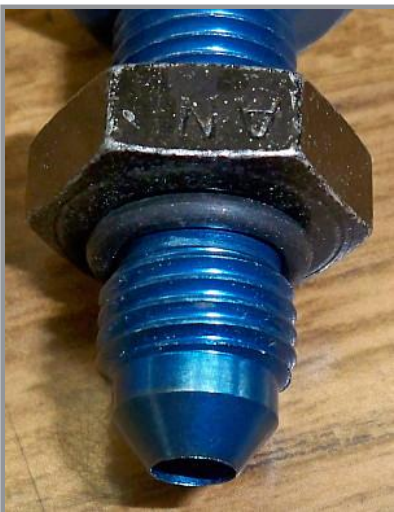
Position O-ring and Nut as Shown 4. Turn the fitting into the AND10050 boss and, at the same time, keep the AN929 nut turning with the fitting until the O-ring contacts the boss. The point can be determined by a sudden increase in torque.

Turn the fitting O-ring contacts the boss 5. Continue to screw fitting into the boss for another 180 degrees. Any further positioning of the fitting must be accomplished by turning the fitting in up to an additional 270 degrees or by backing out up to 10 degrees. Keep the AN924 nut turning with the fitting to prevent cutting the gasket with the fitting thread.

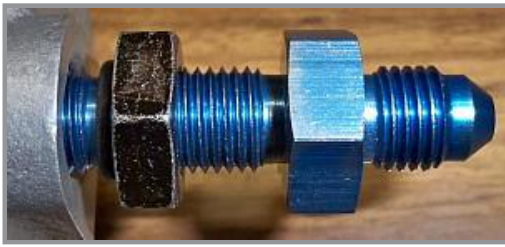
#### AN6289 Nut

This process uses a different lock nut, a AN6289 nut with a groove for a anti-extrusion device.

Backup Ring (anti-extrusion)

The above description follows AND10064 "Fittings, Installation of Flared Tube, Straight Threaded Connectors" Also reference FAA Special Airworthiness Information Bulletin, SAIB: CE-07-46 dated September 6, 2007 for important installation background and details.

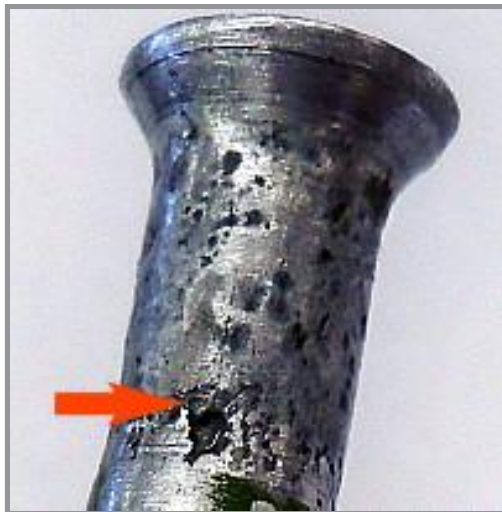
Stainless steel hardware (rivets, bolts, screws) installed into an aluminum fitting creates a potential for dissimilar metals (galvanic) corrosion.

Corrosion Pit from galvanic corrosion  
Leaking hydraulic line from aircraft brake system caused by galvanic corrosion. Aircraft brake systems are drenched in electrolyte (dirty water) so extra caution is advised when mixing metals. Notice that the gap between the tubing and sleeve can trap moisture into the crevice.

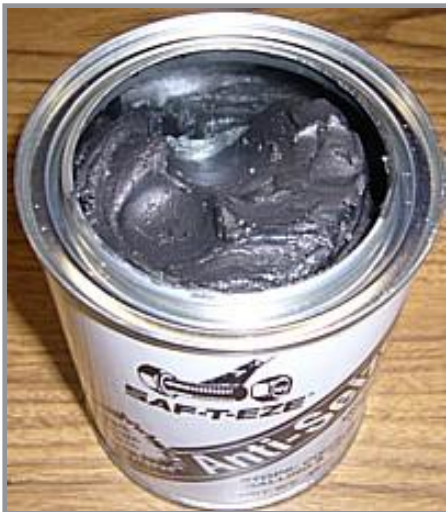
Graphite Antiseize

*"...shown conclusively that graphite in a resin-bonded solid film lubricant is deleterious from the point of view of corrosion protection provided by the lubricant... To use graphite is to invite corrosion difficulties in the presence of moisture."*  
Rock-Island-Arsenal-Lab, Technical Report, Dry-Lubricants and Corrosion, Prepared for Presentation at the Annual Meeting of the Society of Automotive Engineers, Detroit, Michigan 14-18 January 1963. Francis S. Meade and George P. Murphy, Jr.

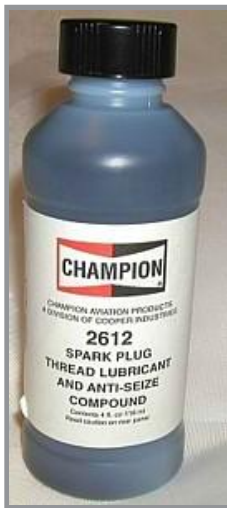
Cleaning spark-plugs using glass-bead shot may remove the nickel plating from the

threads. Now the steel threads are exposed to the water and graphite mixed anti-seize creating a corrosive environment.

When the steel threads rust, their surfaces expands and this causes the spark plug to seize in the threads.

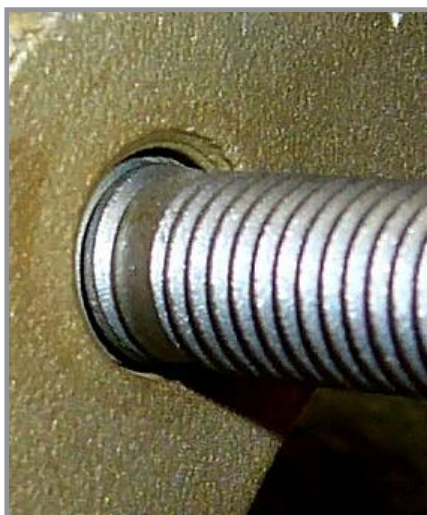
Continental Workmanship Now look at the same stud on a Continental cylinder. Chamfered hole. Notice how the first engaged thread occurs below the surface. Stud is "waisted" - that is a good thing!. Waisting is the reduced diameter in the unthreaded portion of the stud. This diameter is now the same as the root diameter of the thread making the stress evenly distributed throughout the stud.

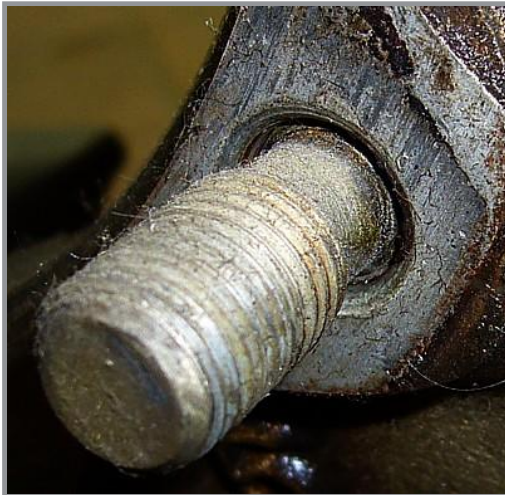
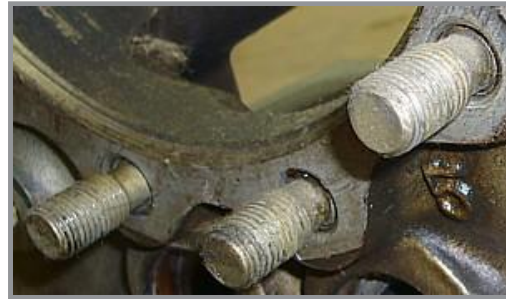
Waisted Cylinder Hold-Down Studs on Continental IO520 engine

Wasted Cylinder Hold-Down Stud Here is a picture of a wasted cylinder hold-down stud on a Continental. The reduced shank diameter also allows the stud to store more energy as it will stretch more than a non-wasted stud for the same amount of applied tightening torque. This increases fatigue strength and helps prevent joint loosening.

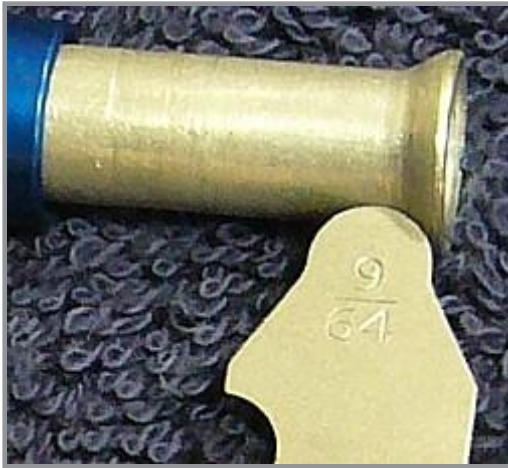
Double Flare Radius. Screenshot from Mechanic's Toolbox Software

A leak-free connection is not the sole measure of an acceptable flare. The proper radius at "B", and no nicks or other damage is required for a durable connection that won't break later in service. This is why using a 45 degree flaring tool and then mashing the flare to a 37 degree with the "B" nut may produce a leak-free connection for the moment but does not produce a safe, durable connection.

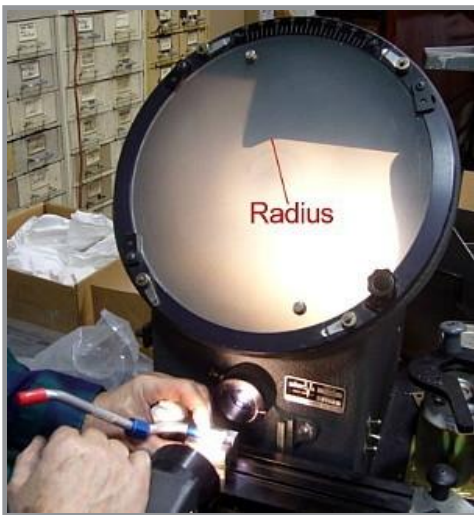
Measuring B radius Measuring B Radius

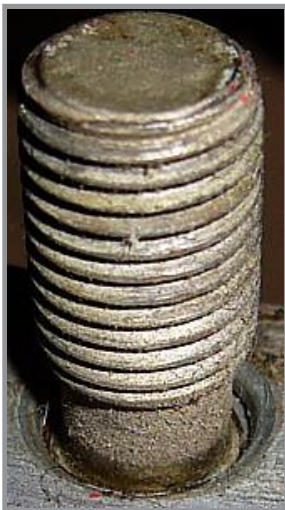
"Clean and Dry" Problem for the Mechanic - Problem for NASA

Is this stud "clean and dry"?

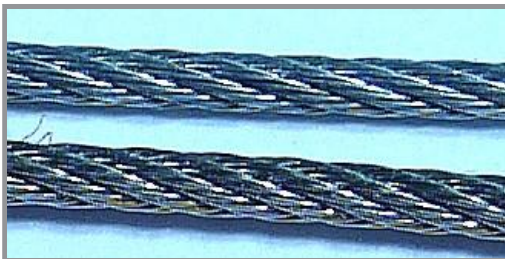
Aircraft Control Cable

Galvanized on top and Stainless on bottom  
"A general service history has shown the use of stainless steel cables in aircraft control systems results in premature wear and has been a factor in minor incidences as well as catastrophic failure. A current trend is underway in the aviation industry to

There are several methods of reducing wear and increasing fatigue resistance in a wire rope. Wear resistance can be increased by changing how the wire stands are wound. In the picture above the individual wires are horizontal (parallel to the axis of the rope). This is called "right regular lay" and is the standard lay. Another method of winding the wire stands is so that they form an angle to the axis of the rope. This is called "lang lay". Lang lay increases fatigue strength and abrasion resistance without any decrease in ultimate strength. Another method of changing the wire characteristics of fatigue strength, abrasion resistance, and flexibility is to use wires of different diameters. For example, Douglas-Specification DMS2192 calls for a Warrington Seal (IWRC) construction. This type of wire rope has larger wires on the outside and smaller wires on the inside.

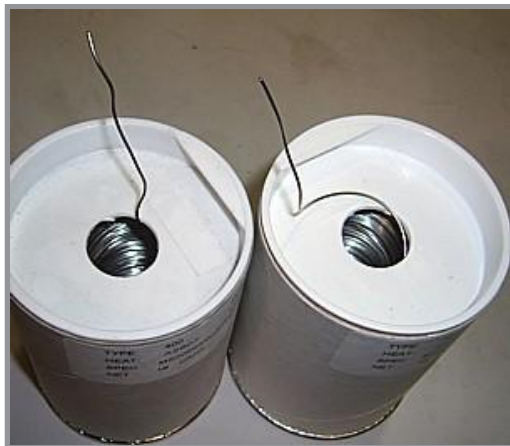
Stainless Steel Safety Wire on left - Monel Safety Wire on right

Hard to tell apart

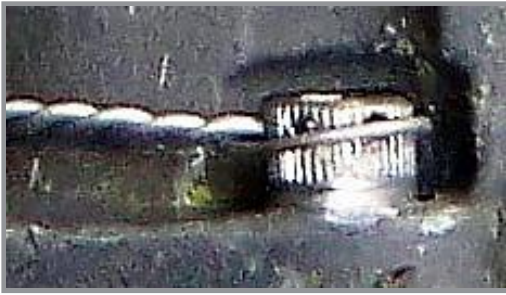
Monel Safety Wire used on the Titan Rocket Engine

Monel wire is used by deep sea fisherman as a trolling, seizing and baiting wire because it can be rolled and bent many times without breaking - unlike stainless wire. And its extra softness makes it easier to use. Monel safety wire was used exclusively on the Titan II rocket engine (picture below is from a Titan II). Given that the operational life was 3 1/2 minutes for this first stage engine one wonders why safety wire was even needed.

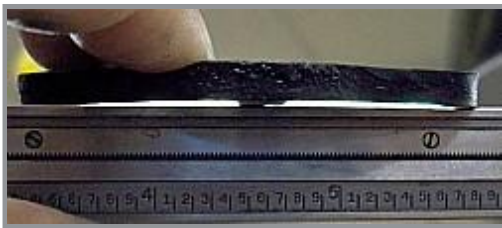
Check your surfaces for flatness. A customer brought this cover plate into my store to purchase a gasket. I have this habit of placing plates on the counter upside down and pressing on the edges to see if they rock - a quick check for flatness - this one rocked! A new gasket wouldn't work any better on this plate than the old one. Pretty amazing to me that the customer was unaware of this. He is going to have to flatten this plate.

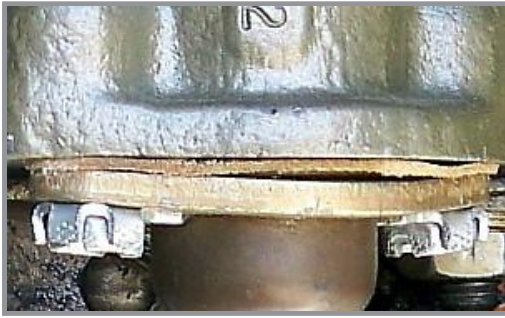
Saturate some 800 wet-or-dry sandpaper with light oil and then swirl the cover plate across the surface a few times - then you look at the cover plate and see if it is distorted. If it is then continue lapping. Another problem with gaskets is too much torque and you crush the gasket. The motivation is to tighten harder if you have a leak. But look at the picture below. More torque on the bolts and you just distort the

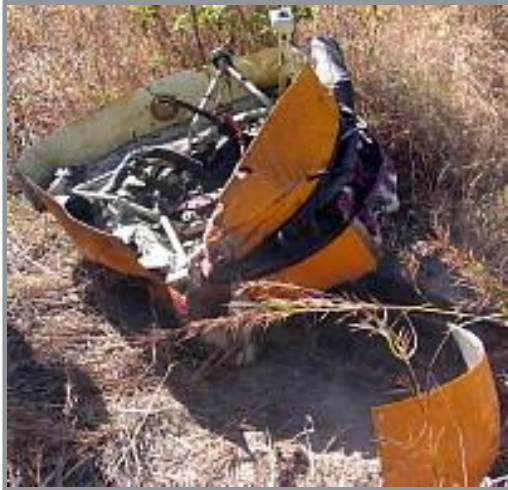
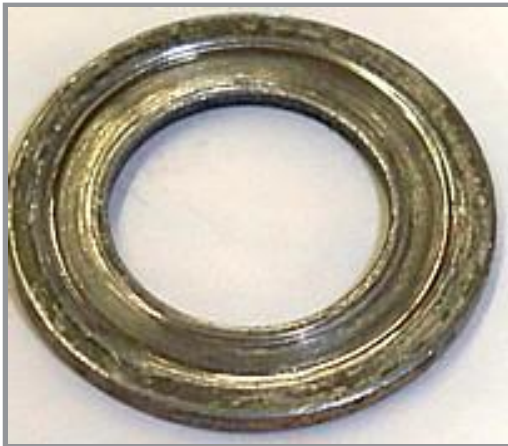
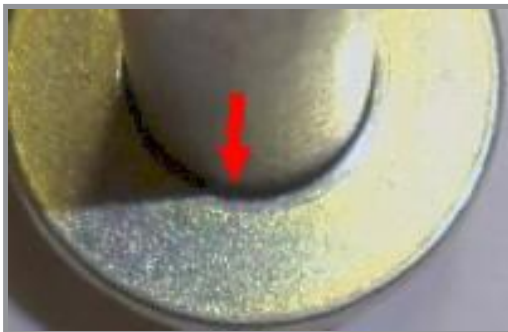
WASHER compressive strength MUST be matched to the BOLT/NUT combination! Pictured above is a low-yield strength hardware store washer placed under a propeller bolt. Low-yield strength washers that score/crush in-service under high strength BOLT heads or NUTS relieve the clamping force, eventually resulting in

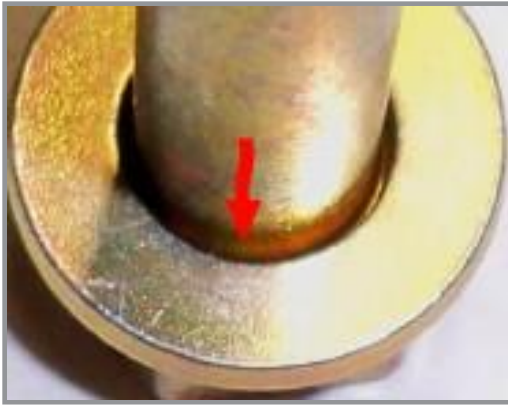
MS20002 smaller inside diameter for closer fit to bolt shank Standard AN960 has larger inside diameter - less bearing surface area A size comparison of the common AN960 washer with the harder MS20002 reveals that the MS20002 washer has a smaller diameter inner hole and a slightly larger outside diameter. The non-chamfered version offers approximately 20% more surface area to the nut. For example, a 1/4 inch AN960 has a surface area of .13989 sq. in. compared

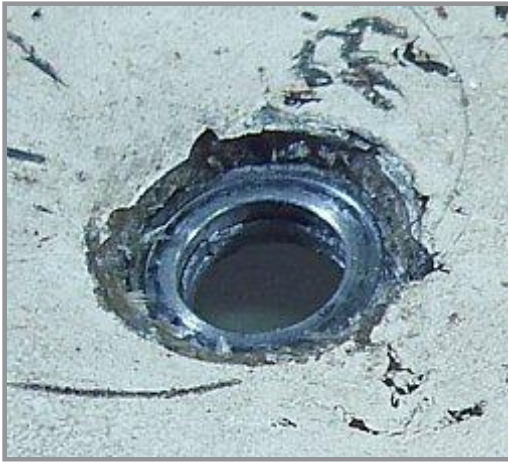
Crushing - tightening beyond compressive yield strength of bearing material.

To calculate bearing-stress (surface-pressure), you take the bolt-tension and divide by the contact area between the bolt head and the part. You then compare this value to the allowable surface pressure for

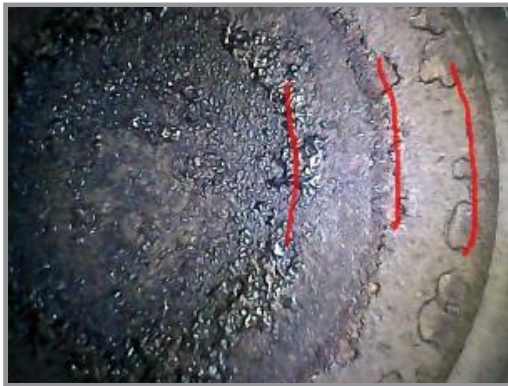
Not Concentric - valve face leakage

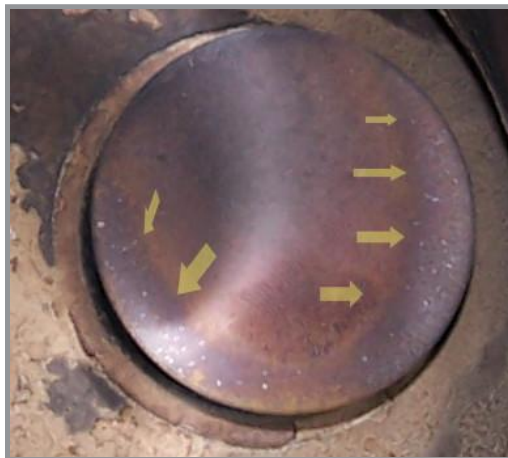
Exhaust valve leakage

Lycoming exhaust valve leakage

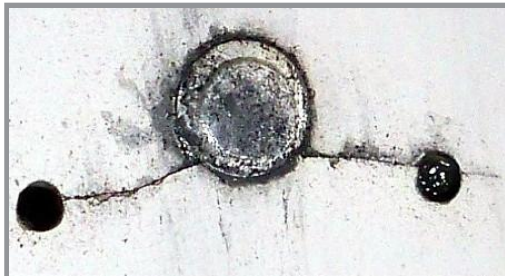
Fatigue Failure with attempted repair

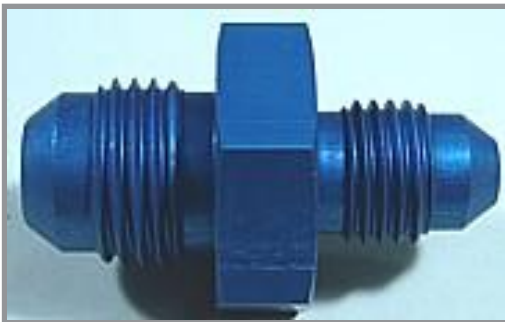
AN919 anodized aluminum fitting is an insulator

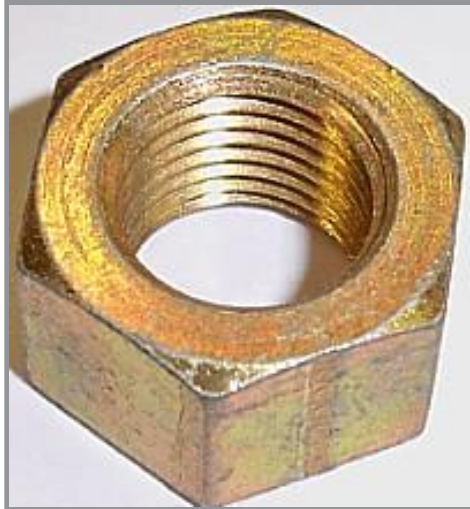
AN315 nut showing washer face

The previous article I discussed the purpose of the washer face on the bolt head. AN nuts may also (optional for most nuts) use a washer face. It seems obvious that the seating face should be flat, smooth, and perpendicular (within 2 degrees) to the bolt axis.

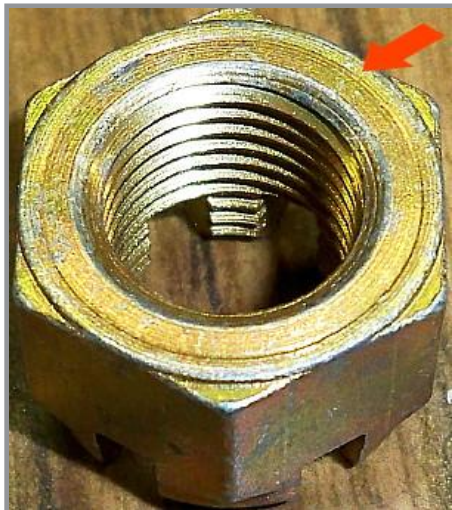
Contact face comparison

AN310 Castle Nut with malformed washer face  
Compare the contact area of a normal washer face on the left with this malformed washer face on the right. The malformed face concentrates the tension onto a small ring which is more likely going to gouge and crush into the contact surface.
