## Aircraft Repair --The Missing Manual

by John Schwaner

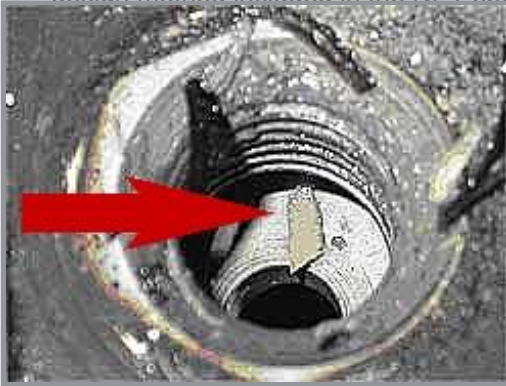
Pipe Dope Contamination of Aircraft Fuel System

I'll throw another one into the pile - poor quality threads. Even in the AN series of fittings the threads quality varies to the point that many will not pass inspection. The responsibility for NPT connection failure should rest on the shoulders of engineering for specifying such an inferior system rather than the mechanic trying to make it work. "Lipstick on a Pig" When a NPT failure occurs on a critical aircraft system, the first question that should be asked is why was NPT specified?

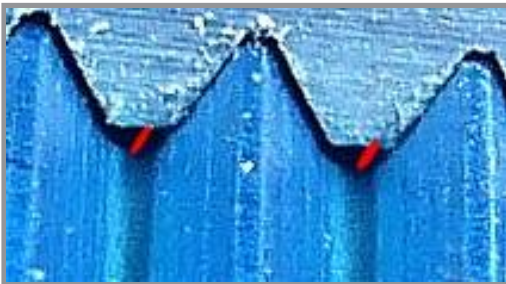
NPT Spiral Leak Path *Leakage path through threads shown at red points. No matter how tight you make NPT threads, a leakage path still exists. It is the function of the jointing compound to block the path between the crest of the male and female thread.*

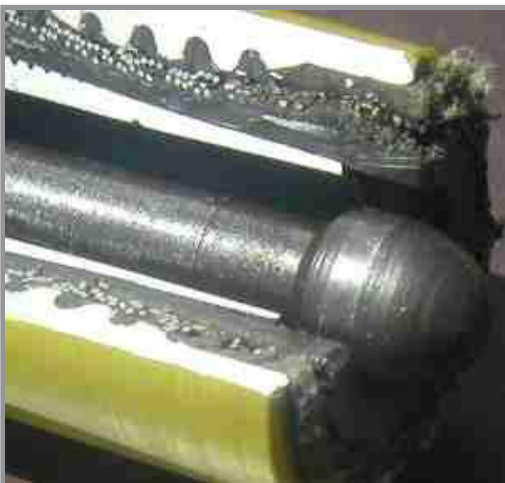
Hose Plug Gauge for MIL-DTL-8794 Hose For hoses with angle fittings where you cannot sight through the hose or use a plug gauge, you drop a ball through the hose. The ball is sized to be just a little bit smaller than the hose fitting inside diameter. For example, a dash 8 111 style hose assembly with 90 degree fittings takes a ball diameter of 0.320 inch. Caution: ball size changes for each type, size, and fitting style hose.

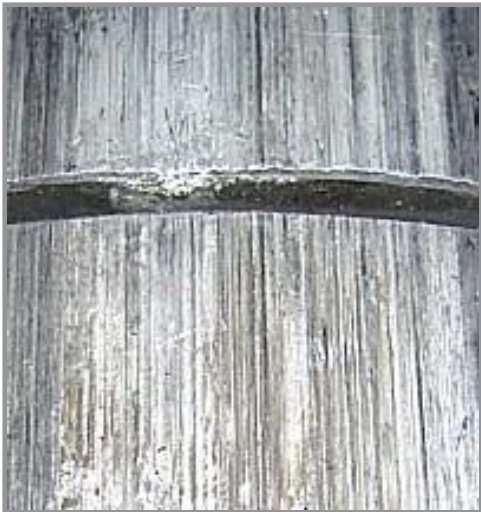
Detonation scours the protective layer of insulating air that separates the hot gasses from the aluminum piston surface. Remember EGT can be 1,600 degrees F. and aluminum melts at 1,200 degrees F.

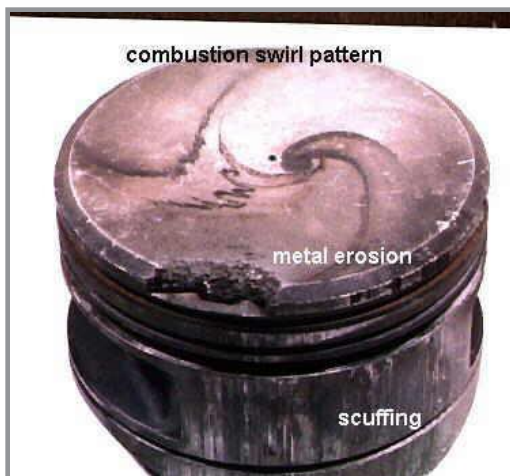
Once the hole is breached in the piston then combustion gas blows into the crankcase and this blows the oil out the breather. You can't stop it from happening without shutting down the engine. Once the oil is blown overboard then this happens. The connecting rod bearing starves of oil and it breaks off; usually by flinging itself through the crankcase.

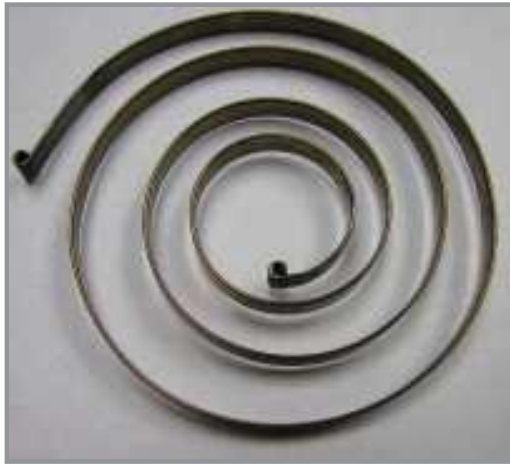
10-52949 Impulse Coupling Spring

*"Aircraft has a 600 rpm drop on left magneto during run-up. Otherwise engine operates smoothly."*

Diagnosis: Retarded engine timing caused by broken impulse coupling spring.

Underlying Condition leading to Failure: Corrosion pitting

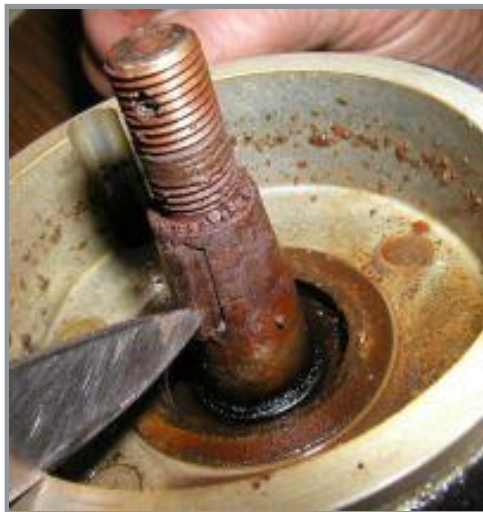
Red rust caused by condensation collecting in magneto. Additional Warnings: D-2000 and D-3000 magnetos, broken impulse coupling can lead to severe loss of engine power and forced landing. Replace spring at each annual inspection might be something to consider.

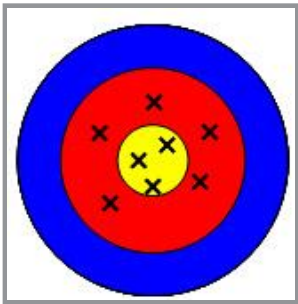
To be precise is to hit the same spot every time. Notice on the target the shooter is precise but not accurate. Now look at the next target. The shooter is accurate (when you average the numbers) but not precise. The next target is both precise and accurate. Precision is repeatability and accurate hits the spot.

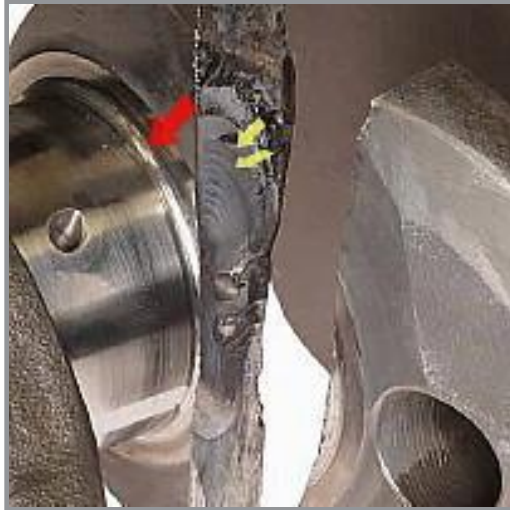
*Broken crankshaft at the fillet*

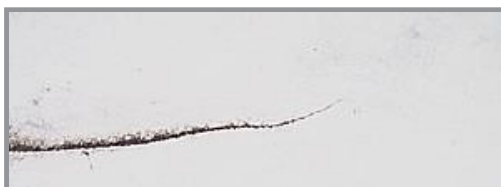
Crack in aircraft fuselage

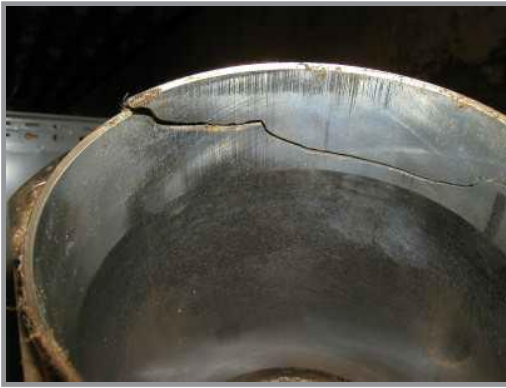
Cylinder barrel crack -aircraft piston cylinder **1. The Definition**

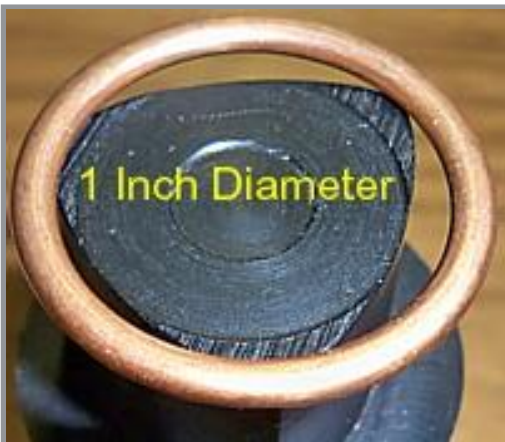
Diameter 1 inch - Shape Round  
Diameter 1 inch - Shape Lobe

The take-away from the video is that there can be significant errors in form that cannot be detected using two-point measurement instruments (micrometers, calipers, bore gauges).

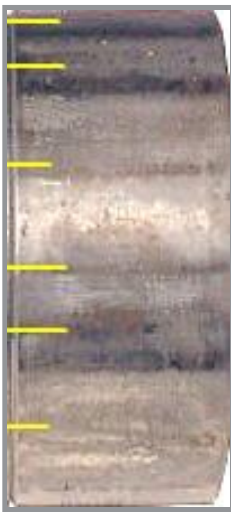
2.476 inches inside diameter at every point - but bad form I like to use a Slinky to demonstrate the difference between a dimension and a shape. Suppose that this represents your cylinder barrel; run a dial indicator down it and it measures 2.476 inches at any point you measure. But, as you can see the barrel is badly distorted. If your barrel is only 10 or 20 thousandths of an inch distorted you would never know. -Your

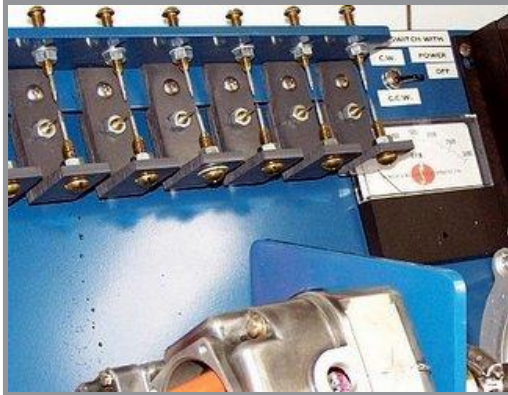
## Magneto Test Bench Electrode Design

*I am building a magneto test stand and I'm wondering why there are typically 3 electrodes coming together at each spark gap? I would think only 2 are needed. For example, see the third contact at each spark gap in the photos below of other test sets. I am currently planning to only have two contact points at each spark gap unless there is a good reason to add the third.*
