# PACSystems™ RX7i

## IC698CRE020-HL

### Redundancy CPU

GFK-2320P

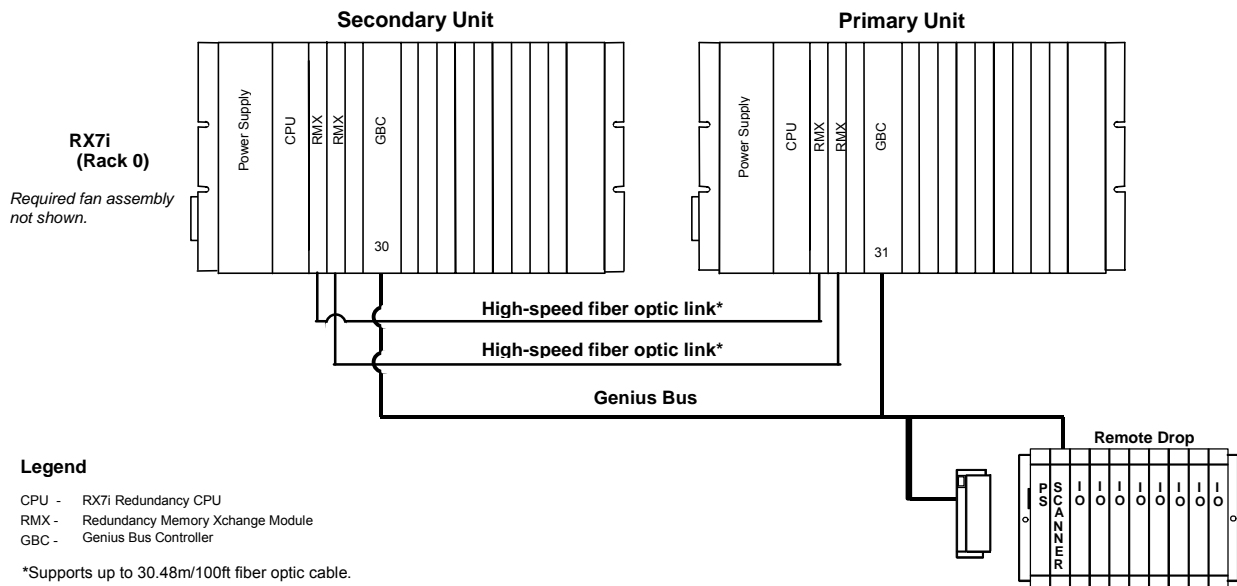
CPU Redundancy System Configuration

- Hot standby (HSB) redundancy. Requires a Redundancy CPU and a Redundancy Memory Xchange module (IC698RMX016) configured as a redundancy link in each unit.

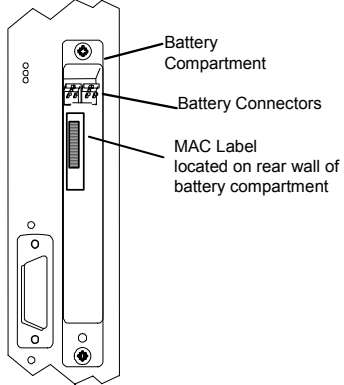
Subject	Description
<p><b>MAC address</b></p>	<p>A label on the rear wall inside the CPU's battery compartment identifies the MAC address assigned to the CPU's embedded Ethernet Interface.</p>
