# IMPORTANT PRODUCT INFORMATION

**Product: IC693 DSM Module (“DSM302”) with Firmware Version 1.41  
IC693DSM302-AF**

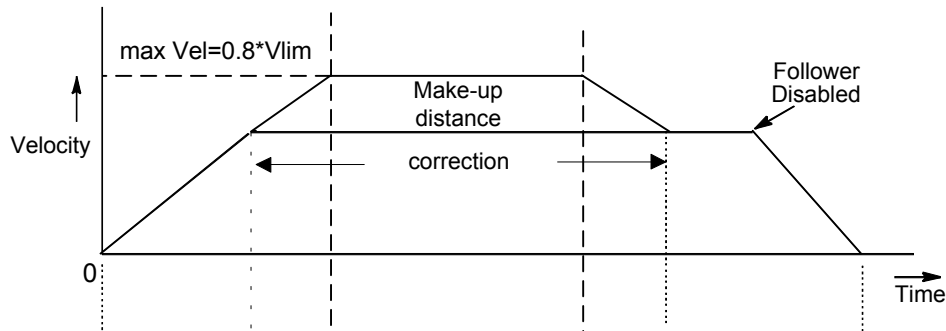
The figure below shows the velocity profile during the follower ramp cycle. *Note: The enhanced follower make-up may affect existing applications that use the old follower make-up feature.*

The Follower Axis Ramp Control Function is enhanced in DSM firmware release 1.30. The enhancement improves motion smoothness. Prior to this release, when the follower was active and the master in motion, the acceleration/deceleration control during the make-up correction phase was not controlled by a velocity profile. This could cause unwanted machine shock. The enhanced method uses a trapezoidal velocity profile to address this problem. During the entire make-up correction phase, the acceleration/deceleration is limited to the jog acceleration value. Also during the correction, the velocity is not allowed to exceed the maximum. Appropriate warning/error codes notify the user about abnormal operation (see error table below).
