Trouble-shooter for Starmon

STAR : ODDI

Table of Contents

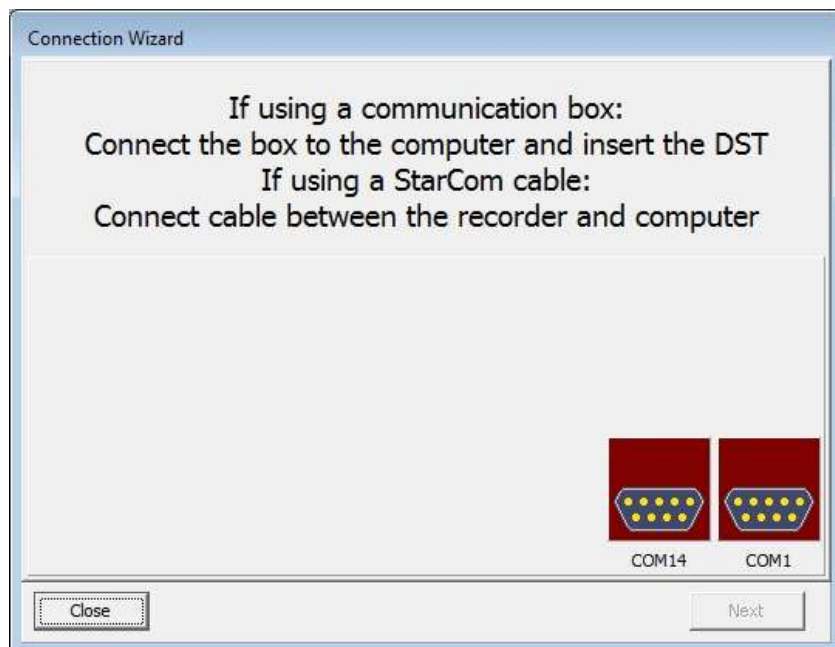
Figure 1.1

The easiest way to find the correct Com Port is to use the **Connection Wizard** which can be found under the **Wizards** menu in the software.

The wizard will display all the com ports available. Plug in the USB cable and the selected com port will turn green.

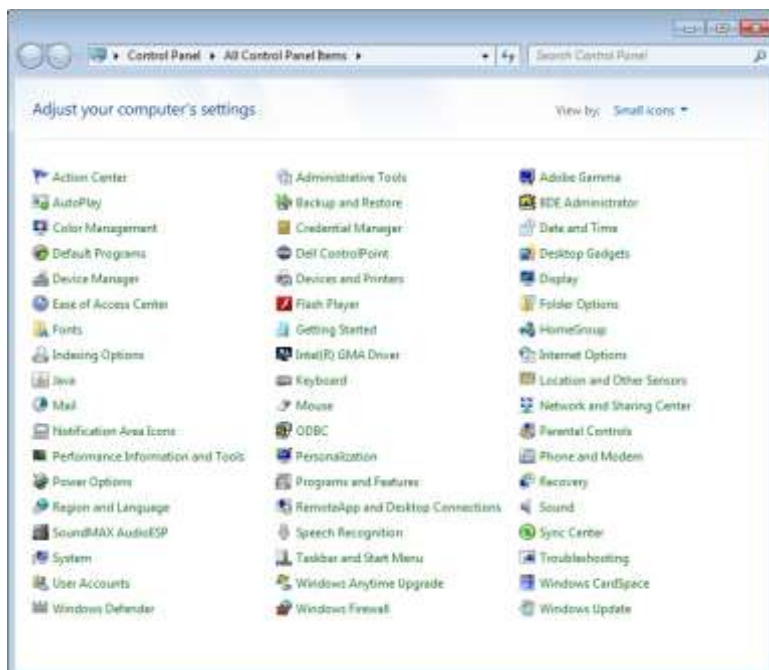
Figure 1.3

First connect the USB serial converter to a USB port. Open the **Control Panel** under the **Start** menu and open the **Device Manager**.

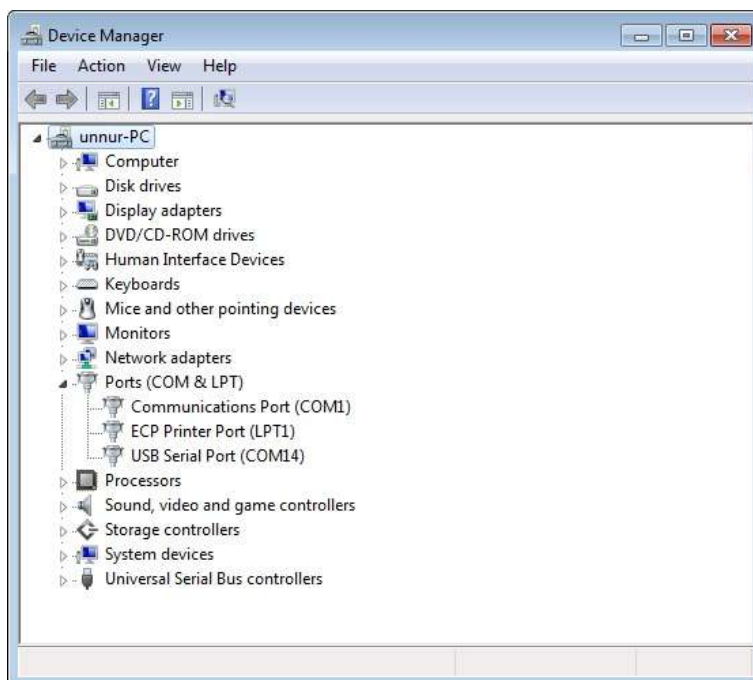
Figure 1.4

Click on **Ports (COM&LPT)**.

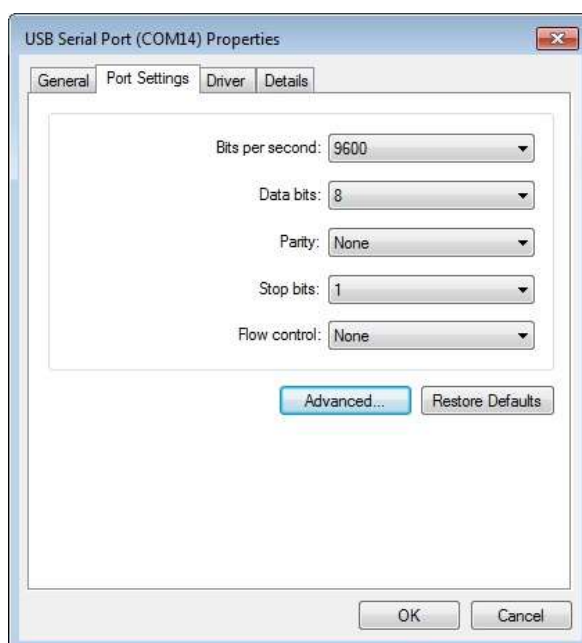
Figure 1.5

Double click on **USB Serial Port** and select **Port Settings**.

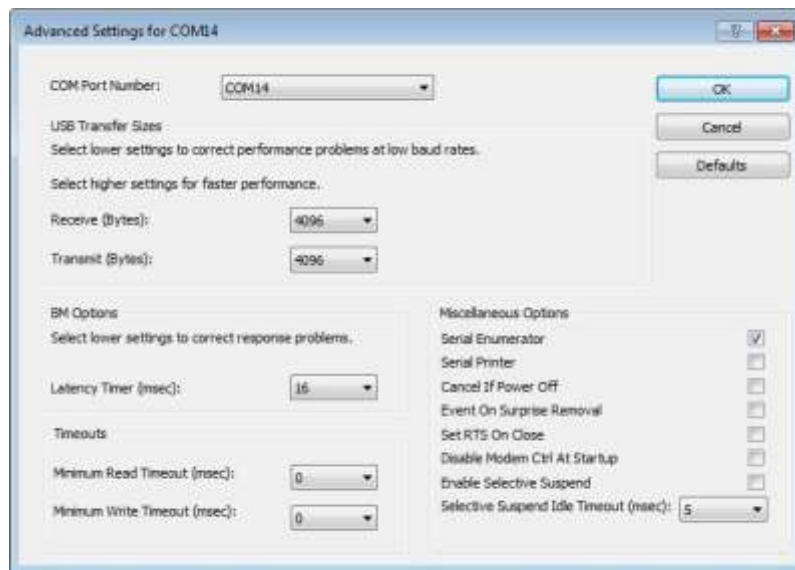
Figure 1.6

Click the **Advanced** button and the following window appears:

Under **COM Port Number** you can define a com port for the USB serial converter. After having selected the **COM Port Number**, make sure to close SeaStar. When re-opening SeaStar, the COM port should become active in SeaStar and can be viewed either under the **Connection Wizard** or **Settings > Communication > Serial Ports**. If the COM port number does not become active in SeaStar please try another COM port number. Even though the **Device Manager** of the computer reports that a COM port number **is in use**, it might be possible to define and use those COM ports for the USB.

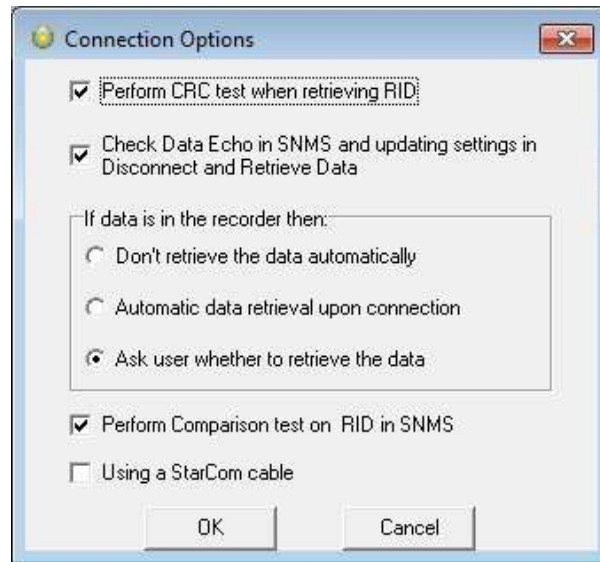
By choosing the **Settings** menu and the **Connection** option command the following window appears:

Figure 1.7 Connection Options

Disable the **Check Data Echo in SNMS**. Press OK and try to connect again.

If there is an existing communication problem while using a USB serial converter the user can try to disable the **Check Data Echo in SNMS** option. This option will bypass data echo checks, resulting in less restriction on communication protocol.
