**Product: IC693CPU364 CPU Module with Ethernet Interface**

**IC693CPU364-BF with CPU Firmware Release 10.50**

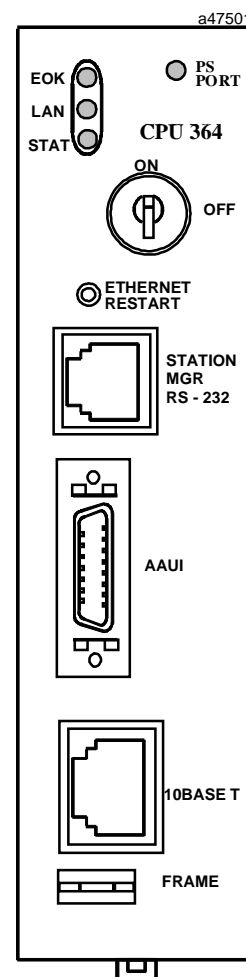
NOTES: On earlier modules, the LED labeled "PS PORT" may read "SNP," and/or the port labeled "STATION MGR RS-232" may read "PORT 1 RS-232"; these are labeling changes only - the functionality was not changed.
