IMPORTANT FIELD SAFETY MODIFICATION

PRODUCT: 3DLINE DMLC

FCO Ref: 200 02 602 032

Device identification of the DMLC IV and DMLC V systems on an Elekta digital linear accelerator with bar codes and a bar code scanner

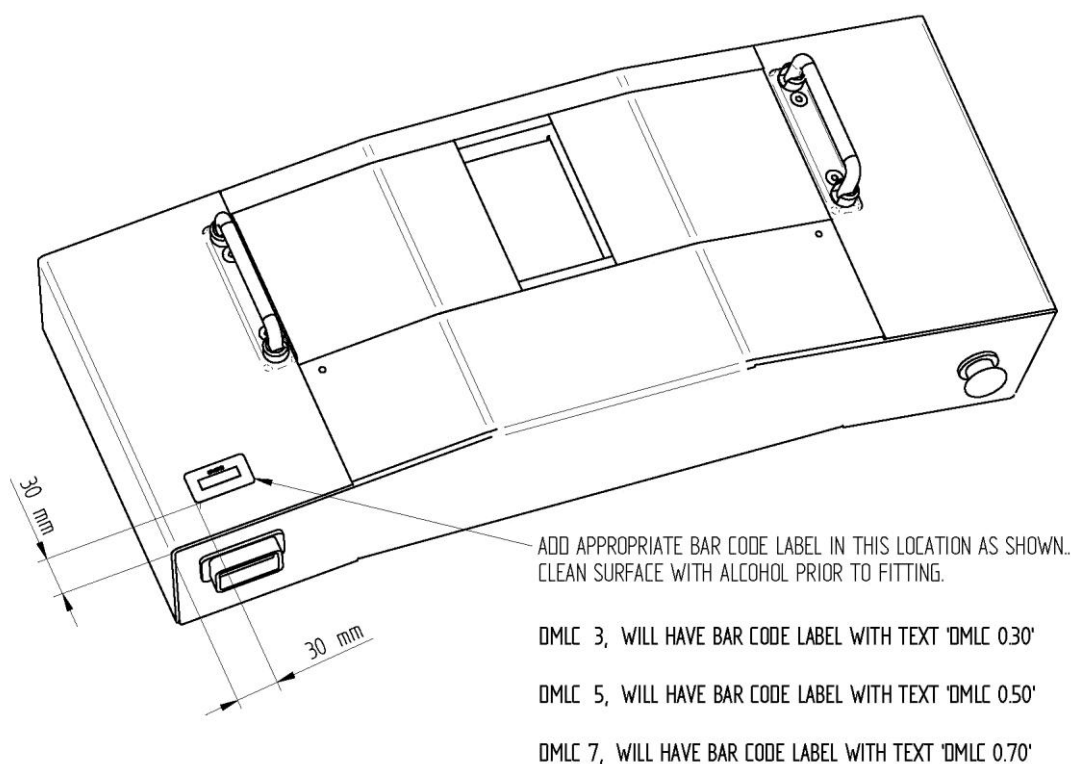
Figure 1: Label position

1. Select the Dynamic Multileaf Collimator
2. Make sure that the DMLC surface where you attach the bar code label is clean.
3. Select the correct bar code label from the supplied bar code label sheet (part number 1500927). It must be the same as the correct type of DMLC.
4. Attach the label in the correct position (see Figure 1).

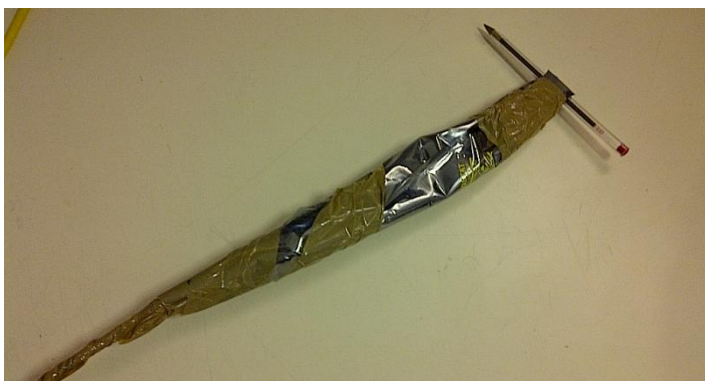
Figure 3: Loop and sleeve on the female connector

1. Attach the male USB connector of the fiber-optic cable (1027546) to the MOSAIQ® computer.
2. Make a sleeve around the female connector of the fiber-optic cable with plastic packaging, or equivalent, and tape to prevent damage to the fiber-optic cable. The fiber-optic cable is easily damaged.
3. You can use a pen to make a loop to attach a draw-string to the end of the fiber-optic cable (see Figure).

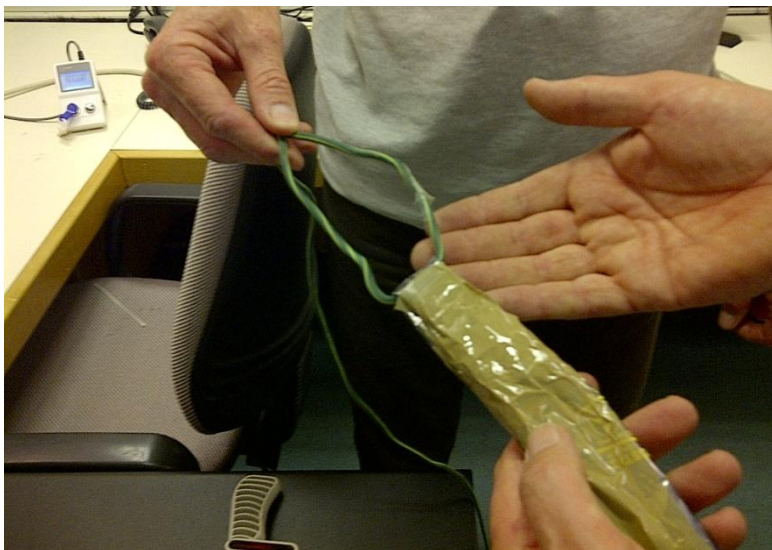
Figure 4: Draw-string through the loop at the end of the fiber-optic cable

4. Attach the draw-string to the sleeve and tape it to the primary part of the cable. This prevents pressure on the connection between the interface box and the fiber-optic cable (see Figure).

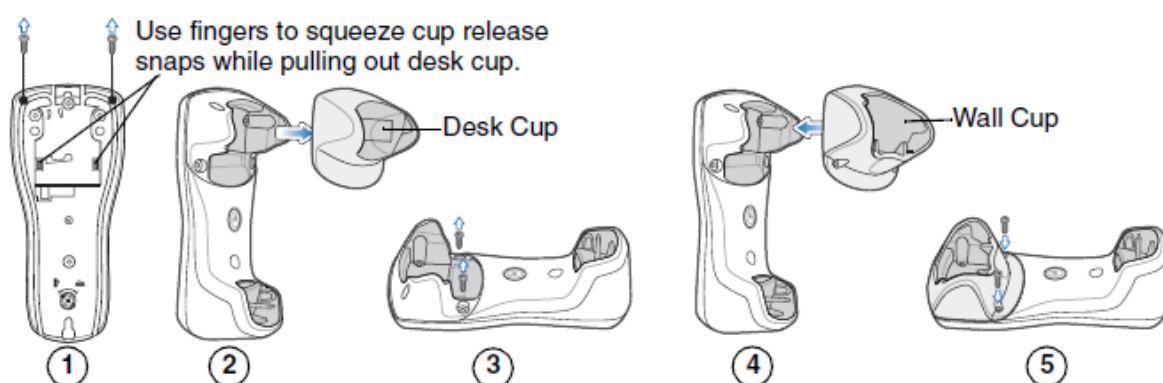
Figure 5: Change to a vertical cradle

1. Use a cross-head screwdriver to turn the Wall Mount Conversion Dial to the correct position to hold the bar code scanner in a vertical position (on a wall). The front latches move out to engage the bottom of the scanner handle.
2. Use a cross-head screwdriver to remove the screws on the rear of the cradle (see Figure 5), and follow the steps in Figure 5 to install the wall cup.

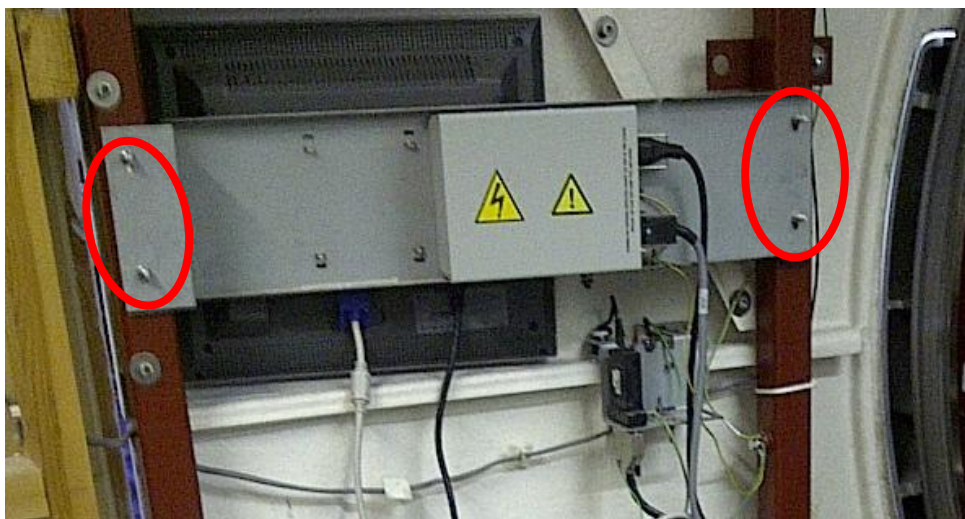
Figure 3: Bolts for the treatment room monitor

1. Hold the TRM and remove the bolts (see Figure 3). Be careful with the cables.

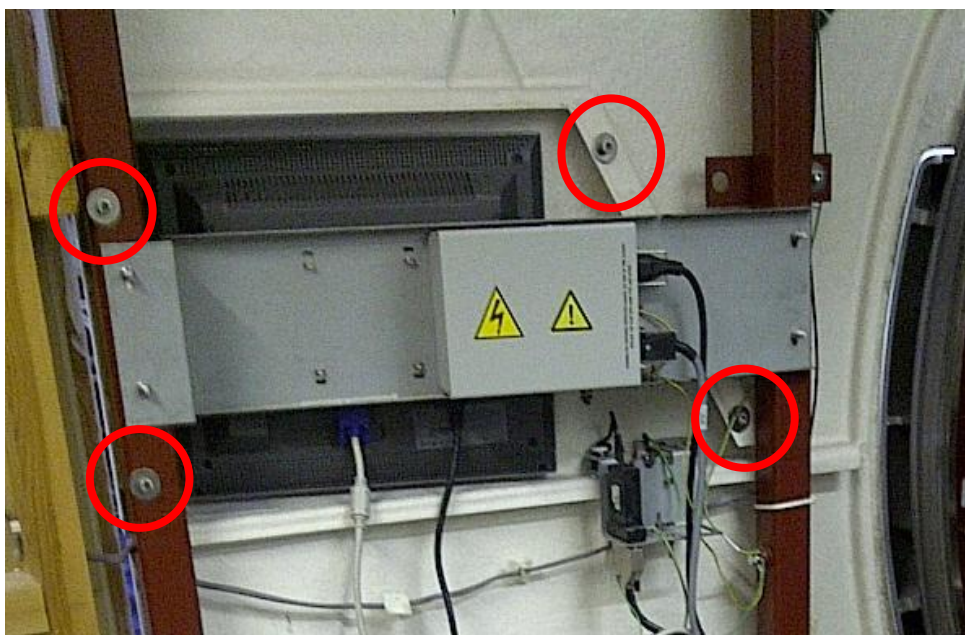
Figure 7: Second set of bolts

2. Remove the TRM.
3. Remove the second set of 4 bolts (see Figure 7).

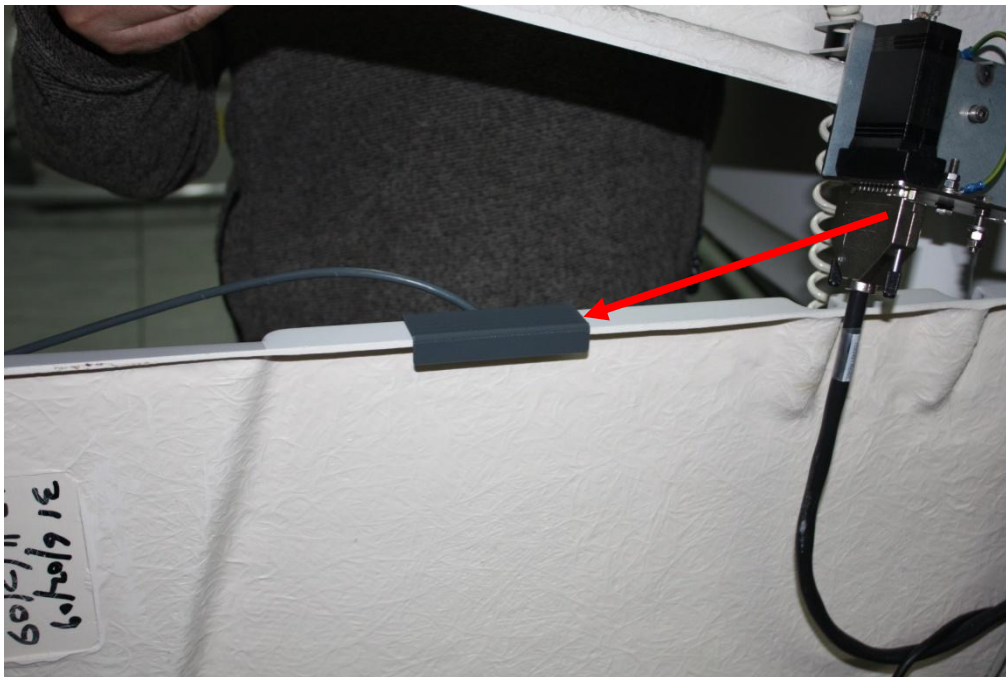
Figure 8: Cradle bracket on lower fascia panel

4. Lift the fascia panel.
5. Put the cradle bracket on the lower fascia panel (see Figure 8).

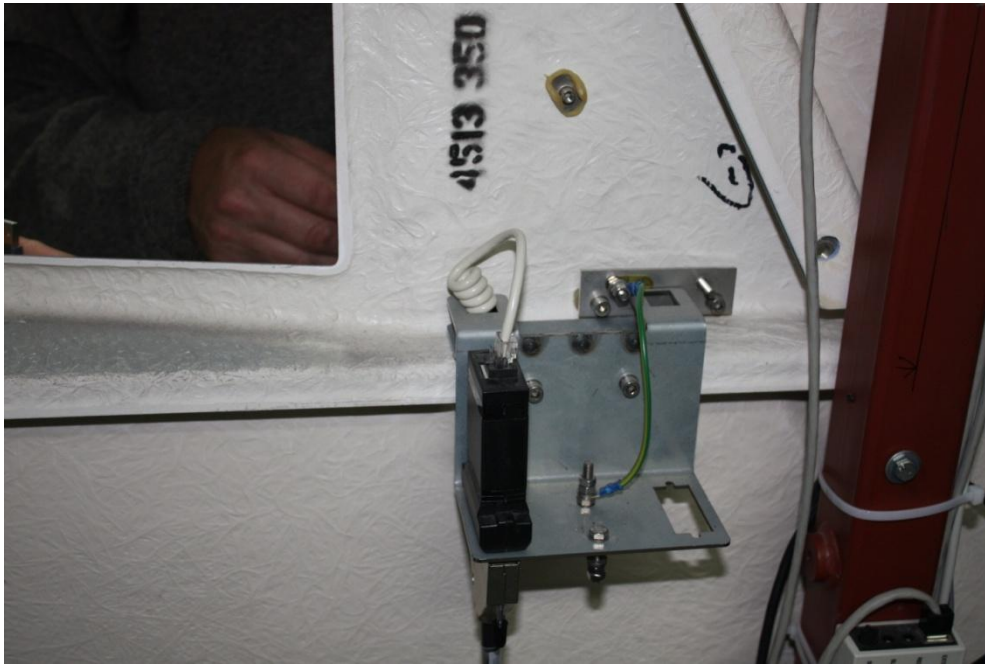
Figure 4: Route the USB cable

6. Route the cable for the handheld controller again from the left hole in the bracket (viewed from the back) to the right hole.
7. Route the USB cable for the bar code scanner through the hole nearest the bar code scanner (see Figure 4 and Figure 5).

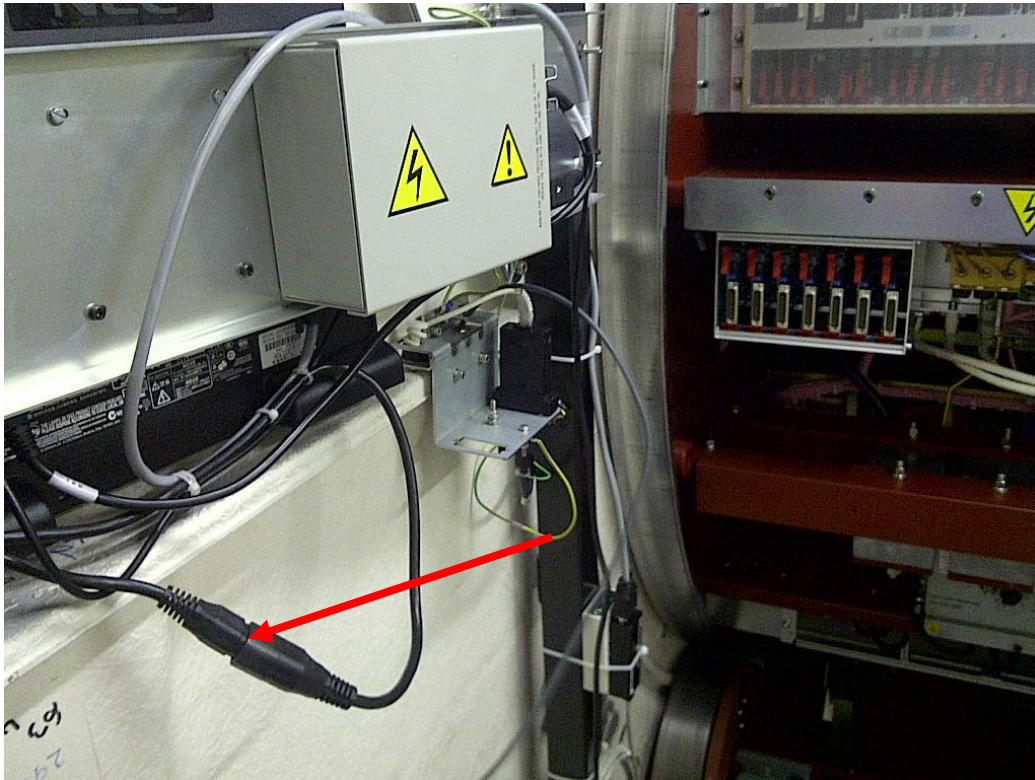
Figure 6: Split power cable

8. Install the panel again.
9. Install the bolts and TRM again.
10. Connect the external PSU (1026959) to the small box on the female end of the fiber-optic cable extender.
11. Connect the split power cable (1028409, part of the upgrade kit) to the mains power supply for the TRM (see Figure 6).

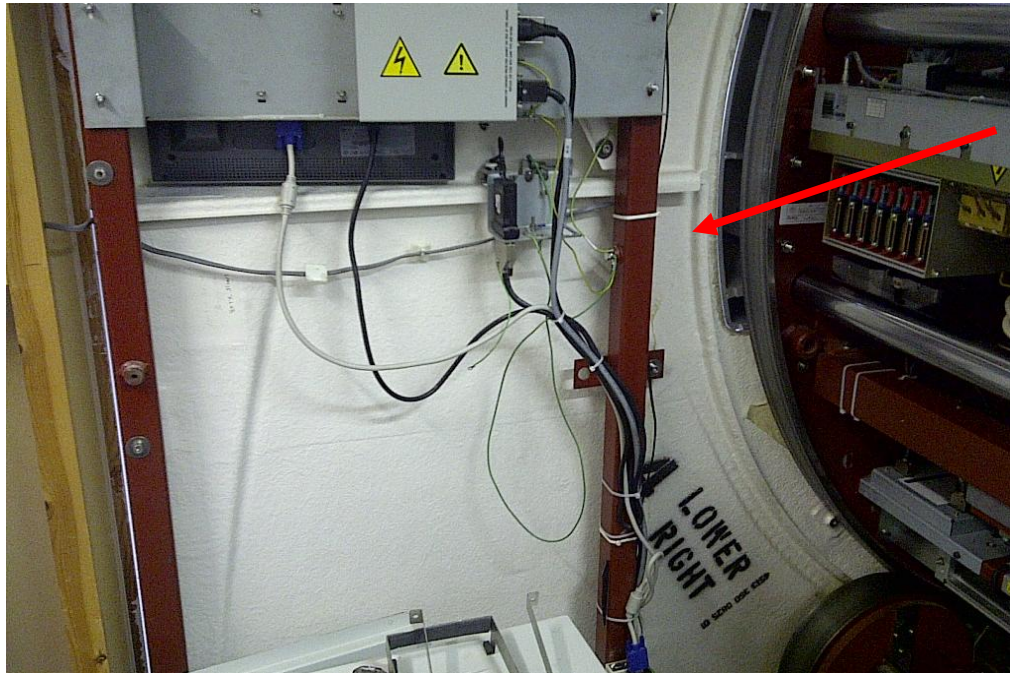
Figure 8: Cable tie to frame

14. After you pulled the fiber-optic cable through the cable ducts, put the end behind the fascia near the selected TRM. Install it to the frame with cable ties (see Figure 8). Be careful not to attach the cable tie too tightly.

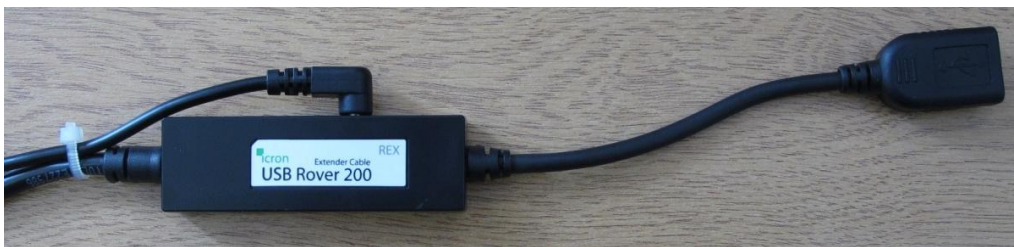
Figure 9: Cable tie for the power cable

15. Use cable ties to attach the power supply cable to the extension cable (see Figure 9).

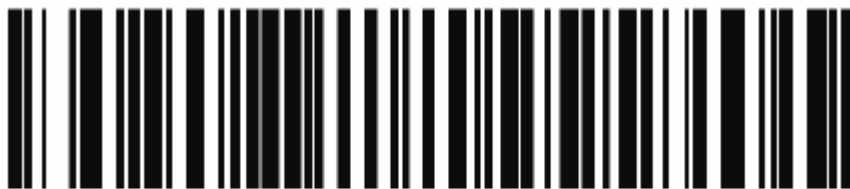
Figure 2: CDC COM Port Emulation code example

3. Do a scan of the CDC COM Port Emulation code (see Figure 2 for an example).
