PANEL & PLC ERROR CODE TABLES

Introduction	A-2
C-more Micro Panel Error Code Table	A-3
Modbus Protocols Error Code P499 Explanation	A-4
AutomationDirect CLICK	A-4
AutomationDirect DirectLOGIC - Modbus (Koyo).....	A-4
Modicon Modbus RTU	A-4
Entivity Modbus RTU	A-4
Productivity Error Code P499 Explanation	A-5
Do-more Error Code P499 Explanation	A-6
Direct LOGIC Error Code P499 Explanation	A-7
Direct LOGIC – K-Sequence PLC Error Code Table.....	A-7
Direct LOGIC – Direct NET PLC Error Codes.....	A-7
Allen-Bradley Error Code P499 Explanation	A-8
Allen-Bradley DF1 Protocol – PLC Error Code Tables.....	A-9
Allen-Bradley DH485 Protocol – PLC Error Code Tables.....	A-11
GE Error Code P499 Explanation	A-13
GE SNPX Protocol – PLC Error Code Tables	A-14
Mitsubishi FX Protocol – PLC Error Codes	A-23
Mitsubishi Q / QnA Series – PLC Error Codes	A-23
Omron Error Code P499 Explanation	A-25
Omron Host Link Protocol – PLC Error Code Table	A-26
Omron FINS Protocol – PLC Error Code Table	A-27

Introduction

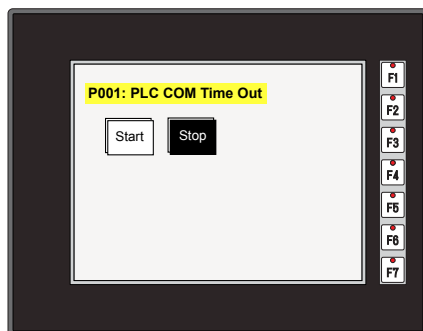
C-more Micro Panel Error Example

The **C-more** Micro panel also monitors any errors that are generated by the PLC that is connected to it. If any of the PLC generated errors are detected, they are displayed across the top of the panel's display embedded as a hexadecimal value in error code P499. An explanation of how the specific PLC error is identified in the panel error code P499 is shown preceeding the specific manufacturer's PLC error tables. How the hexadecimal error code value is interpreted is slightly different between manufacturers, so it is important to check the explanation at the beginning of each manufacturer's tables. Since these errors are generated by the PLC, refer to the PLC manufacturers documentation for further explanation.

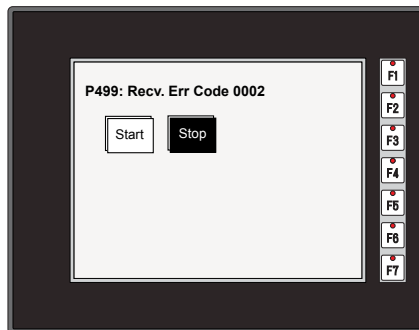
DirectLOGIC PLC Error Code Displayed Example:

The P499 error code is used to show any errors that are generated by the connected PLC. The P499 error message includes a four digit hexadecimal value displayed at the end of the message. This value can be found in the specific PLC's error tables to determine the cause of the error. The possible PLC generated error codes for the various **DirectLOGIC** communication protocols breakdown into a four digit hexadecimal value.

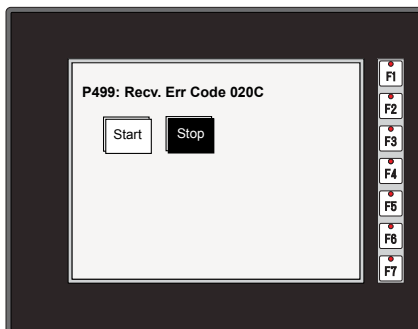
GE Error Code P499 Message Example:

The P499 error code is used to show any errors that are generated by the connected PLC. The P499 error message includes a four digit hexadecimal value displayed at the end of the message. This value can be looked up in the specific PLC's error tables to determine the cause of the error. The possible PLC generated error codes for the GE 90-30, 90-70, Micro 90 and VersaMax Micro SNPX communication protocols breakdown into a four digit hexadecimal value.

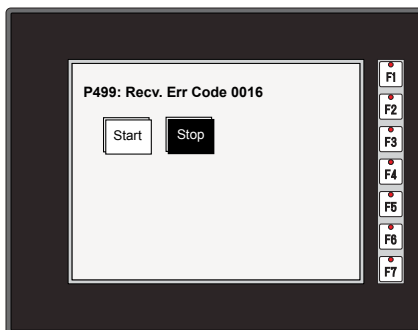
Omron Error Code P499 Message Example:

The P499 error code is used to show any errors that are generated by the connected PLC. The P499 error message includes a four digit hexadecimal value displayed at the end of the message. This value can be looked up in the specific PLC's error tables to determine the cause of the error. The possible PLC generated error codes for the Omron Host Link communication protocols breakdown into a four digit hexadecimal value.
