# **ALEXA Classic SUP 9.0**

**for ALEXA Classic models (SUP\_Alexa\_9.0\_25486)**

**RELEASE NOTES**

**Date: December 17, 2013**

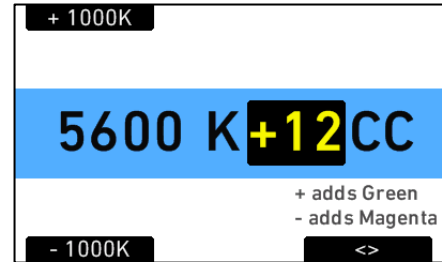
**Increased CC range for white balance:** The green/magenta shift correction range has been extended from +/- 8 to +/- 12 steps which allows balancing the camera for a larger range of light sources. Please note that for ARRIRAW images with CC values beyond 8, ARRIRAW Converter (ARC) 3.0 open beta 2 or later or a third party tool that uses the ARRIRAW SDK 4.4.1 patch release or later are required. Please check with the respective software developers about compatibility.

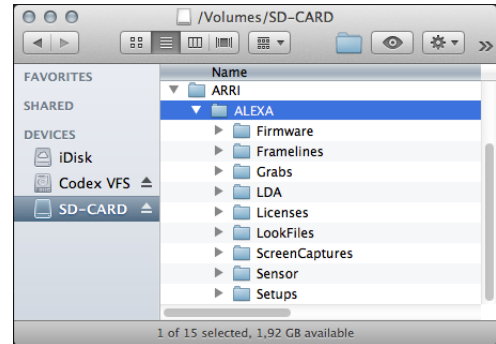
- Have a FAT16 or FAT32 formatted SD-Card ready.
- Cards larger than 4 GB are not supported. If you have a larger SD card, you need to create one partition with max. 4GB so it will be compatible with ALEXA.
- Go to MENU > SYSTEM > SD CARD and choose
  - 'Prepare SD card' to create the ALEXA folder structure on the SD card, and keep the existing data.
  - 'Format + prepare SD card' to DELETE ALL DATA on the SD card before creating the ALEXA folders.
- Copy the update package  
SUP\_AlexaX\_x.x\_zzzzz.pkg (for ALEXA XT/XR)  
SUP\_Alexa\_x.x\_zzzzz.pkg (for ALEXA Classic)  
into the 'Firmware' folder on the SD card.
