Trouble-shooter for
DST CTD
&
DST Logic CTD

STAR : ODDI

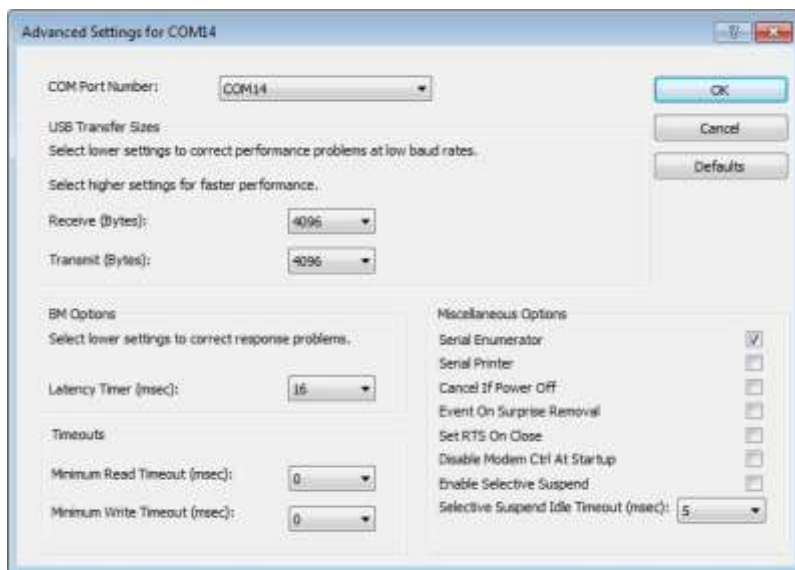
Figure 1.6

Click the **Advanced** button and the following window appears:

Under **COM Port Number** you can define a com port for the USB serial converter. After having selected the **COM Port Number**, make sure to close SeaStar. When re-opening SeaStar, the COM port should become active in SeaStar and can be viewed either under the **Connection Wizard** or **Settings > Communication > Serial Ports**. If the COM port number does not become active in SeaStar please try another COM port number. Even though the **Device Manager** of the computer reports that a COM
