PACSystems* RX3i

IC695PNC001-AF

PROFINET Controller Module

GFK-2573F
August 2013

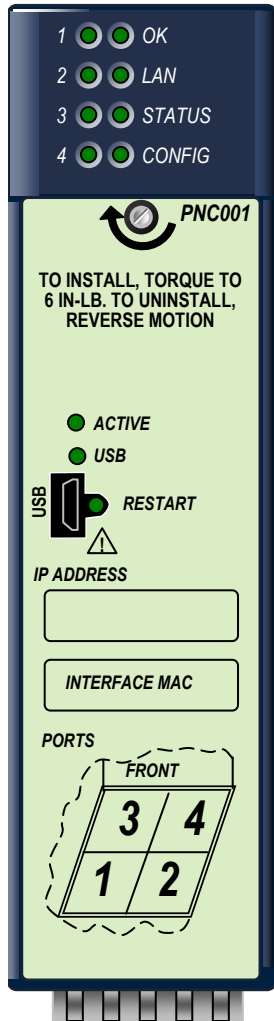
The PACSystems^{*} RX3i PROFINET Controller (PNC) module, IC695PNC001, connects a PACSystems RX3i controller to a high-speed PROFINET local area network. It enables the RX3i controller to communicate with IO-Devices on the LAN. The PNC provides all the functions, services, and protocols required for certification as a PROFINET IO Version 2.2 IO Controller, running at both 100 Mbps and 1 Gbps.

- Support for star, ring, and daisy-chain/line network topologies.
- Four switched Ethernet ports - two 8-conductor RJ-45 shielded twisted pair 10/100/1000 Mbps copper interfaces and two Small Form-factor Pluggable (SFP) cages for user-supplied SFP devices.

- LEDs: OK, LAN, STATUS, CONFIG, ACTIVE, USB, and four Port LEDs.
- Compliant with EU RoHS Directive using the following exemptions identified in the Annex: 7c-I and 7c-III.

OK	Indicates whether the module is able to perform normal operation.
LAN	Indicates network packets are being processed by the network interface (not just passing through the embedded switch).
STATUS	Indicates the condition of the PROFINET Controller during normal operation. It indicates whether an entry other than the startup event is present in the module's local log. STATUS can also indicate whether any of the MAC addresses are invalid.
CONFIG	Indicates whether the module has received its configuration from the RX3i CPU.
ACTIVE	Indicates the status of PROFINET connections.
USB	Indicates activity on the USB port.
Port LEDs	Indicate link speed, link connection and link activity corresponding to the four possible external Ethernet ports.
