Compact Controller for Stand-by and Parallel Operating Gen-sets

**InteliGen<sup>®</sup>**  
**InteliSys<sup>®</sup>**

Software version IG-6.2, IS-3.4, August 2005

## Troubleshooting guide

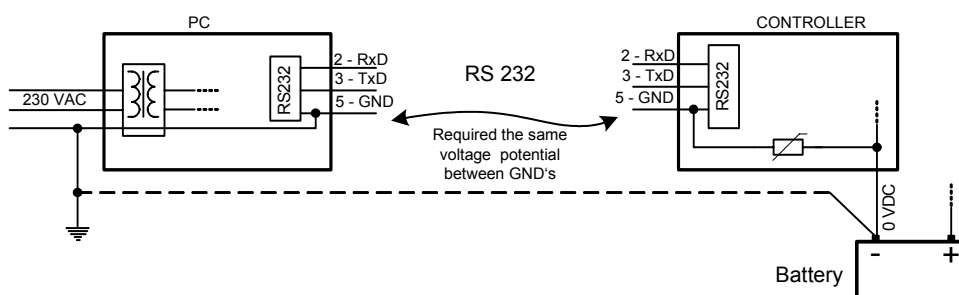
Make sure the grounding system on controller and PC – COM port (negative of the PC DC supply) are identical – before the first direct connection. There must not be any voltage between these two points otherwise the internal PTC protection activates and interrupts RS232 communication (resistor in older types controller burns out). The simple solution is to assure, that the PC supply 240/20V is ground free (GND terminal is not connected) - see also the next point.

The RS232 recoverable PTC ground protection is in IntelliGen and IntelliSys (IntelliLite) controller. Activation of PTC ground protection causes communication interruption and “[Supply is OK, display is still dark](#)” (see in the chapter General) when it happens during firmware reprogramming.
