PACSystems™ RX3i IC695CMU310

Max-ON Hot-Standby Redundancy CPU

GFK-2420
November 2005

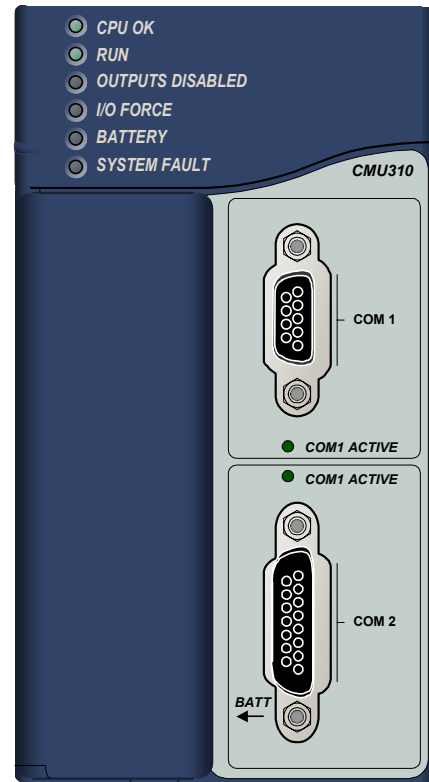
The RX3i Max-ON CPU IC695CMU310 provides Hot-Standby CPU redundancy using two RX3i systems. The redundant PLCs exchange operating data by way of one or two dedicated Ethernet LANs. Each RX3i system in a Max-On application consists of:

- Two serial ports: RS-485 and RS-232.
- CPU and module firmware upgrades via Winloader through CPU's RS-232 or RS-485 serial port.

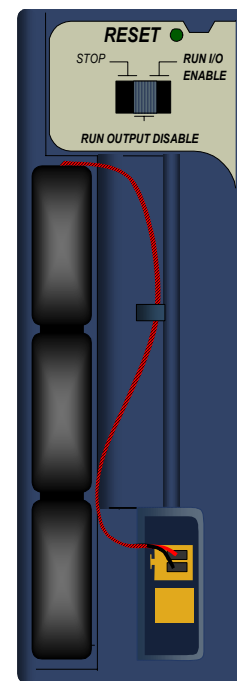
Operation of the CPU can be controlled by the three-position RUN/STOP switch or remotely by an attached programmer and programming software. Program and configuration data can be locked through software passwords.

CPU status is indicated by the CPU LEDs on the front of the module. The following table lists the LED functions during normal operation (after initialization is complete).
