INSTRUCTIONS FOR INSTALLING VENDAPIN VENDING PRODUCTS

XEROX/SAMSUNG COPIERS

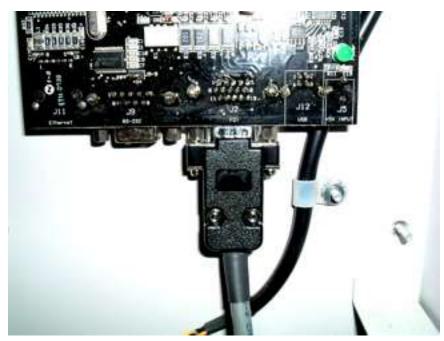
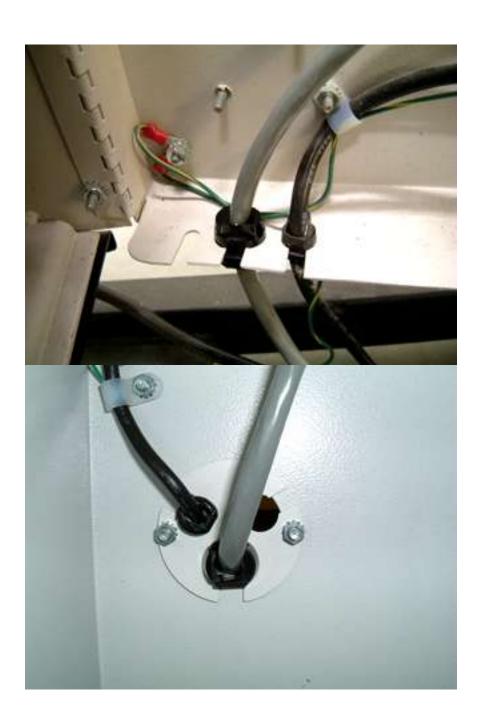
- 5. Find the Xerox/Samsung fifteen-position foreign interface receptacle located on the rear, right cover panel. Connect the 15 pin D-Sub male connector of the Machine harness (Gray Cable) to the Foreign Device Interface port.

- 6. Connect the VENDAPIN LLC machine harness to J2 of the Raptor II VMC board. Route the cable as shown in the following photos.

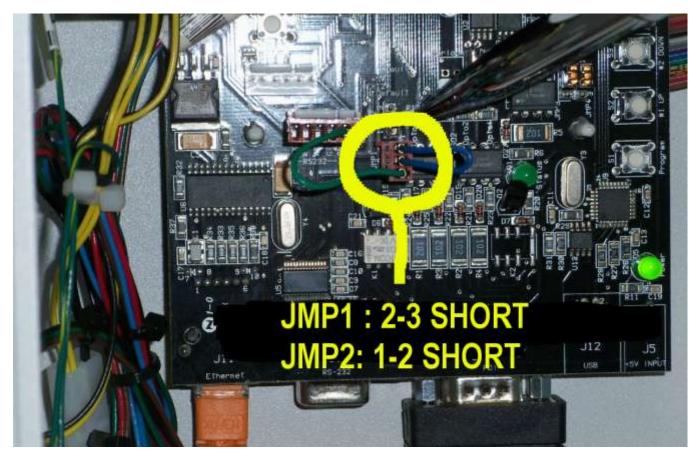
NOTE: There are jumpers that need to be installed on the Raptor II VMC Board.

JMP 1 – Pins 2 and 3 connected. JMP 2 – Pins 1 and 2 connected.
