Dynamix 2500 Data Collector, Firmware Revision 1.020

Catalog Numbers 1441-DYN25, 1441-DYN25-Z

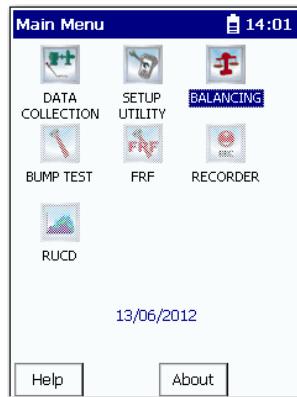
Any modules that were licensed prior to the upgrade will still be licensed. Any modules that are installed, but which have not been licensed will appear grayed out as unavailable.

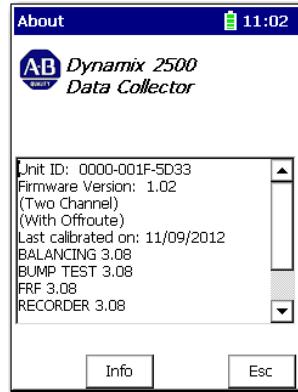
To confirm that the correct revision was loaded, press F3 (About) on the Main Menu screen. The firmware revision should match the operating system file just loaded.
