# Troubleshooting

*Cepheid HBDC training  
2013*

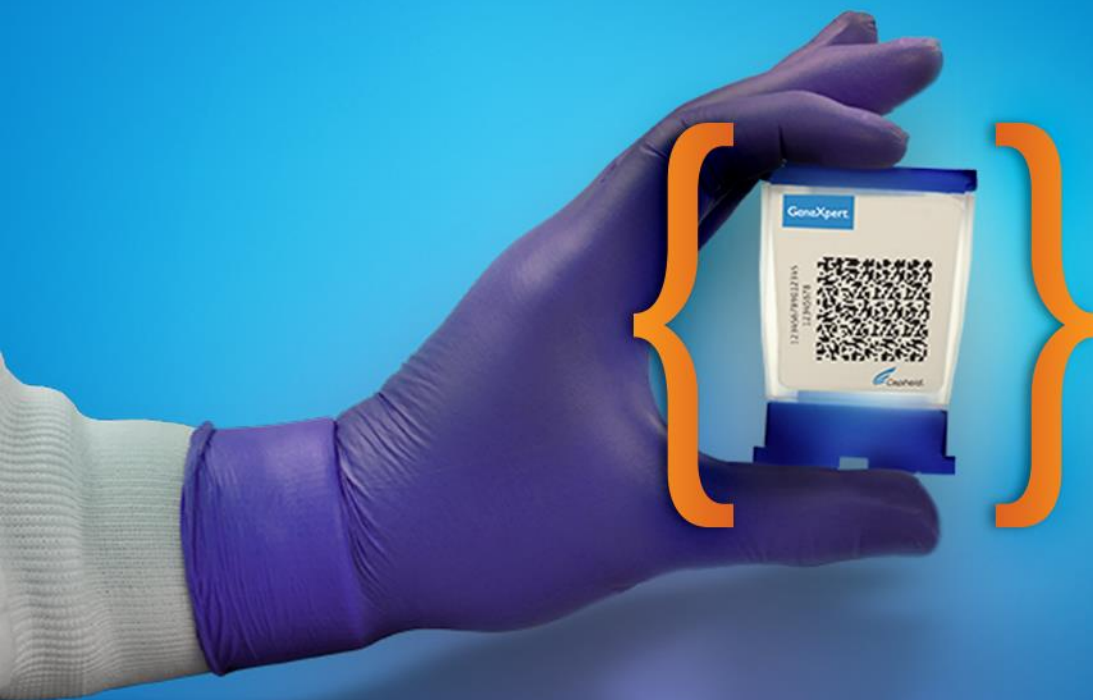
Information of the system	
Serial number of your GeneXpert (at the back side, near the power button)	
Computer Service Express Service Tag Number	
Installation date of the system	... / ... / ....
